# TECHNICAL MEMORANDUM

Utah Coal Regulatory Program

RE: Channel Repair Plan, Plateau Mining Corporation, Star Point Mine, C/007/0006, Task #4196

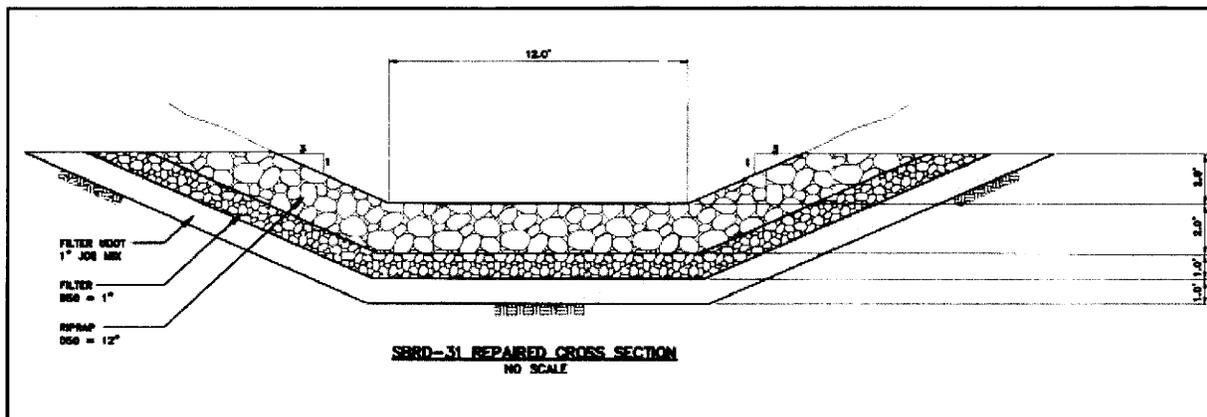
The erosion of SPRD-30 and SPRD-31 was the result of runoff exceeding the design flow due to the effects of the burn in the upper watershed. Plateau commits to working with the U.S. Forest Service to re-vegetate the burned area and restore the watershed to a pre-burn condition as soon as practical.

SPRD-30 was designed and constructed with a 4-foot bottom width and a minimum depth of 1 foot. The channel was lined with a three-dimensional geofabric (Pyramat or equivalent). The same cross section will be installed during the channel repair. Because the flow in the channel exceeded its capacity, some erosion has occurred adjacent to the channel. The geofabric will be removed and the channel will be re-graded by hand to remove rills. The geofabric will then be replaced and anchored in accordance with the manufacturer's instructions.

The original design for SPRD-31 called for a trapezoidal channel with a bottom width of 12 feet, 3: 1 side slopes, and a depth of 2 feet. The channel was lined with riprap having a median diameter of 12 inches, underlain by two filter layers to protect against soil piping beneath the riprap. This same cross section will be installed during the channel repair.

Plan views and cross sections of the channels were included with the application on Plate 2 (see cutouts below). The basic plan for repair of the channel is as follows:

- Mobilize equipment and materials to the site and install sediment controls as necessary. It may be necessary to install these controls immediately downstream from the current permit area since site access will be at the permit boundary.
- Re-grade all areas of the damaged channel, as necessary, to achieve the required grades.
- Install appropriate filter bedding in areas intended for installation of riprap.
- Install D50 = 12 inch riprap in the re-graded portions of the channel.
- Work topsoil into the top of the riprap layer.
- Seed and fertilize all areas disturbed by this project.
