OGMCOAL - 0070006 Star Point Insp Rpt 3208

Inspection Report

InspectionID Report Number: 3208

Permitee: **PLATEAU MINING CORP**
 Operator: **PLATEAU MINING CORP**
 Site: **STAR POINT MINE**
 Address: **PO BOX 30, HELPER UT 84526-0030**
 County: **CARBON**
 Permit Type: **PERMANENT COAL PROGRAM**
 Permit Status: **RECLAIMED**

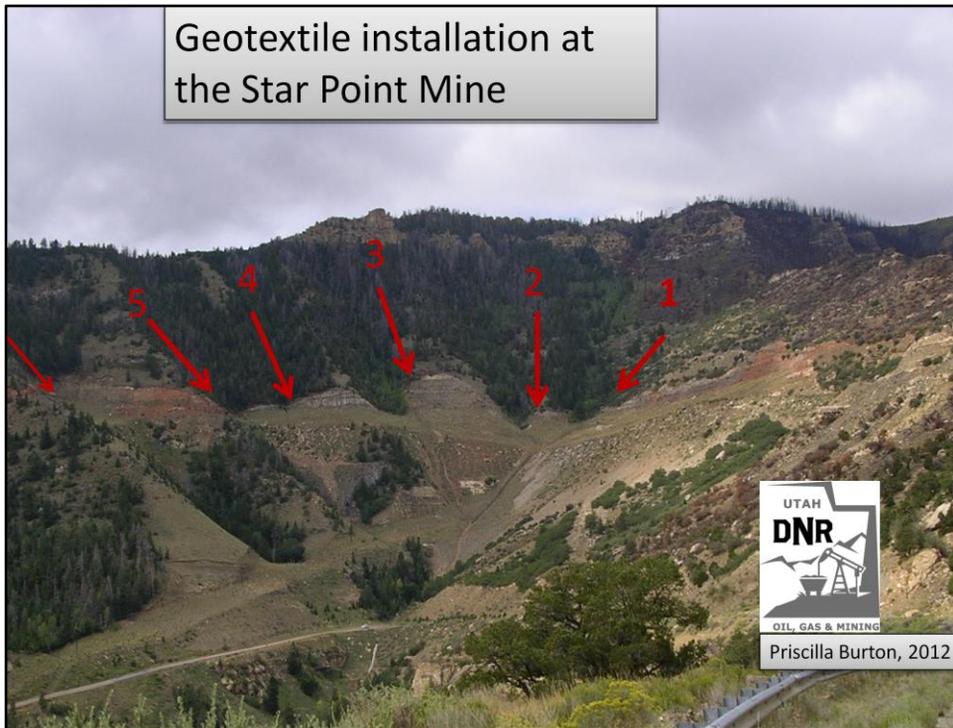
Reclamation treatments included installation of 'Pyramat' geotextile fabric in six "draws" that carried ephemeral flow. Pyromat was used to hold the soil in place and allow vegetation to get established.

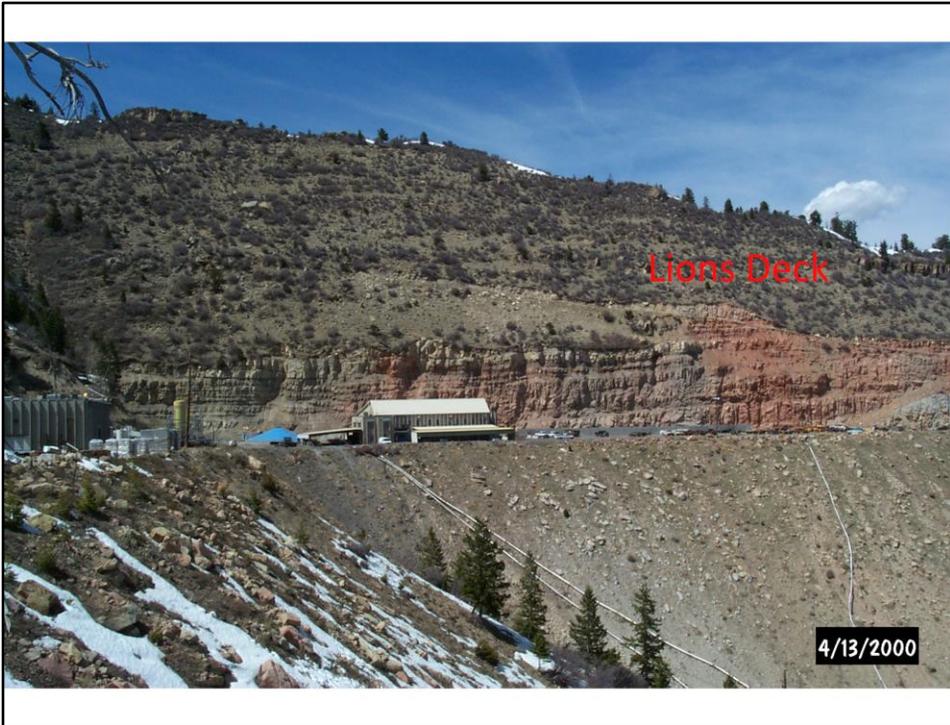
The facilities at the Lion's Deck: bathhouse, portals, rock tunnel, warehouse.

Mine waste was buried against the cut
and covered with four feet of soil

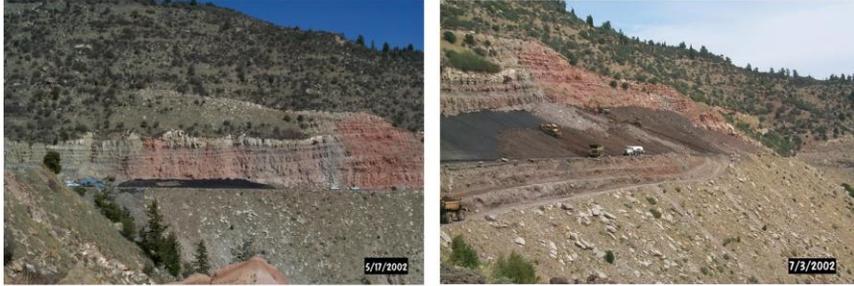
The County road remained, but was reduced in size. Reclamation of highwalls required disturbance of the downhill slopes. Disturbed drainages were treated with Pyramat.

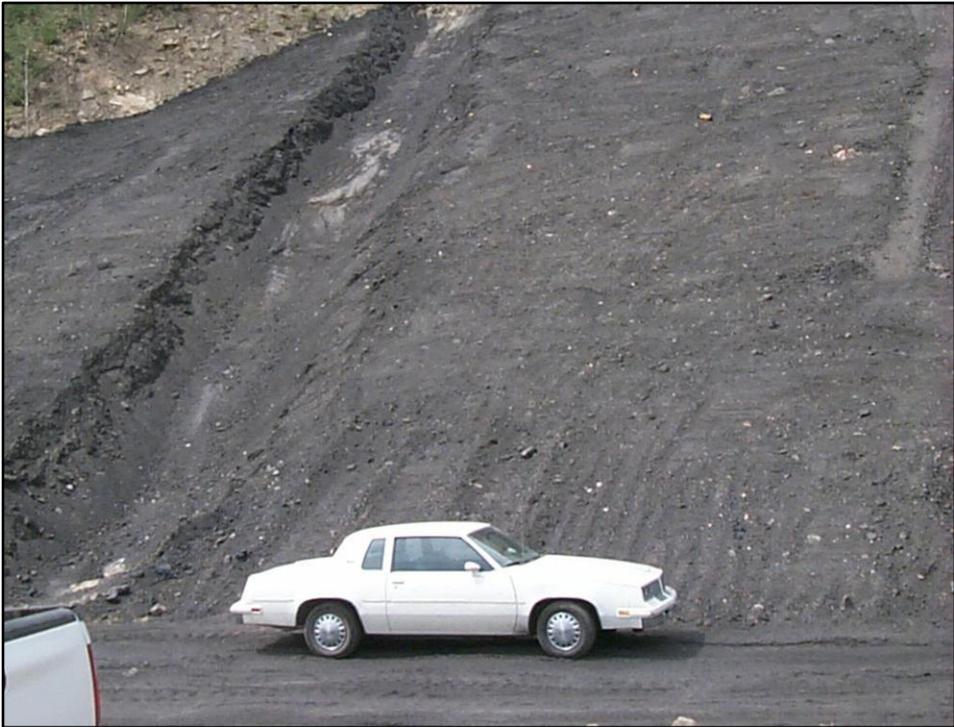
The contour of the drainage channel was graded into the mine waste.

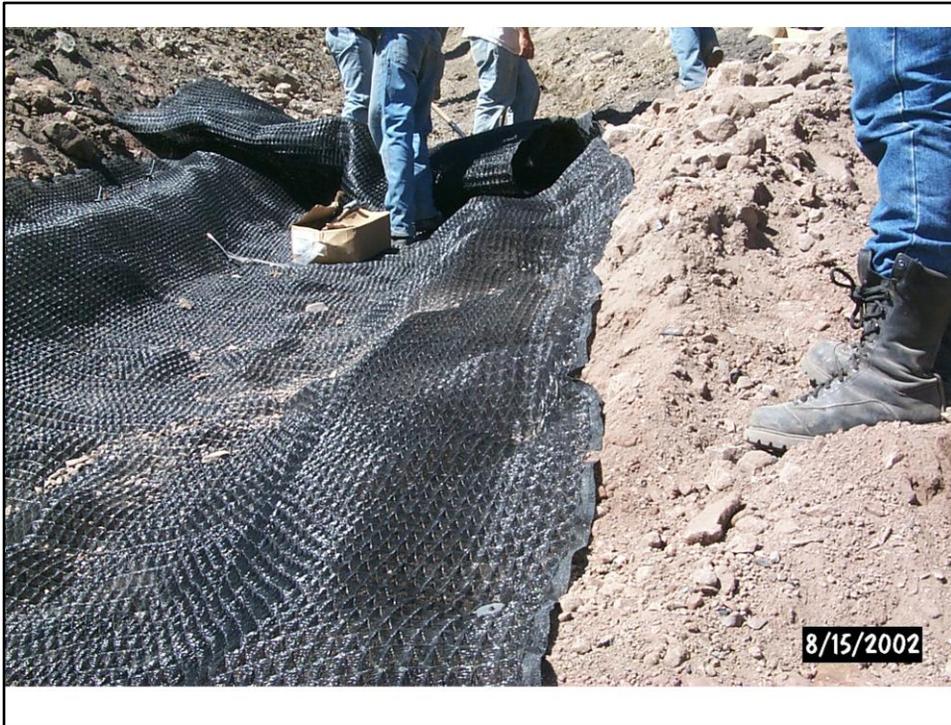
The geotextile fabric is laid on top of the 4 ft. of soil covering the mine waste. The geotextile is pliable to conform to shape of the slope.

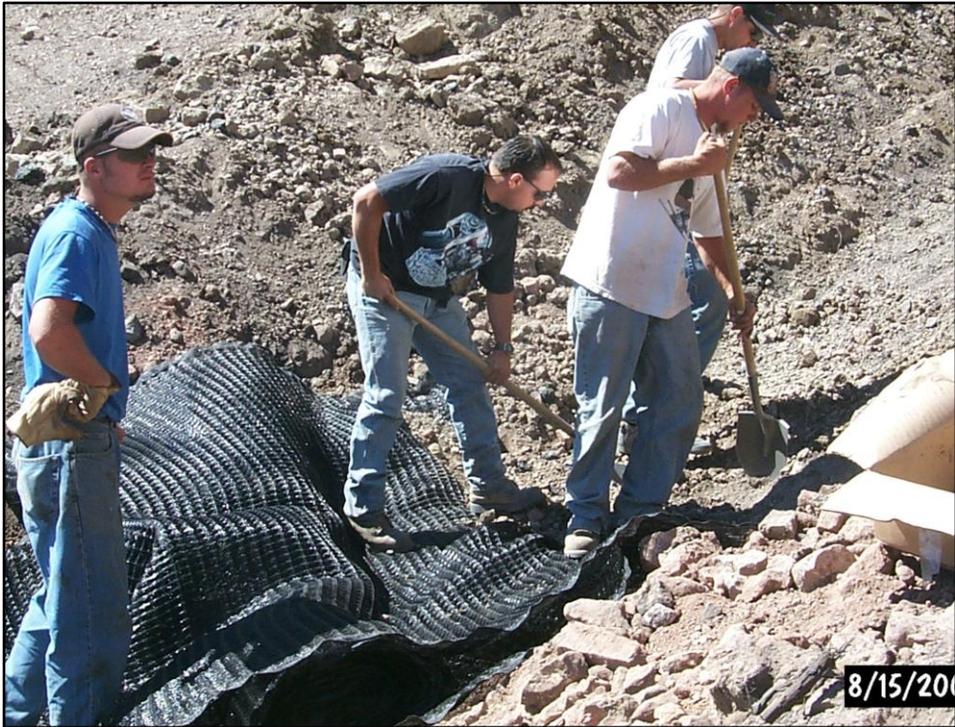
Geotextile is placed on the prepared drainage and covered with soil.

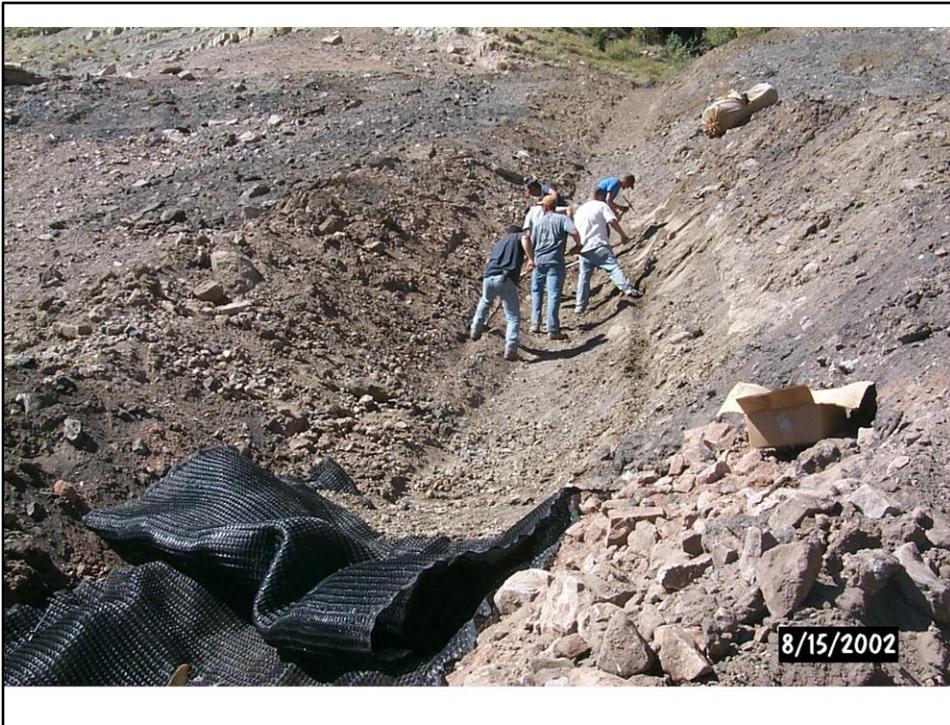
The installation continues upslope.

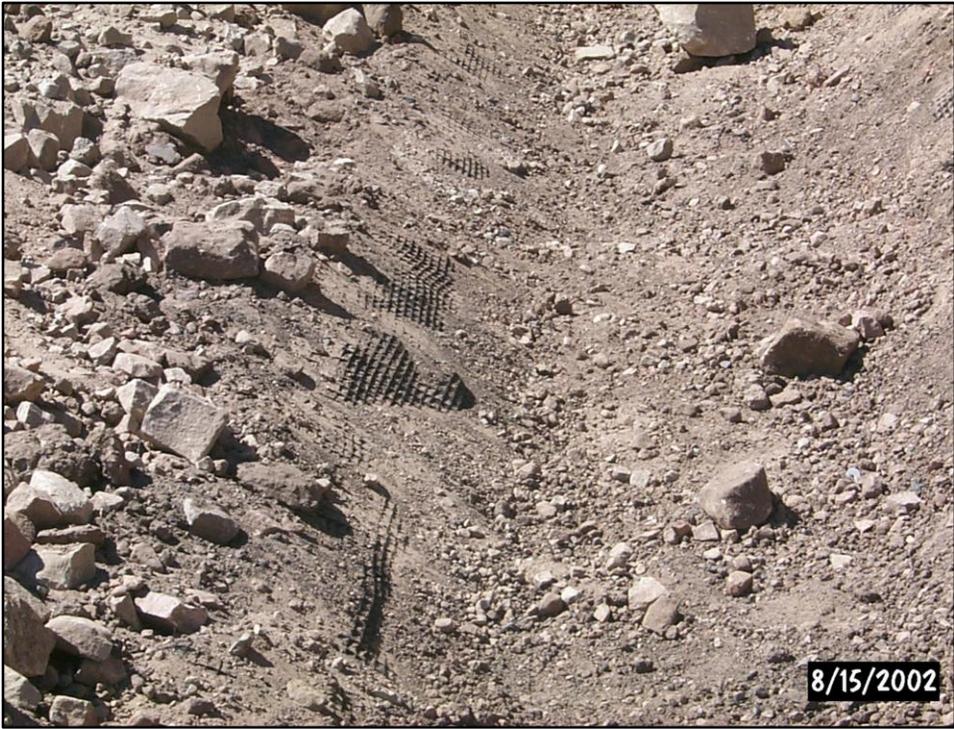
Completed installation .

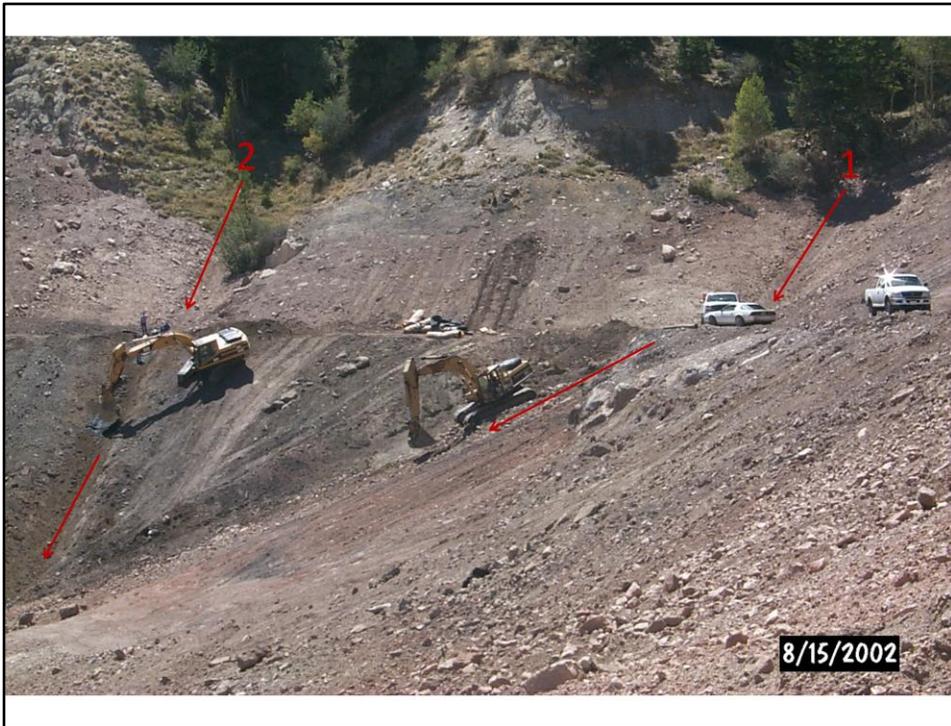
Track hoes are placing soil over geotextile fabric that was used above and below the road. The road remained for the post mining land use. (There are no culverts on the road, the water passes across the road.)

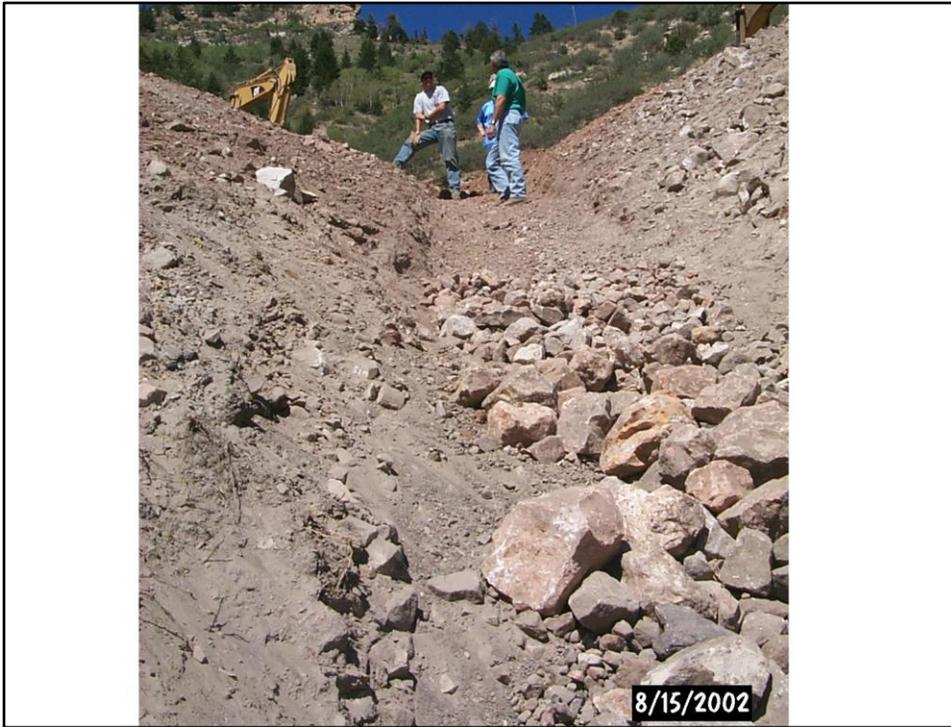
Fabric has been covered with soil. The Division records confirm that the site was seeded and hydromulched with tackifier by 9/5/2002 (2002 Internal 0029.pdf).

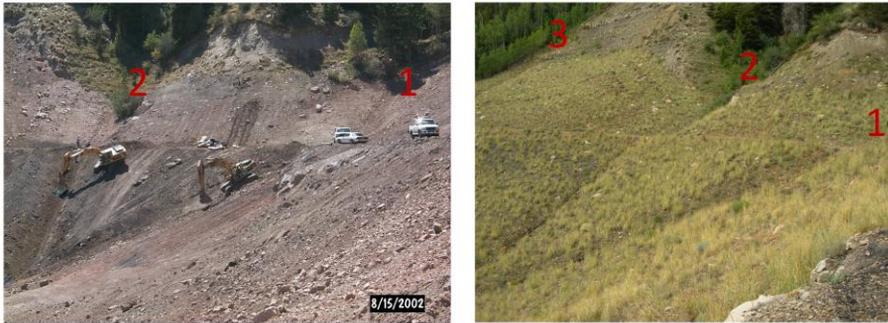
2002 and 2012

Pyramat installation in 2002 and appearance in 2012. Two Tons/ac hay was incorporated into the slopes with gouging. One T/ac straw mulch was blown on the surface. The site was seeded, and a hydromulch with tackifier was applied. The seeding was accomplished in late August or early September.

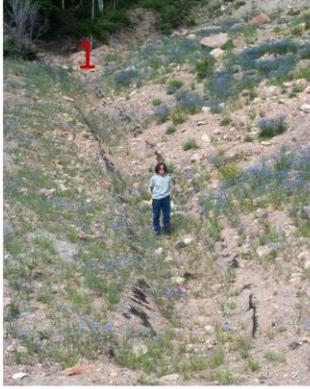
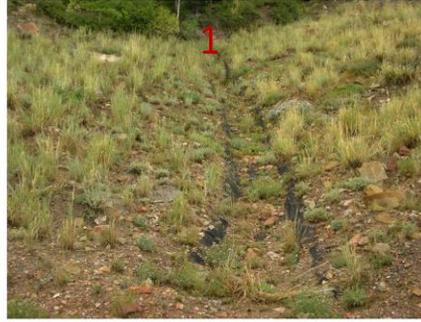
2004 and 2012

Installation at location 1 after 2 years and 10 years.

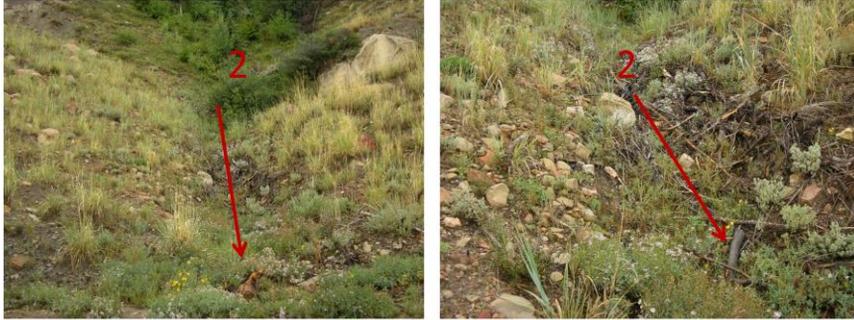
Location 2 is invisible in 2012

Pyramat is totally overgrown in location 2.

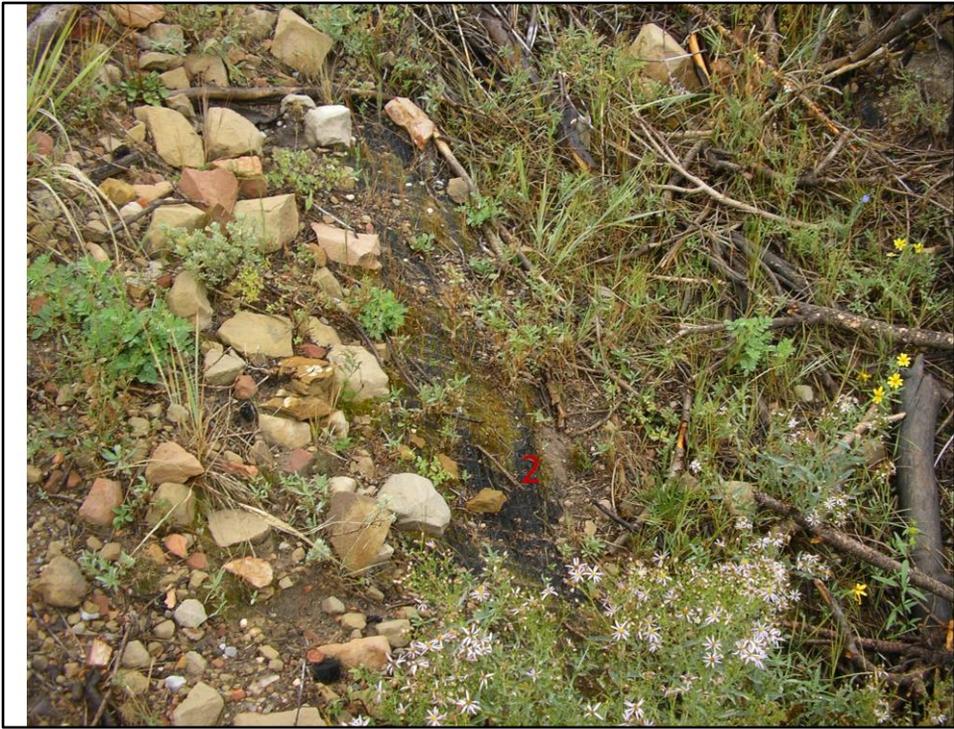
It took a close up look to find the Pyramat in location 2.

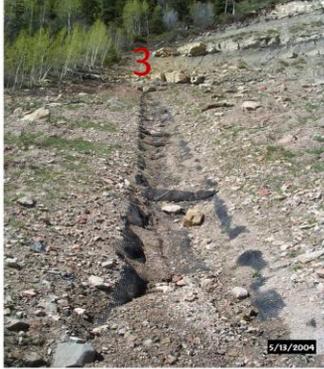
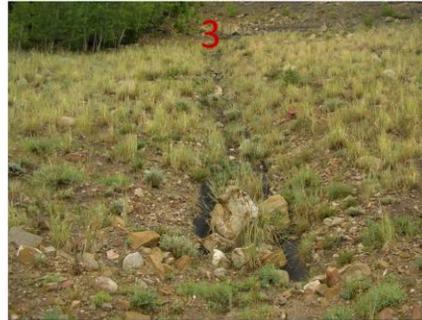
2004 and 2012

After a couple years of seasons, the geotextile slumped in places.

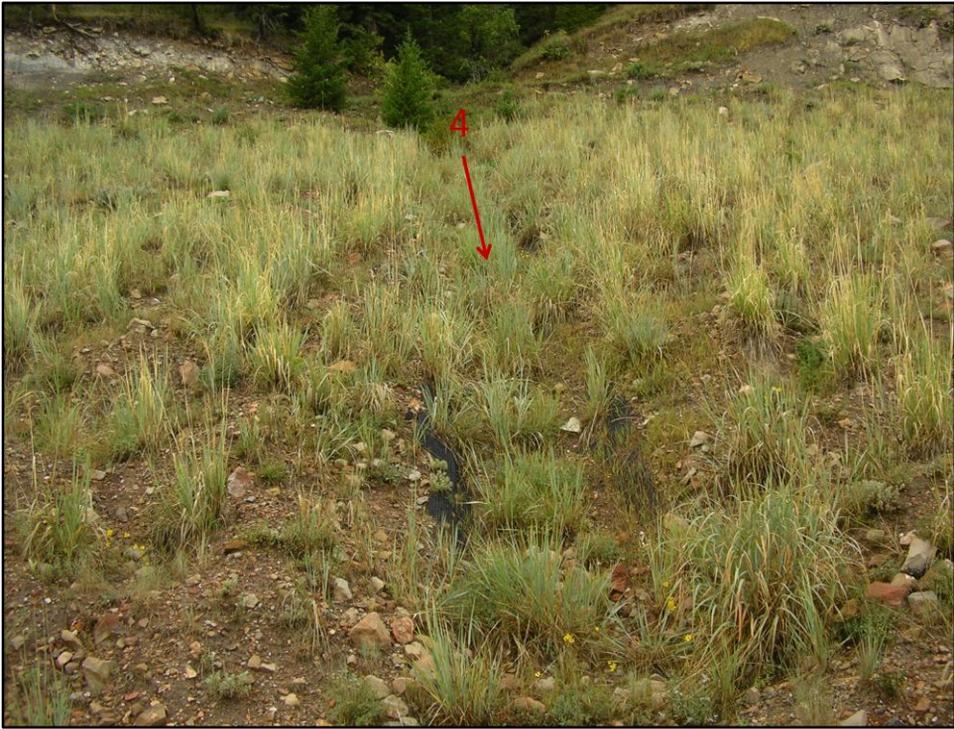
Location 4 has filled in with vegetation.

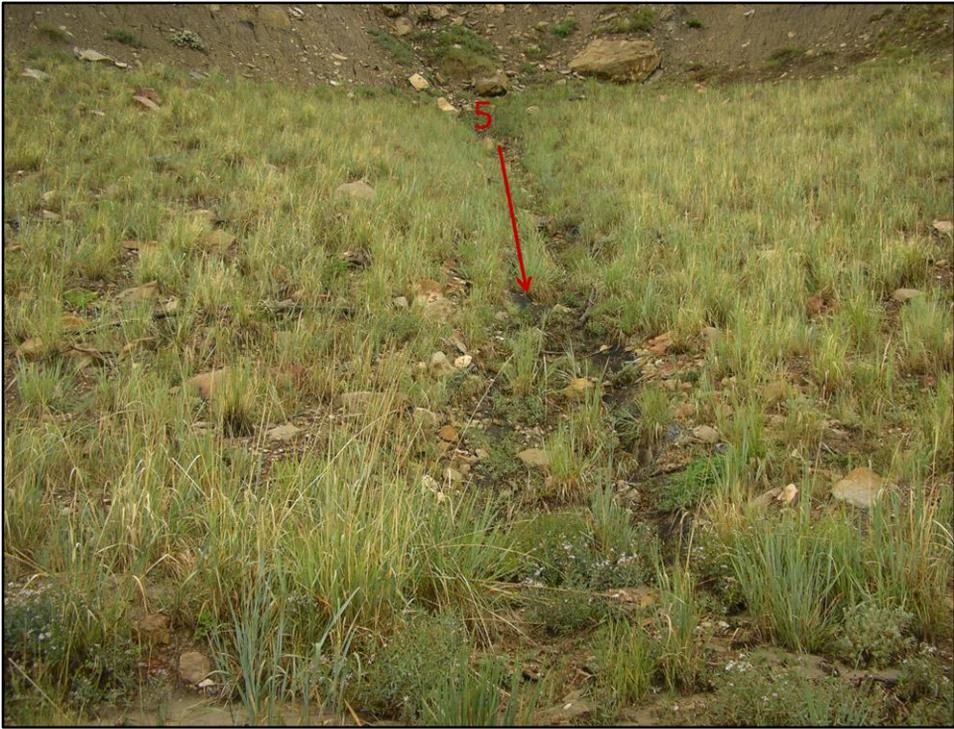
Location 5 has filled in with vegetation.

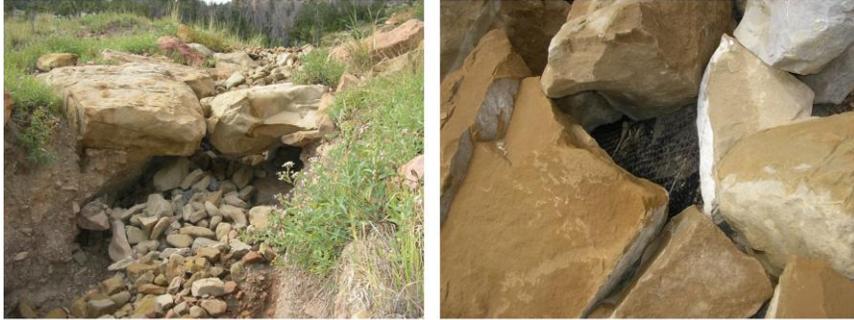
Rock covers geotextile installation at #3 where soil washed out from beneath it on the steep road outslope

This steep convex road outslope required a layer of rock to keep the pyromat in place.

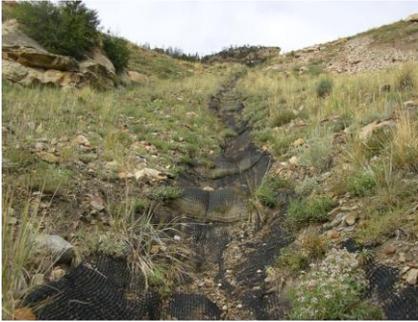
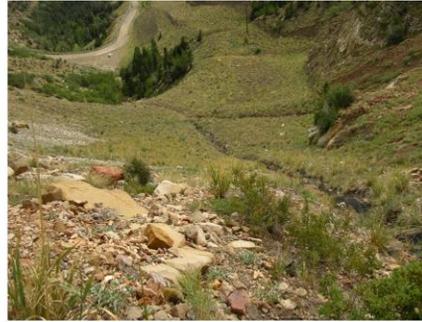
1.5h:1v portion of the slope treated with geotextile.

Soil movement on this long, straight, 1.5h:1v (30 degree) slope is evident in the many bumps of slumped fabric that act as drop structures in the channel.

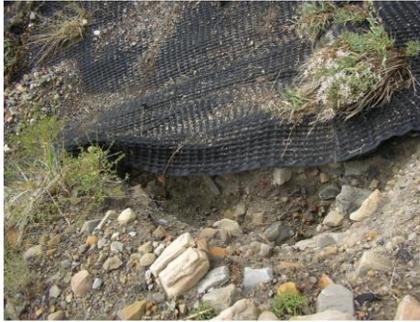
Steep 1.5h:1v section

Erosion along the edges

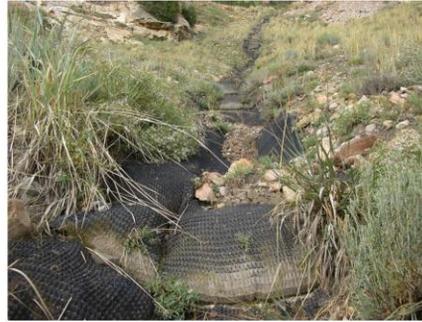
Slumping fabric creates drop structures.

Erosion of soil from beneath the Pyramat is a concern on very long, steep sections. After ten years, the fabric is suspended 6 inches above the surface in some places on this 1.5h:1v slope. The fabric movement may be due to the way the fabric was laid from bottom to top of slope (not in accordance with the manufacturer's instructions). However, the slumping fabric has created desirable drop structures.

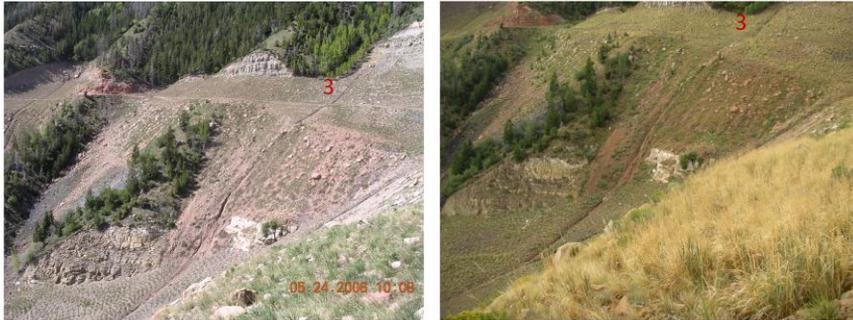
May 2006 and Aug 2012

Field notes confirm that geotextile was installed on the outslope of the pad, below the road, but not down the full length of the drainage in location #3. The location of Pyramat treatment in the drainage corresponds with the extent of surface gouging on the slope which is visible in the photo on the left.

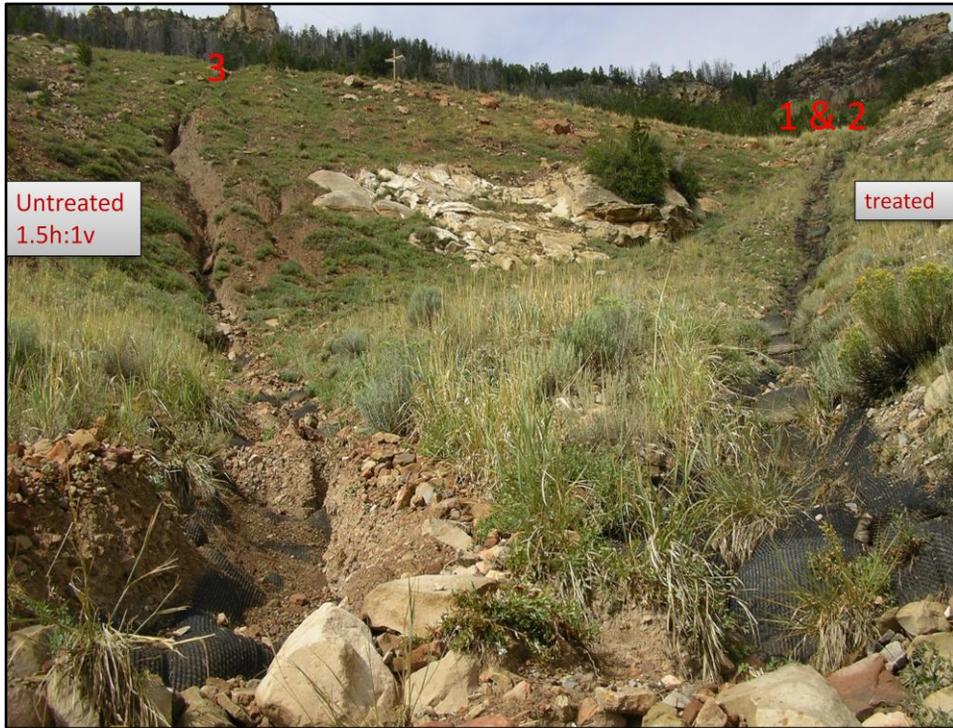
This confluence provides a good contrast of sediment control with and without Pyromat. Geotextile was installed all the way up the drainage at the right, but only about 50 ft. up the drainage on the left. Both drainages are 1.5h:1 v.

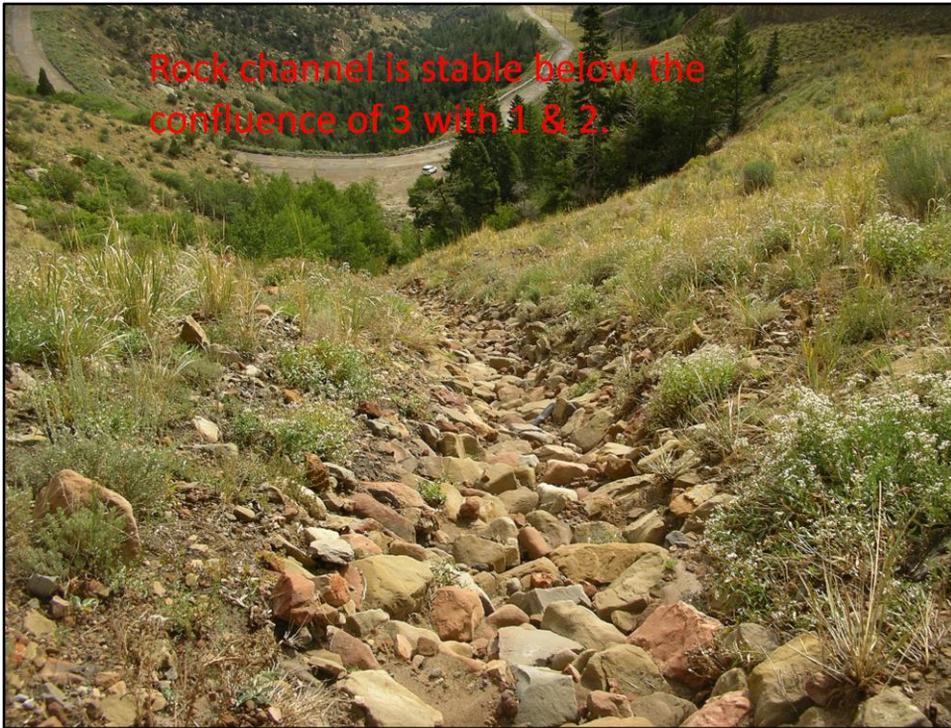
Continuing on down the slope from the confluence of 3 with 1 & 2, the rock channel is stable.
