**RE: Phase III Bond Release, Plateau Mining Corporation, Star Point Mine, C/007/0006,
Task #4320**

INSPECTION NARRATIVE

COMPANY: Plateau Mining Corporation
MINE: Star Point Mine
PERMIT NO: C/007/0006
DATE OF INSPECTION: May 23, 2013
WEATHER: Sunny and windy, mid 70's
COMPANY OFFICIALS: Dennis Ware, Patrick Collins, and Richard White
STATE OFFICIAL: Priscilla Burton, Amanda Daniels, James Owen, Daron Haddock, Joe Helfrich
OSMRE OFFICIAL: Flynn Dickinson
FEDERAL LAND MANAGEMENT AGENCY OFFICIALS: Vaughn Hughes and Sue Wiley (BLM), Kyle Beagley, Ethan Mangum, and Tom Lloyd (USFS)

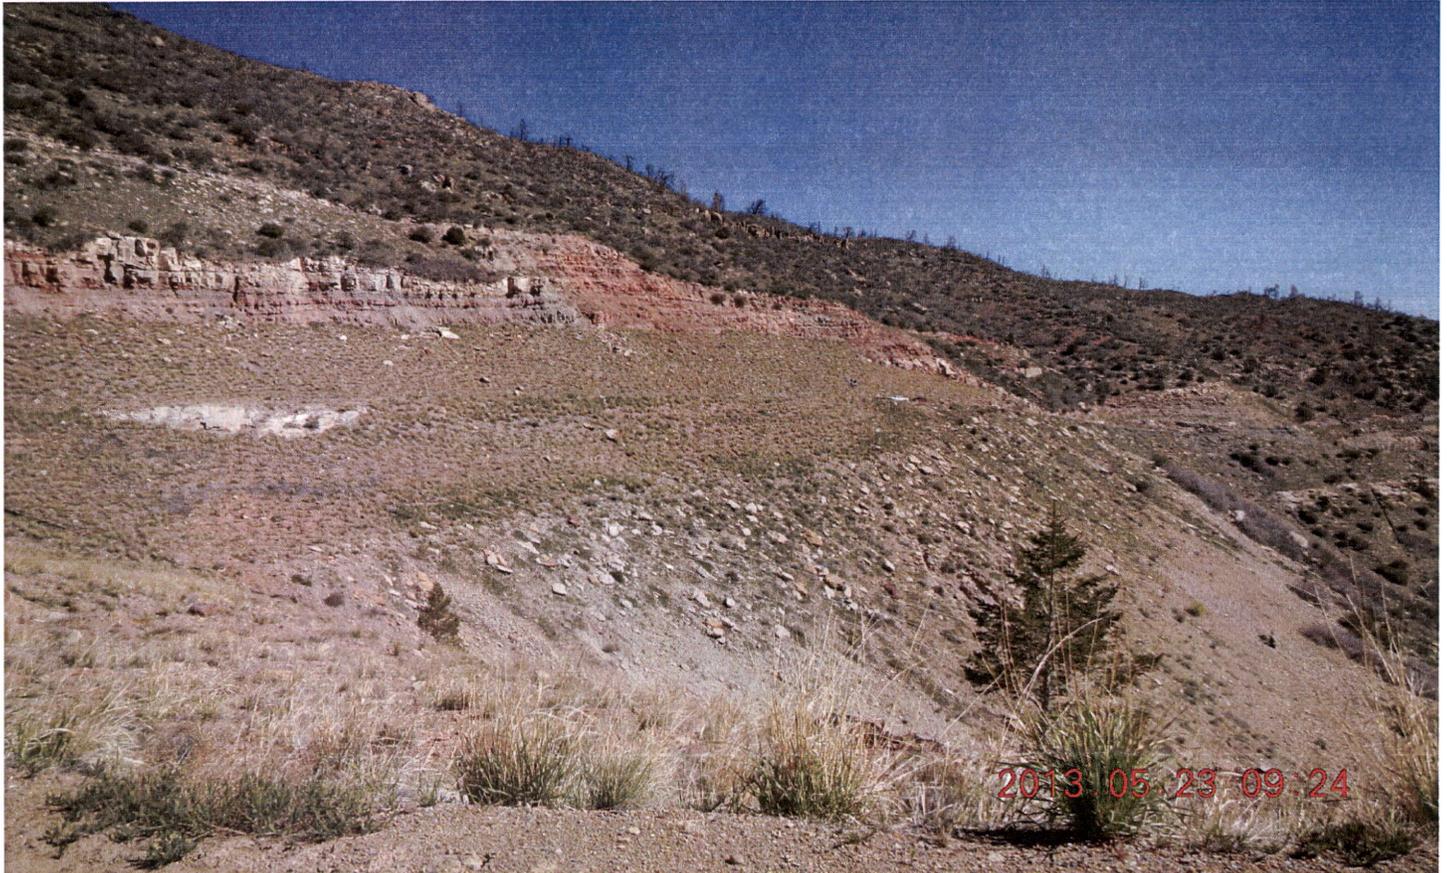
The Star Point mine is located in an area with steep slopes. There was a cutslope associated with a county road which runs through both the No. 1 and No.2 Mine areas which could not be backfilled due to the fact that access has to be maintained on this road. There is a similar situation with a section of highwall in the No. 2 Mine area which was retained due to both a lack of backfill material being available and to maintain access on the county road, as is highlighted in Figure 1. OSM conducted a special focus evaluation regarding highwall retention at the Star Point Mine and other mines in 2001. See OSM Special Focus Evaluation document, "Highwall Elimination and Retention as a Part of Approximate Original Contour (AOC) Restoration" for details.

Figure 1: Highwall retention in No. 2 Mine Area

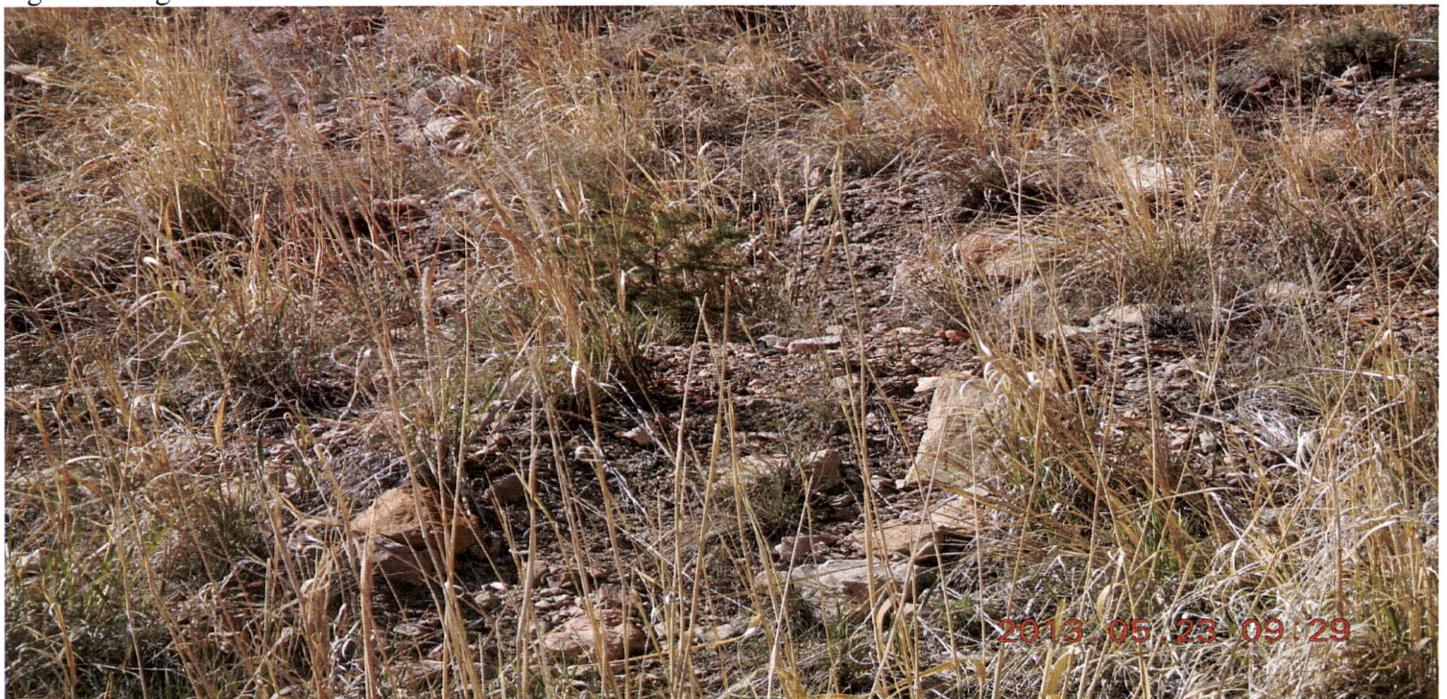
The vegetation on the reclaimed areas was diverse, provided adequate coverage and sediment control, and was well established. In addition to grasses and shrubs that were planted in the initial augmented seeding, volunteer conifers were noted on both the No. 1 Mine and No. 2 Mine areas. They were thriving in the rocky, surface gouged topsoil-substitute material that had been spread on these areas. See Figure 2 for details.

Figure 2: Volunteer conifers in reclaimed area

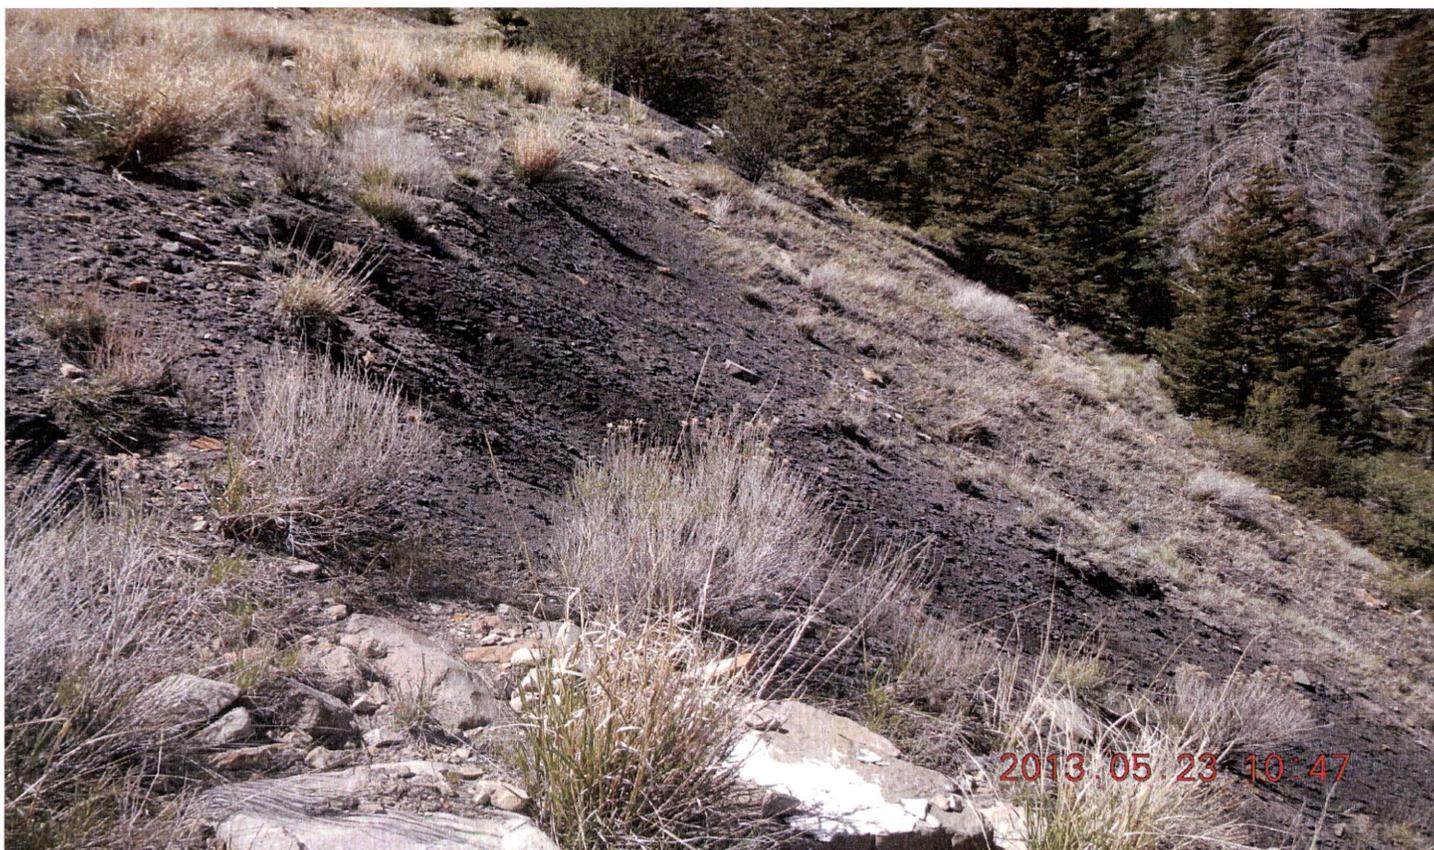
It was noted that there was an area on the No. 2 Mine where it appeared that coal refuse had either been mixed with the topsoil substitute material or that the overlying material had eroded away and exposed some coal refuse. This area appeared to consist of less than a quarter acre and had minimal vegetative cover on it. This should have been addressed either in previous bond release phases or otherwise in DOGM's inspection and enforcement program. See Figure 3 for details.

Figure 3: Small area with coal refuse at the surface

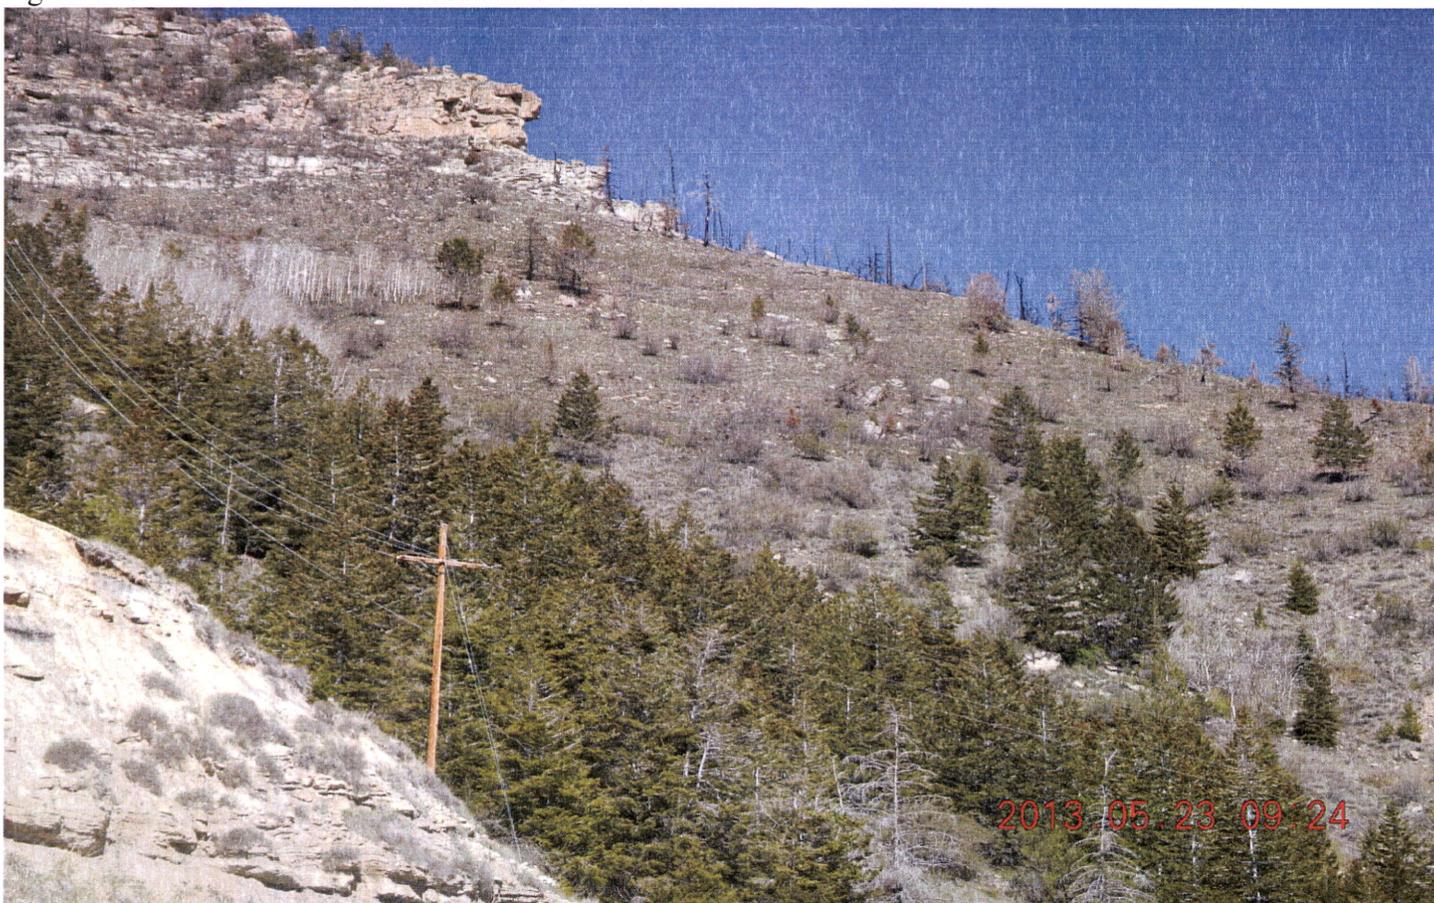
Figure 4: New growth on the burn area above the reclamation

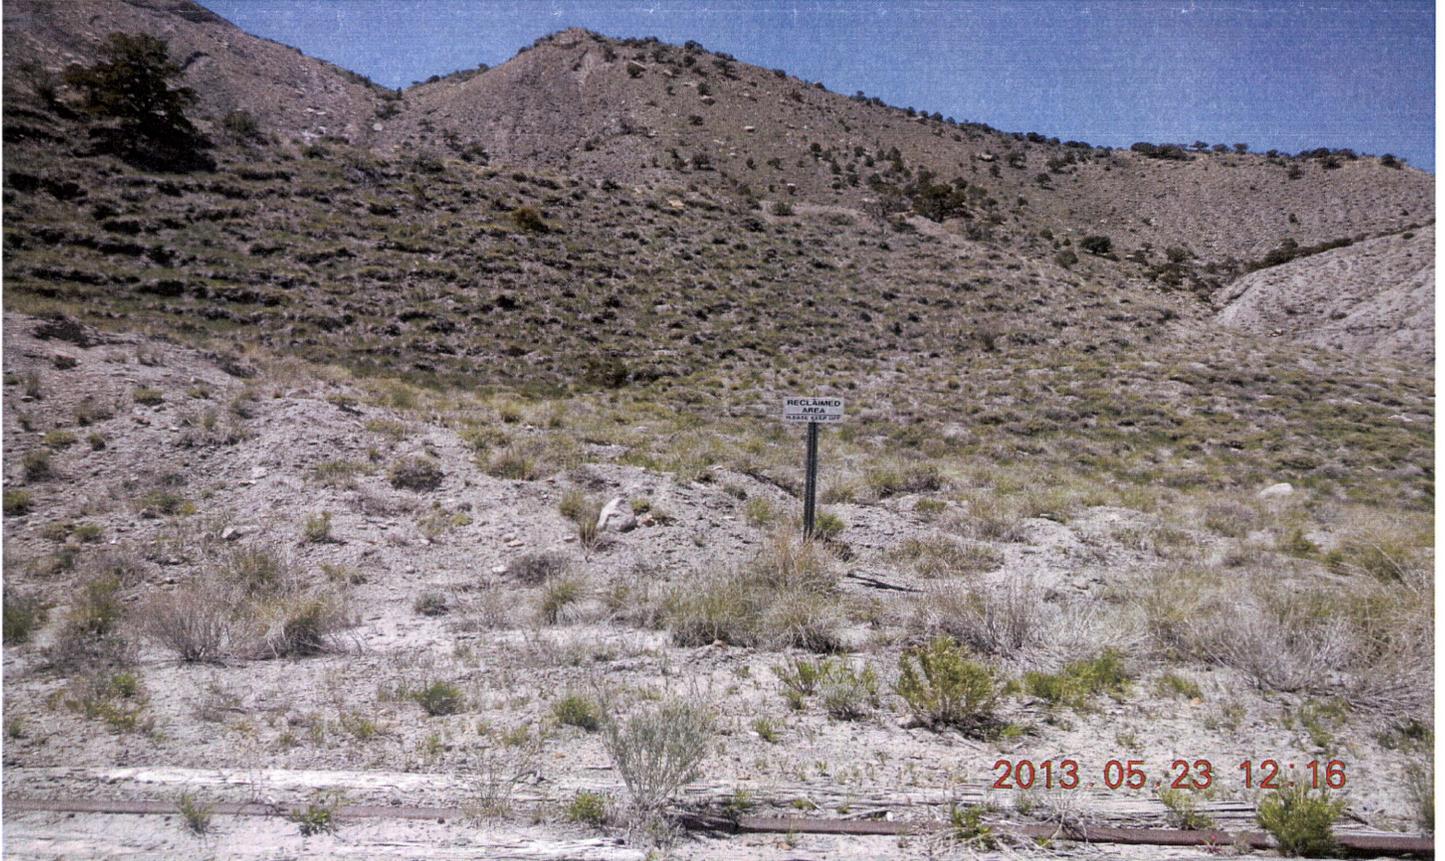
The final area inspected was a site which previously held a train loadout facility and associated conveyor belt which ran from the coal stockpile area. Other than the railroad track which is not owned by Plateau Mining Corporation, all the facilities associated with this area were removed and vegetation has been established, as is shown in Figure 6.

Figure 6: Reclaimed loadout facility
