STABILITY ANALYSIS

KAISER STEEL DIKES  
SUNNYSIDE, UTAH

March 1984

Rollins, Brown and Gunnell, Inc.  
Professional Engineers  
1435 West 820 North, P.O. Box 711  
Provo, Utah 84603

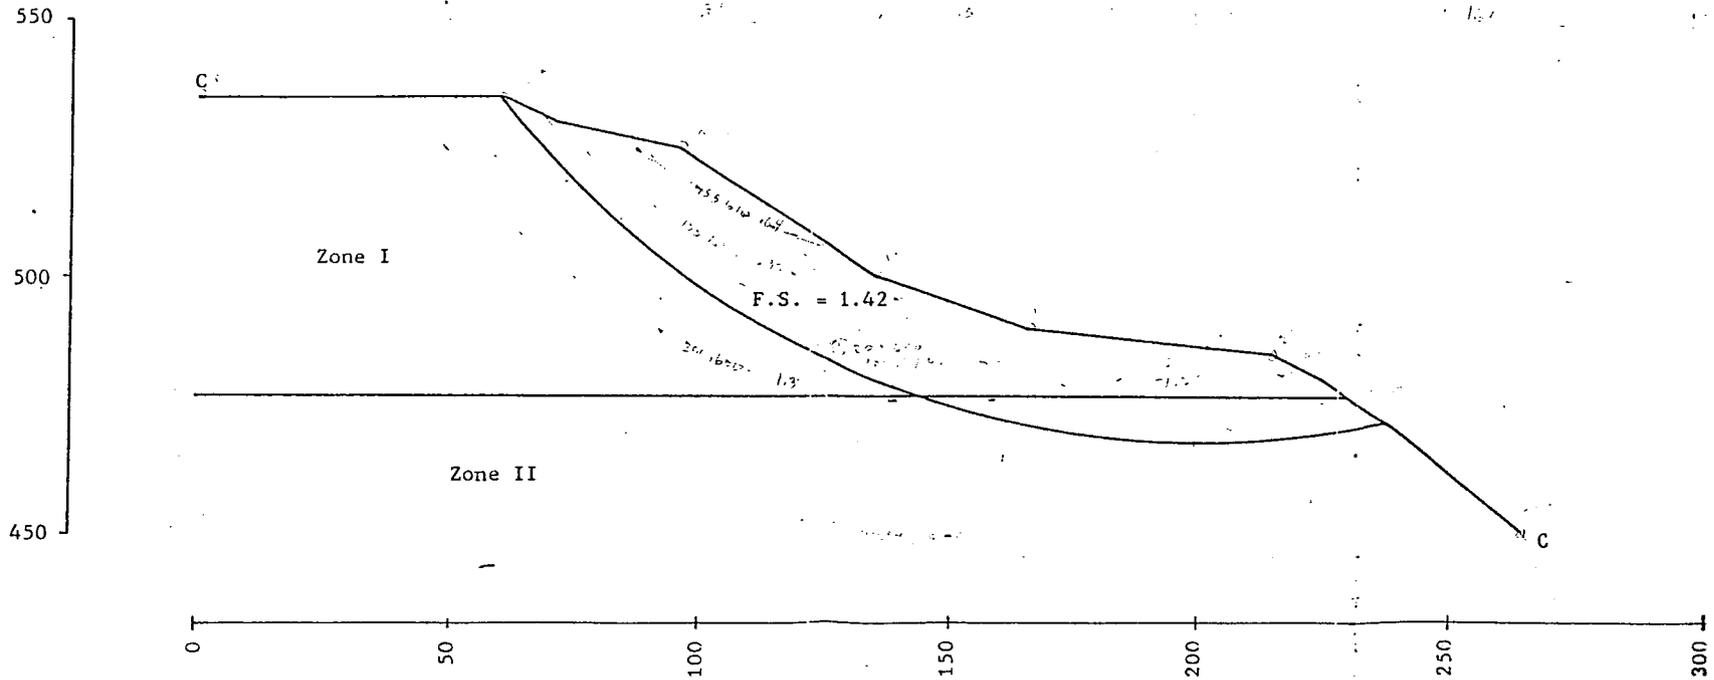
FIGURE  
NO. 8

A profile through the refuse material at the east side dike is presented in Figure No. 8. Shear strength parameters used in the stability analysis along with the in-place unit weight of the refuse material and the natural material is also presented in this figure. The critical failure surface for this slope is presented in Figure No. 8, and it will be noted that the factor of safety for this slope is 1.42. It will be observed that a friction angle of 35 degrees was used for the refuse material.

The results of the laboratory tests performed on the refuse material indicated a friction angle of between 36 and 37.8 degrees. Using a friction angle of 37 degrees for the refuse material, the factor of safety for the east side slope is slightly greater than 1.5, which in our opinion is satisfactory for this facility

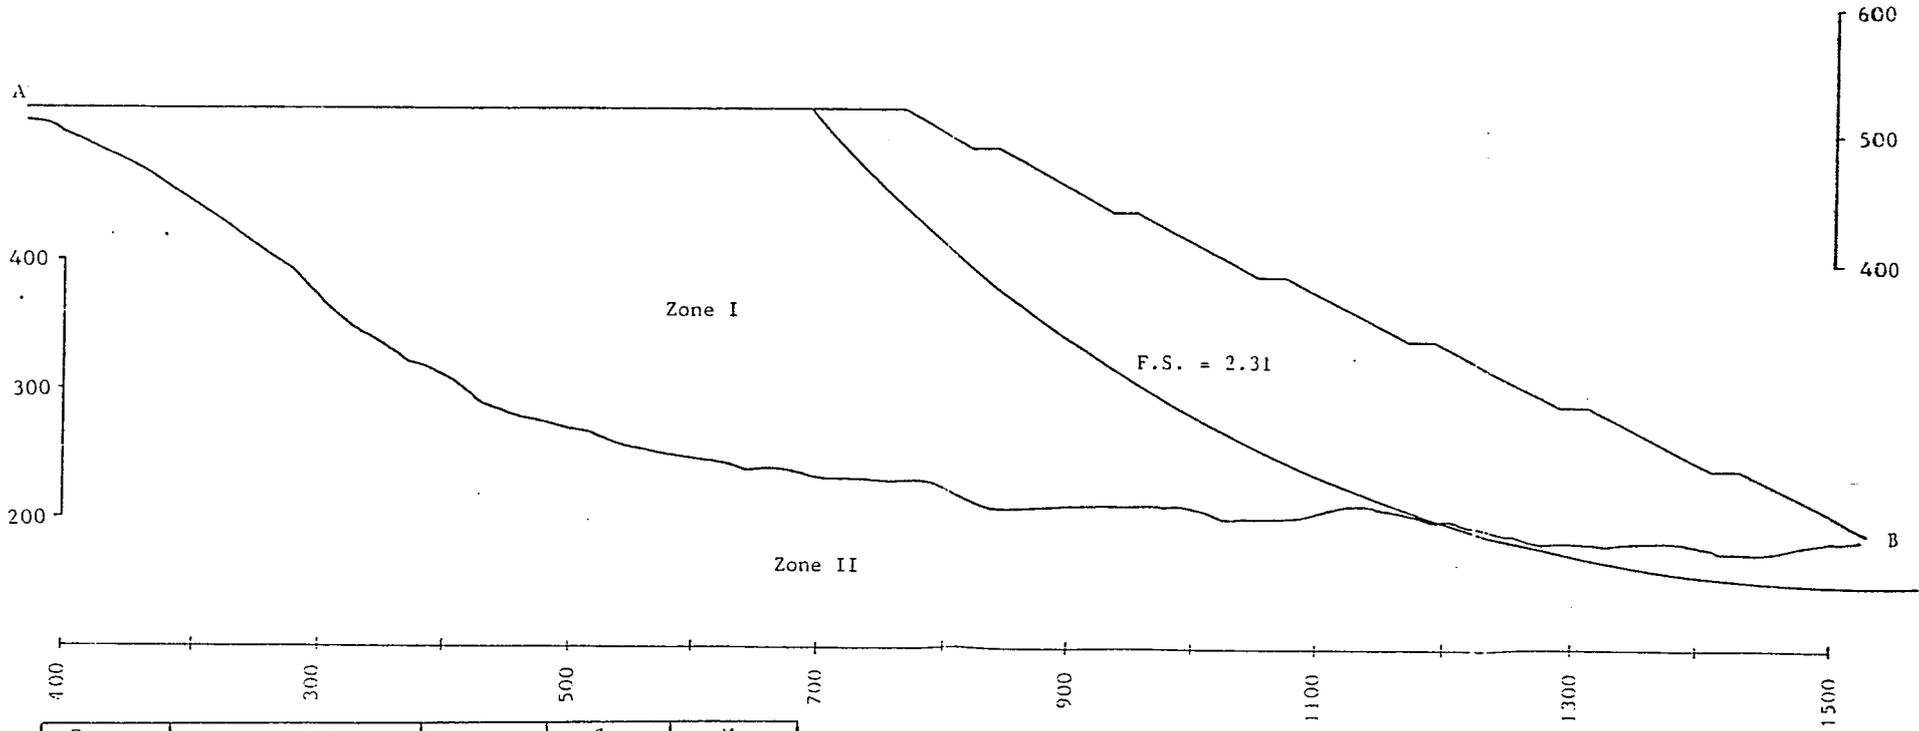
FIGURE  
NO. 9

A cross-section through the west side dike when it reaches its ultimate height is presented in Figure No. 9, along with the shear strength parameters and the critical failure circle. It will be observed that a friction angle of 35 degrees and a cohesion of 200 pounds per cubic foot was used. It is recognized that the refuse material has no friction angle in a saturated condition, however in an unsaturated condition capillary pressures within the material can produce an apparent cohesion of at least this amount. Since there is essentially no opportunity for the refuse material to become completely saturated, it is our opinion that a cohesion of 200 pounds per square foot is a reasonable value. It will also be noted that a friction angle of 35 degrees was used, which is about 2 degrees less than the measured friction angle. It will be observed that using the shear strength parameters indicated above, a factor of safety of 2.31 was obtained, which is entirely satisfactory for the proposed slope.

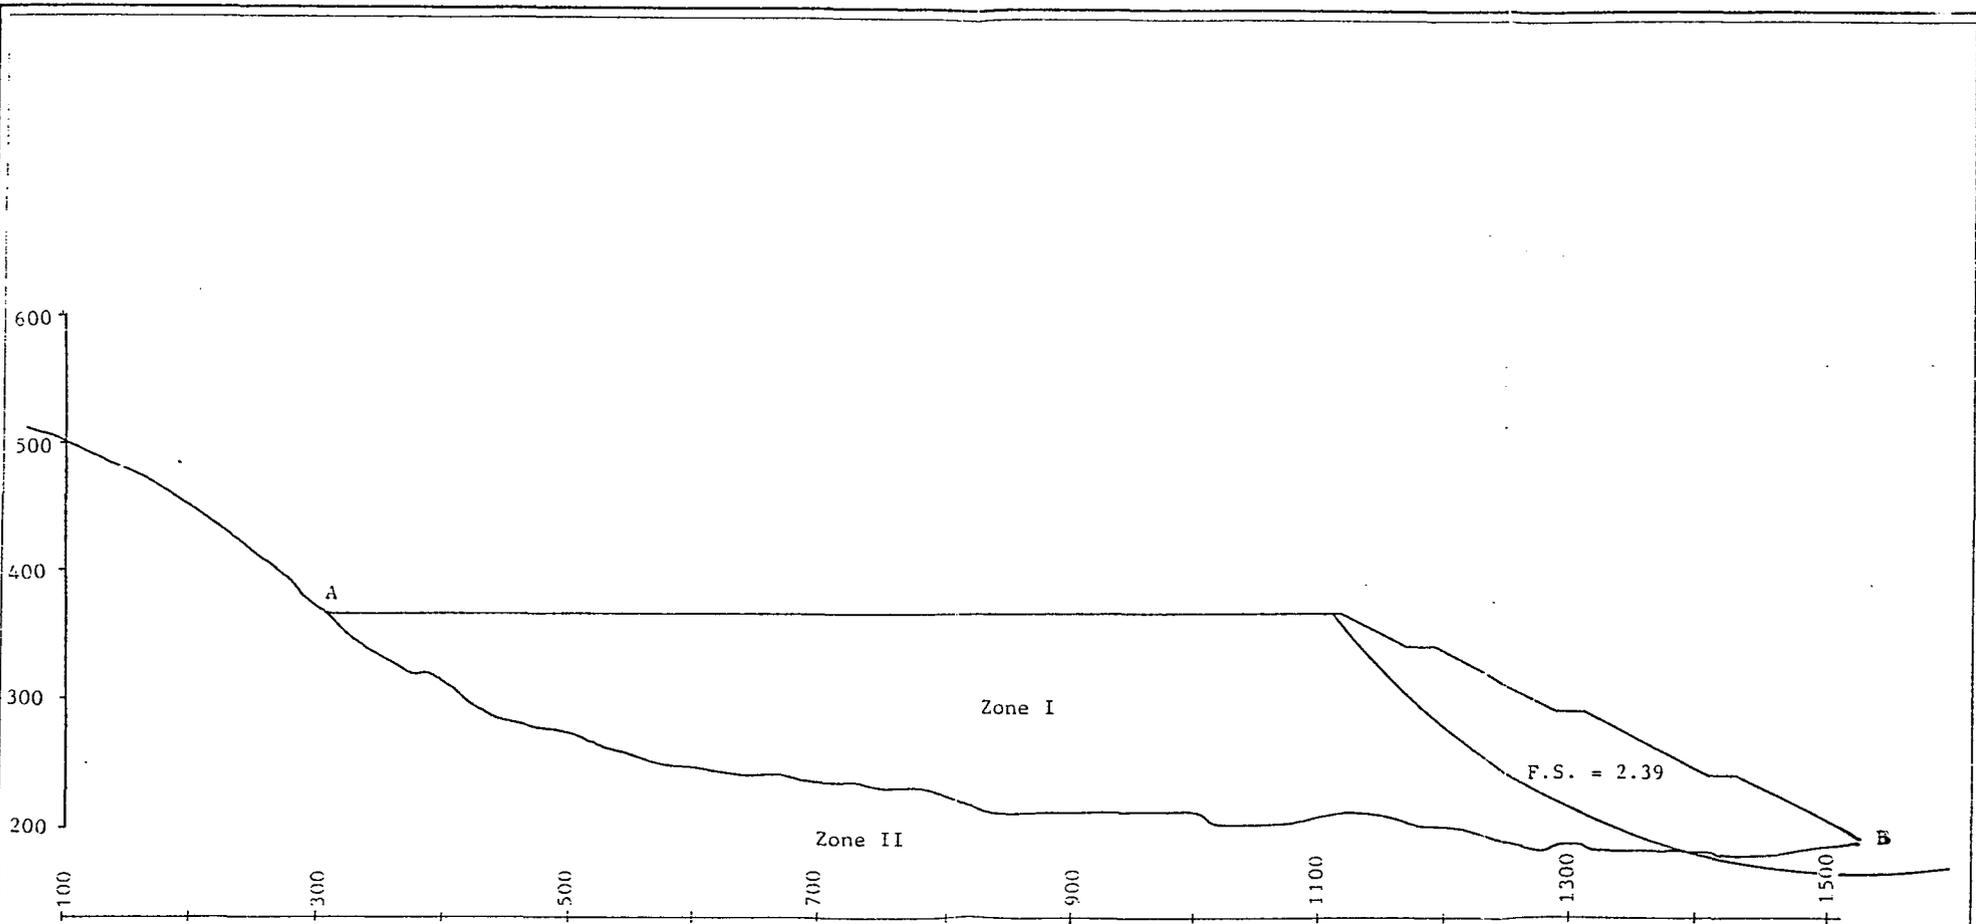
FIGURE  
10

The approximate elevation and profile of the existing west side dike extension is presented in Figure No. 10. The shear strength parameters of the refuse and the sandy gravel underlying the refuse is also presented in this figure. The stability analysis indicates a factor of safety of 2.39 for the critical failure surface for this slope. Since a factor of safety of 1.5 is generally considered

satisfactory under limiting equilibrium conditions, the existing slope is satisfactory.

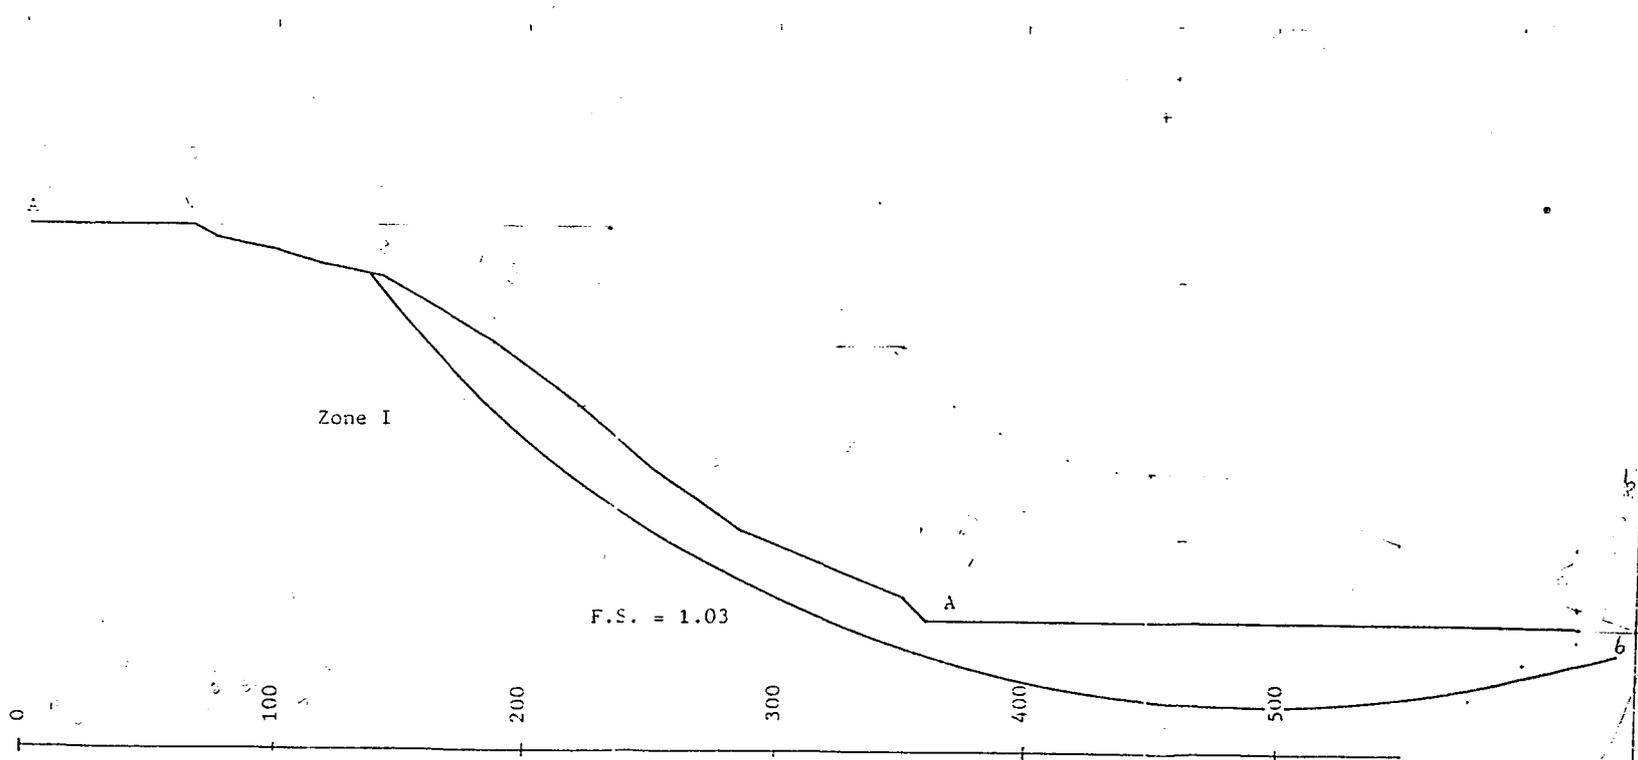
FILE NO. 11

As indicated earlier in this report, the west side dike extension is only partially complete. The profile of the refuse material above the west side extension is shown in Figure No. 11. A stability analysis has been performed for this slope using the shear strength parameters shown in Figure No. 11. The critical circle as shown in Figure No. 11 indicates a factor of safety of 1.03, which is unsatisfactory for this slope.

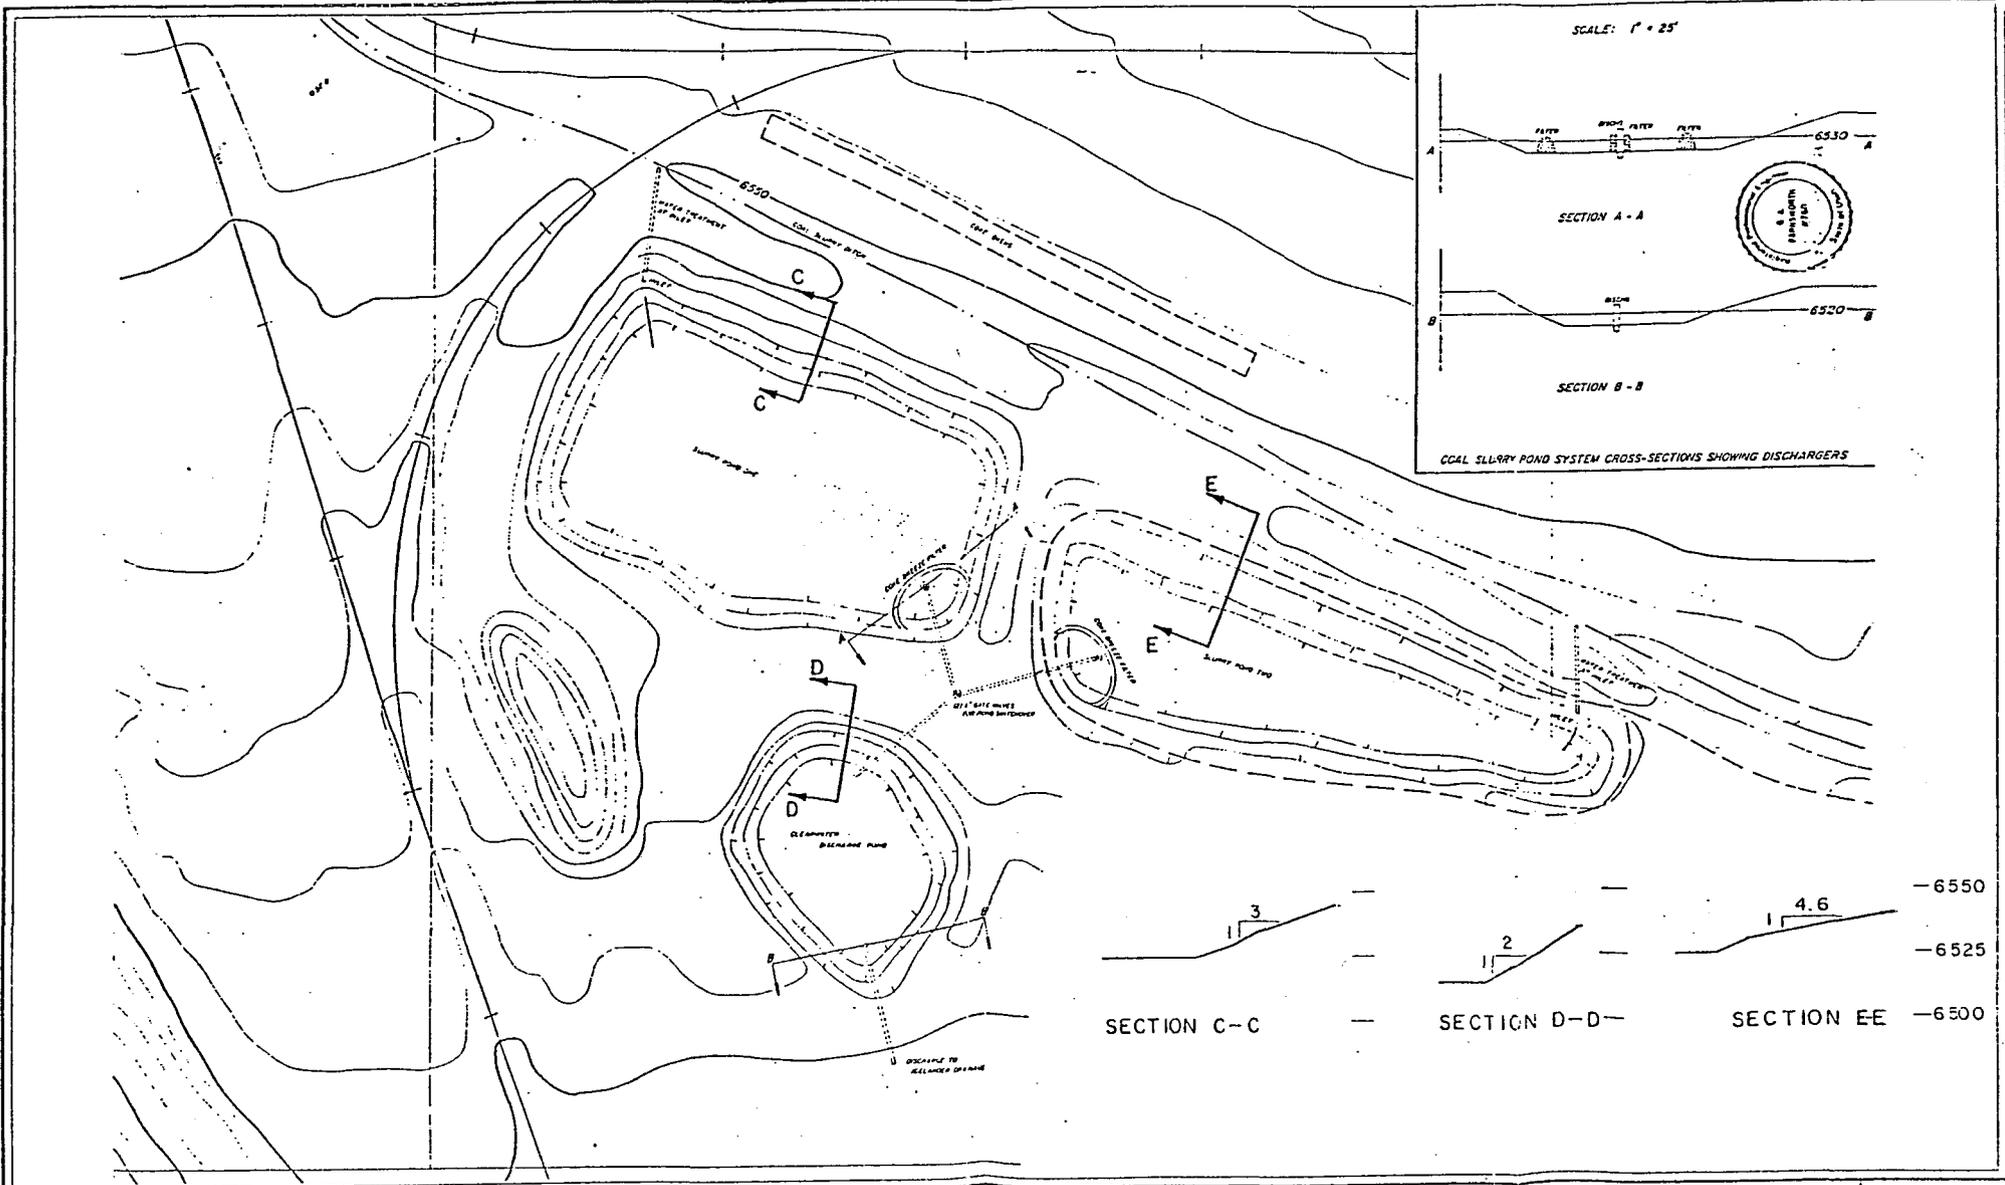
FIGURE  
 NO. 13

A plan view of the coal slurry water sediment control system is presented in Figure No. 13. As indicated earlier, the ponds at this location have been excavated into the existing ground. The contours showing the shape and topography are presented in Figure No. 1, along with sections through the slopes of each of the ponds. It will be observed that the side slopes vary from 2 horizontal to 1 vertical to 4.6 horizontal to 1 vertical. The depth of the ponds do not exceed 20 feet and an inspection of the area indicates that no slope stability problems exist for these facilities. Since the ponds are generally below ground, there is little or no possibility of a rupture which would release water from the ponds to adjacent areas. Any slope stability failure which would occur in the ponds would not result in any hazardous situation. It is our opinion that the slopes for these ponds are stable under the existing situation and that if any of the slopes failed, no serious problems could result.

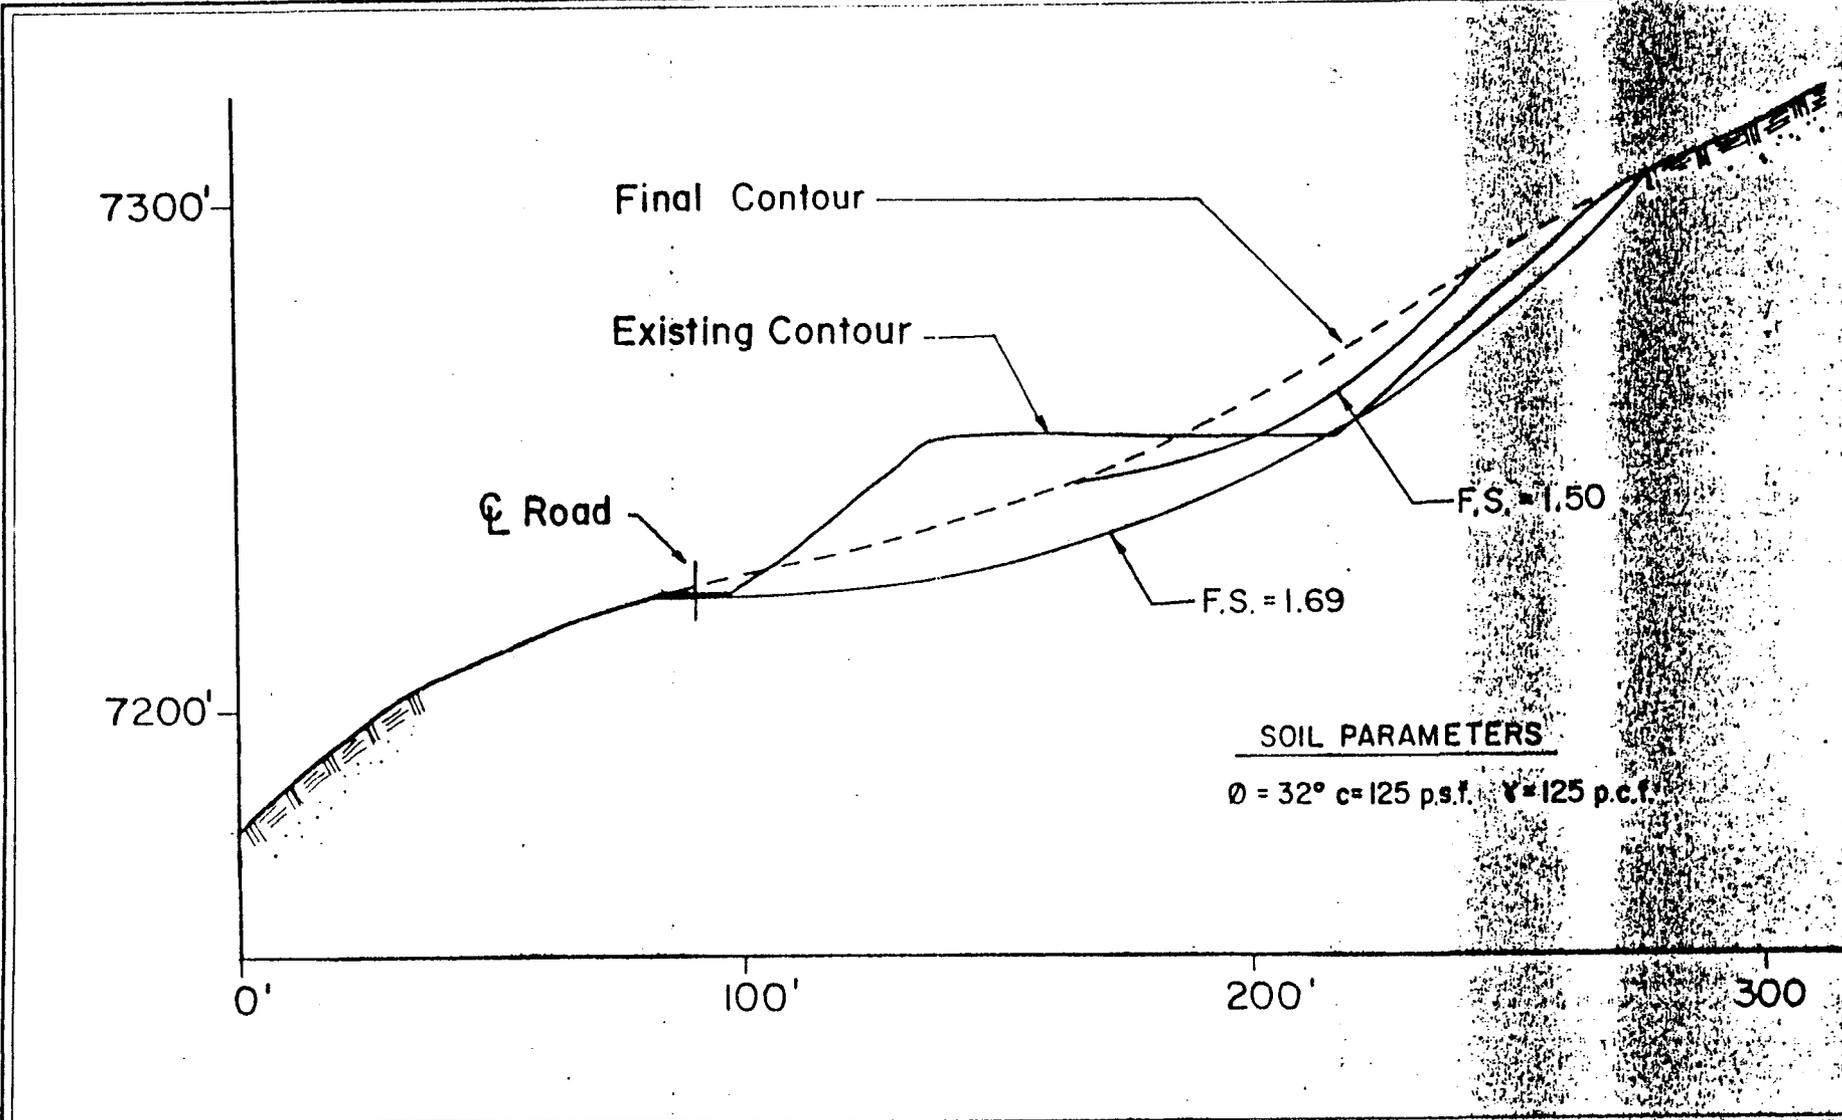
FIGURE NO. 9

Stability computations were performed for the overall slope along with a shallow slope in the center of the profile. The shear strength parameters used in performing the stability analysis at this location are presented in Figure No. 9, and it will be noted that a friction angle of 30 degrees and a cohesion of 125 pounds per square foot were used. The results of the stability computations indicate a factor of safety of 1.5 and 1.69, respectively for the finished slope.

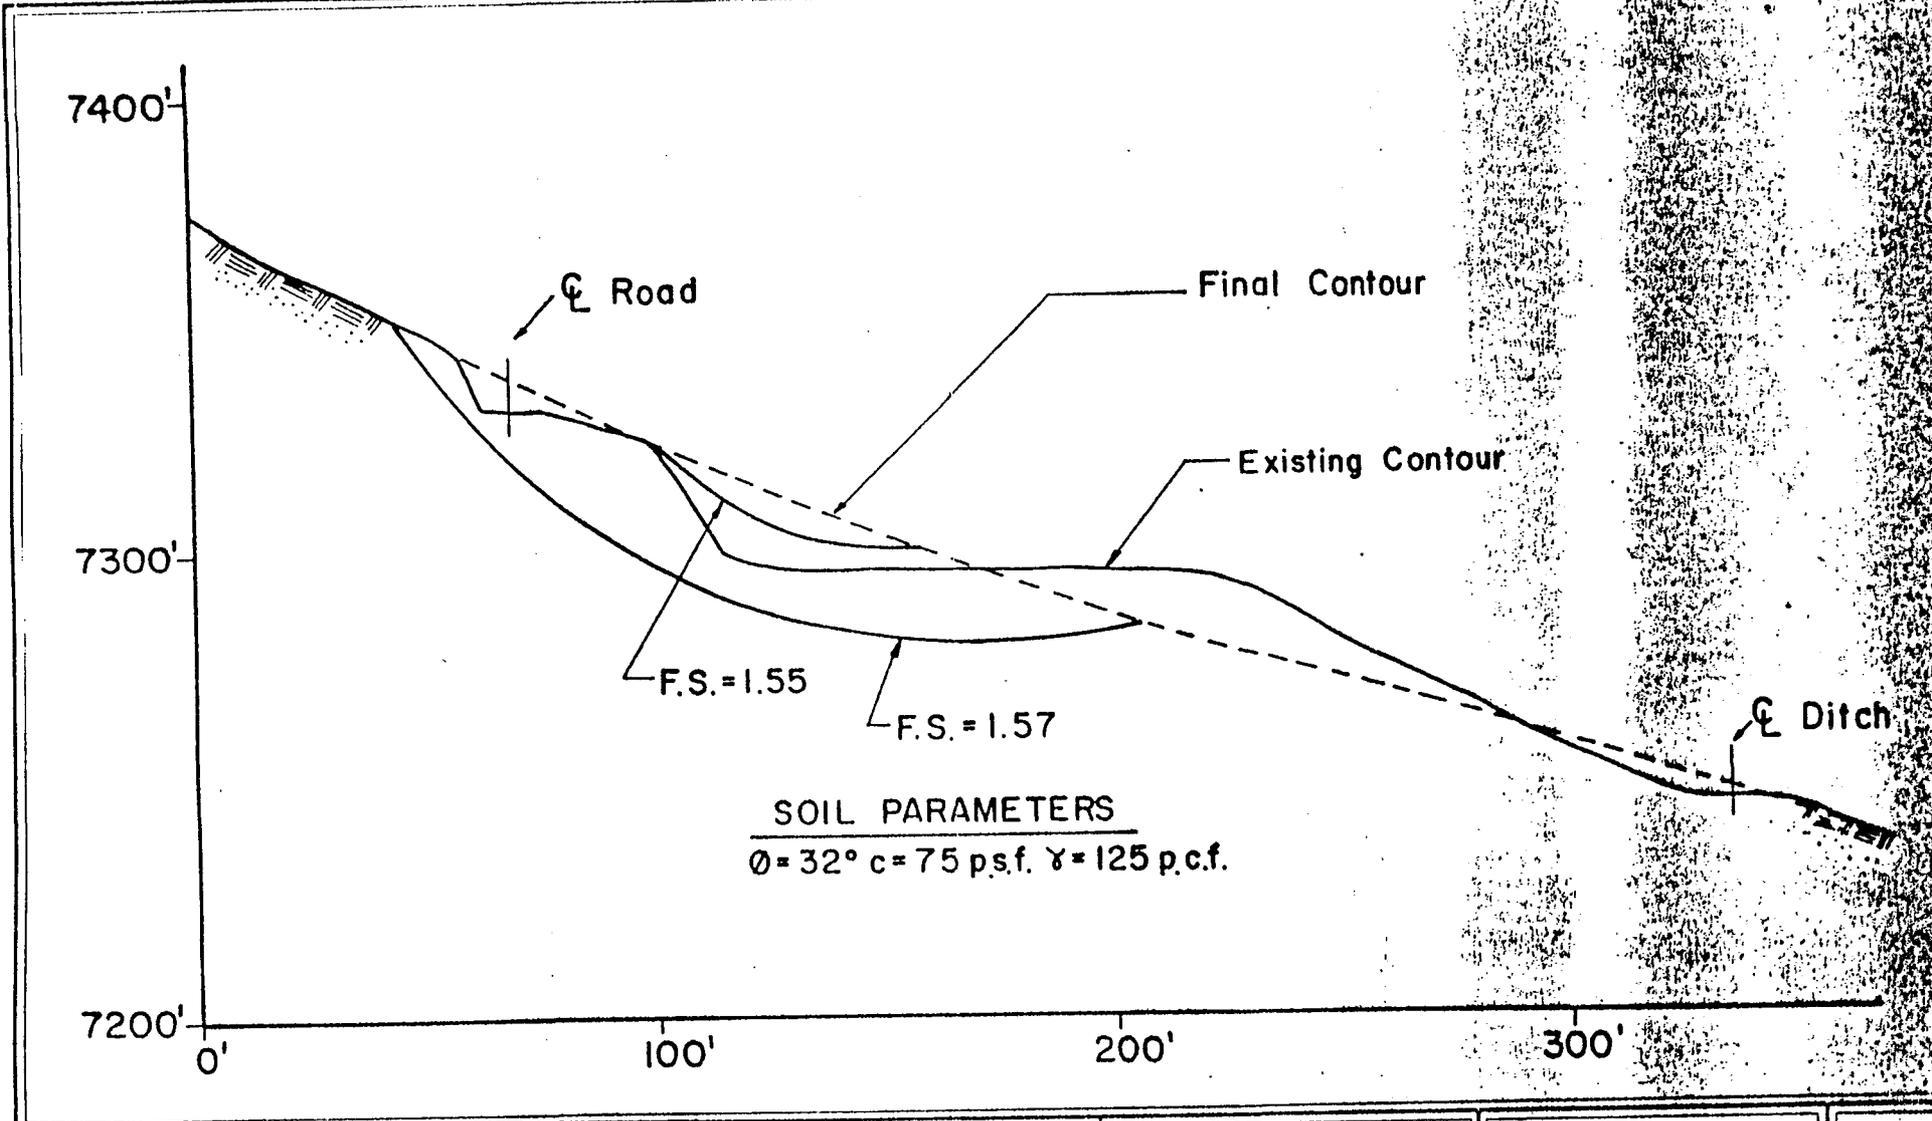
FIGURE  
 NO. 13

A stability analysis was performed for both the overall slope and for a shallow slope within the overall slope. The shear strength parameters used in performing the analysis are presented in Figure No. 13, and it will be observed that a friction angle of 32 degrees and a cohesion of 75 pounds per square foot were used. The factors of safety observed for the finished slope were 1.55 for the shallow slope, and 1.57 for the overall slope. It is our opinion, therefore, that the factor of safety of the finished slopes will be satisfactory.

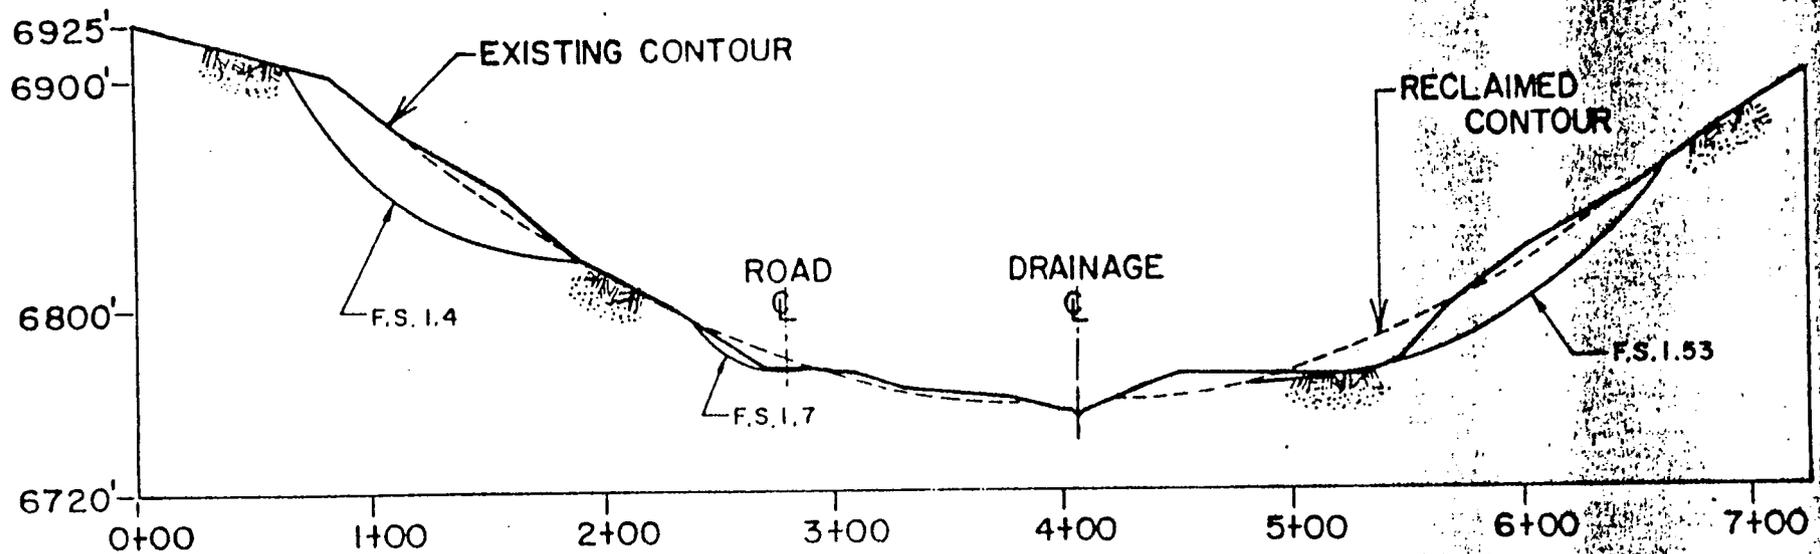
It should be noted that in the vicinity of the Station 1+00 to 2+00 a disturbance in the soil profile appears to be relatively small, and that the low factor of safety for the reclaimed profile exists because of the low factor of safety for the original slope. In view of this situation, it is our opinion that the factors of safety of the proposed reclaimed contour are as good as can be obtained for this site.

$\phi = 30^\circ$   $c = 150$  psf. 1.05 = F.S.  
 $\phi = 30^\circ$   $c = 200$  psf. 1.11 = F.S.  
 $\phi = 34^\circ$   $c = 200$  psf. 1.26 = F.S.  
 $\phi = 32^\circ$   $c = 400$  psf. 1.41 = F.S.

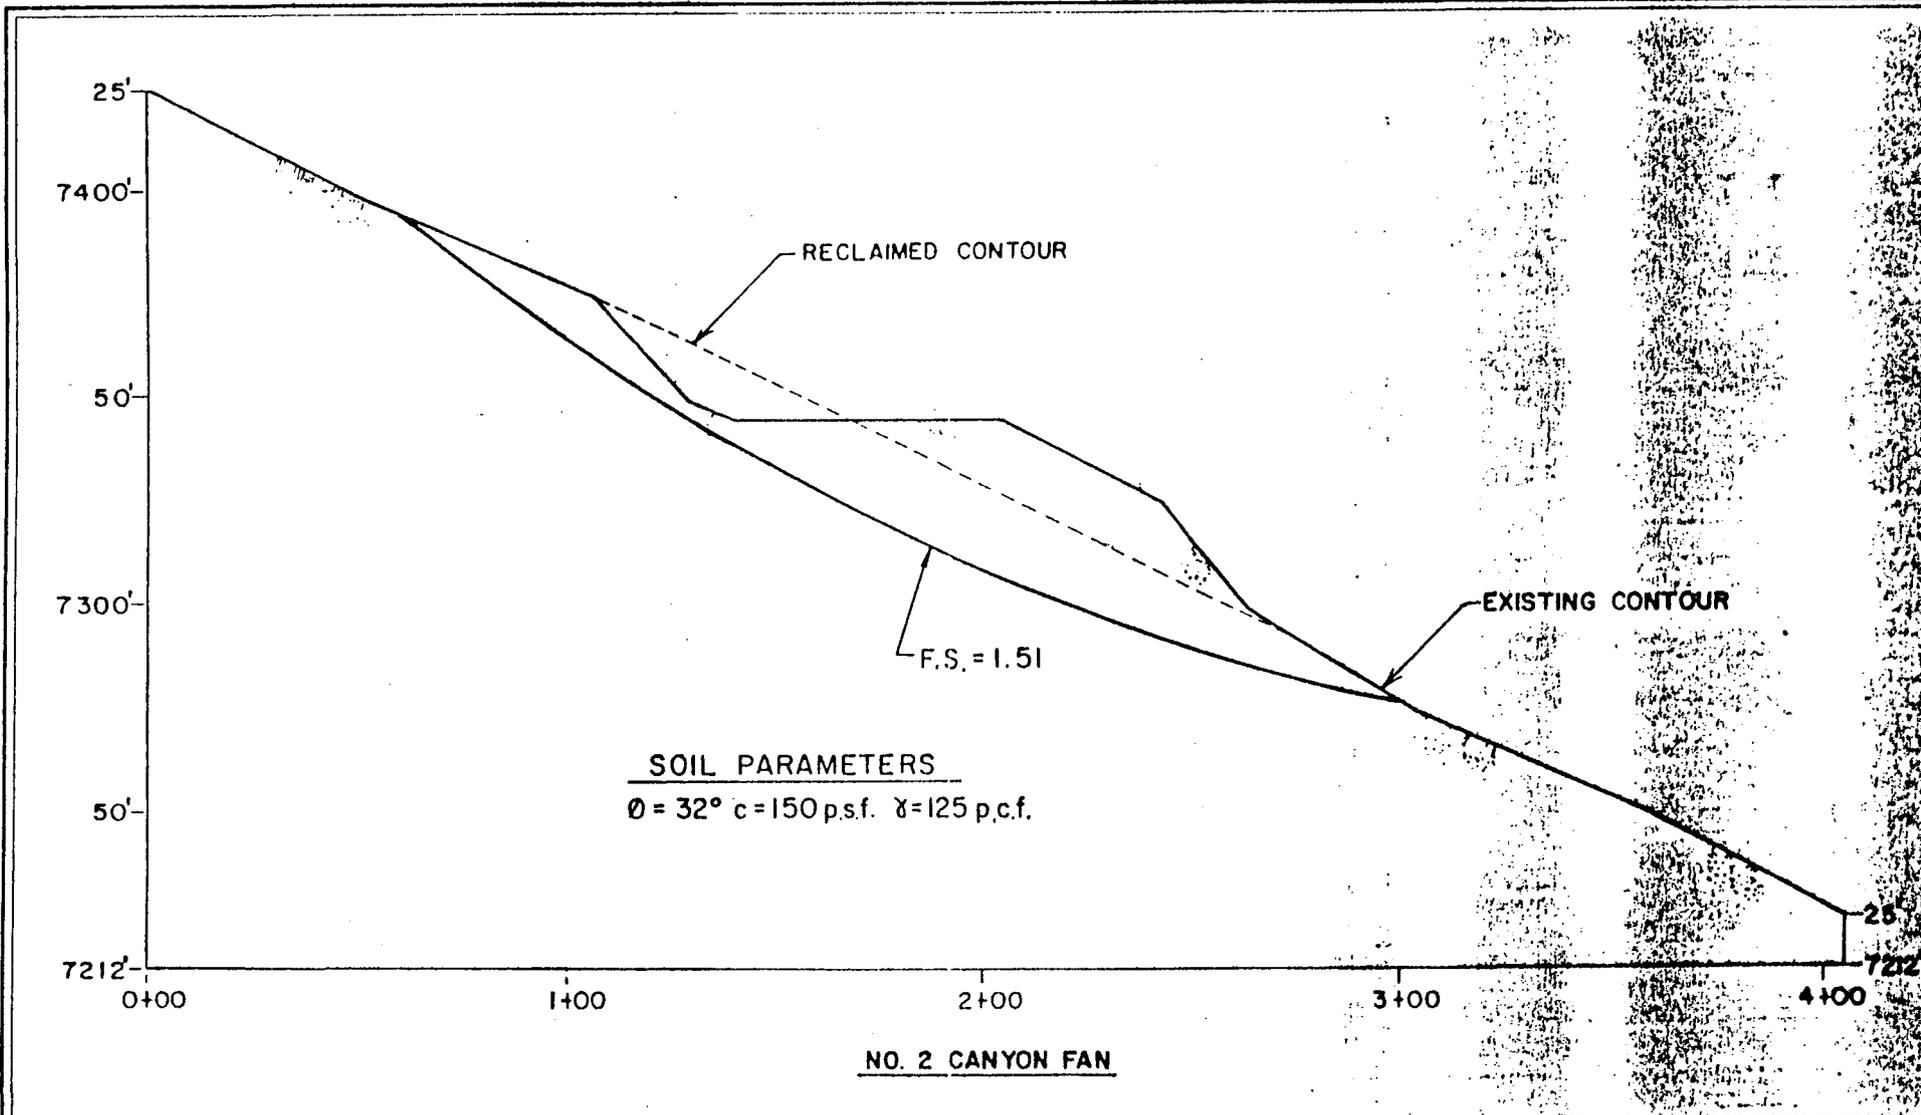
FIGURE  
 NO. 18

A profile through the canyon at this site is presented in Figure No. 18 along with the proposed reclaimed contour. The shear strength parameters used in the stability analysis for this site are also shown in this figure, and it will be observed that a friction angle of 32 degrees and a cohesion of 150 pounds per square foot were used in the analysis. A factor of safety of 1.51 was obtained for the overall slope at this site. It is our opinion that the shear strength parameters used in the analysis for this site are conservative, and that the reclaimed slope will have a factor of safety meeting state and federal regulatory requirements.

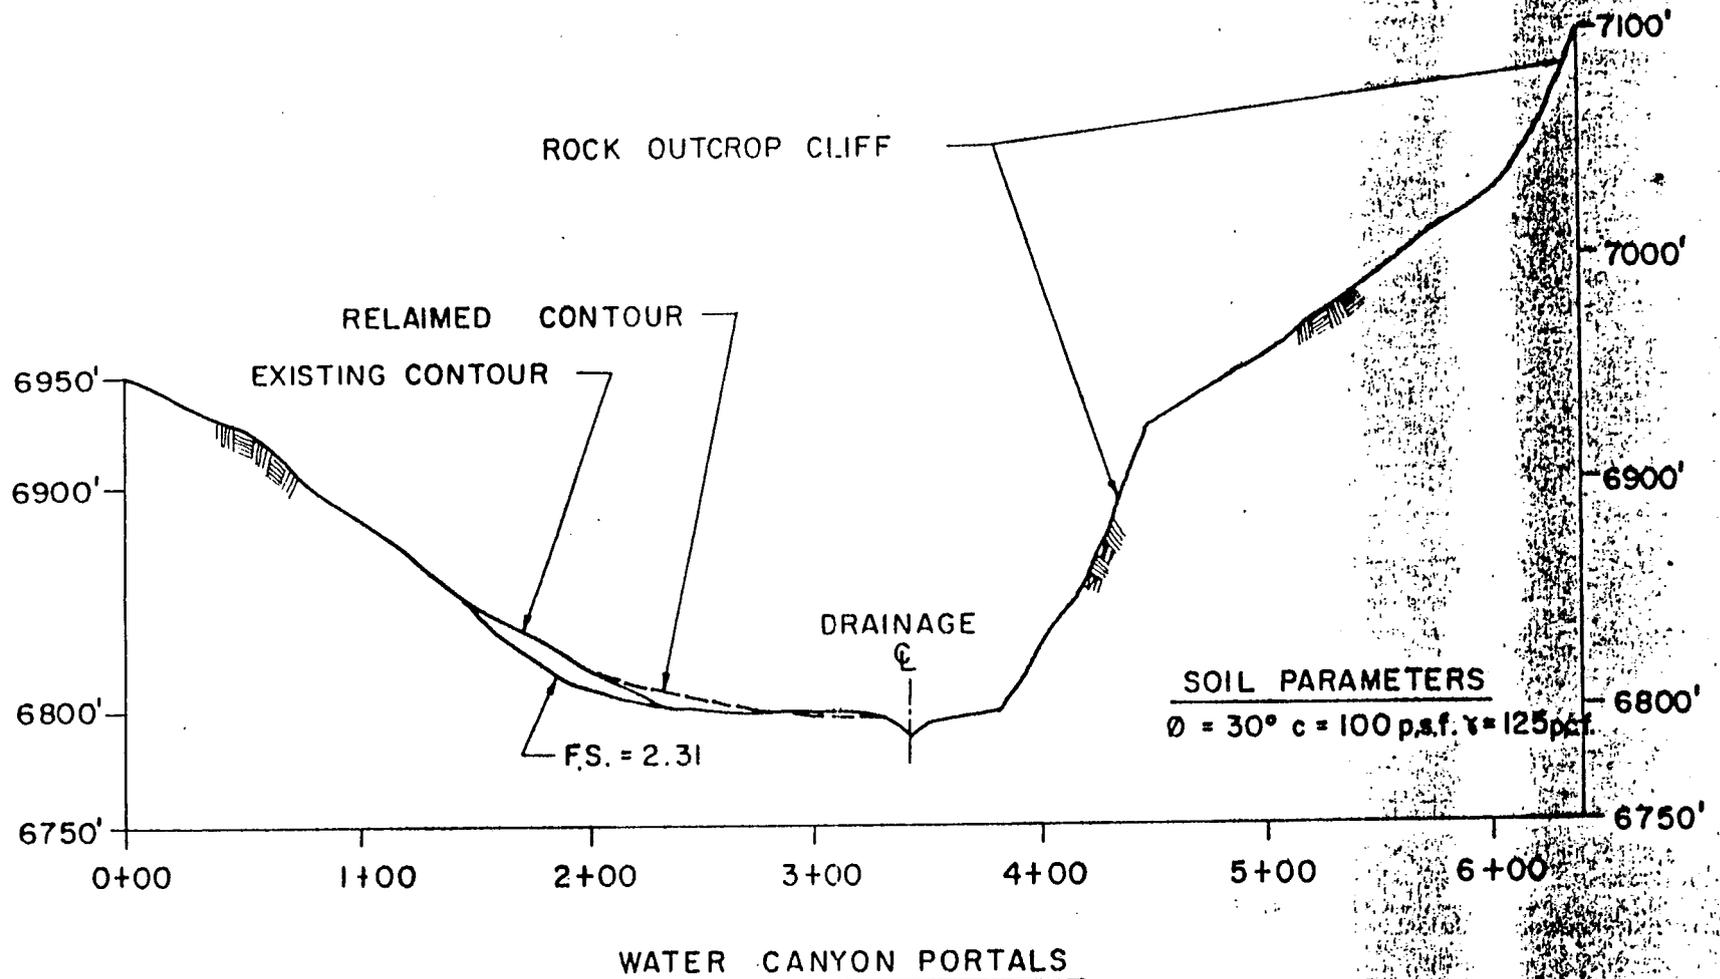
FIGURE  
 NO. 20

The sample contained approximately 74 percent of granular type soils and 26 percent of low-plasticity silts and clays. A cross-section showing the existing contours along with the reclaimed contour for this site is presented in Figure No. 20. It will be observed that this slope has a low height and that a factor of safety of 2.31 was obtained for shear strength parameters of  $\phi = 30$  degrees and  $c = 100$  pounds per square foot. It is apparent that the slope formed by the reclaimed contour will be entirely stable at this location.

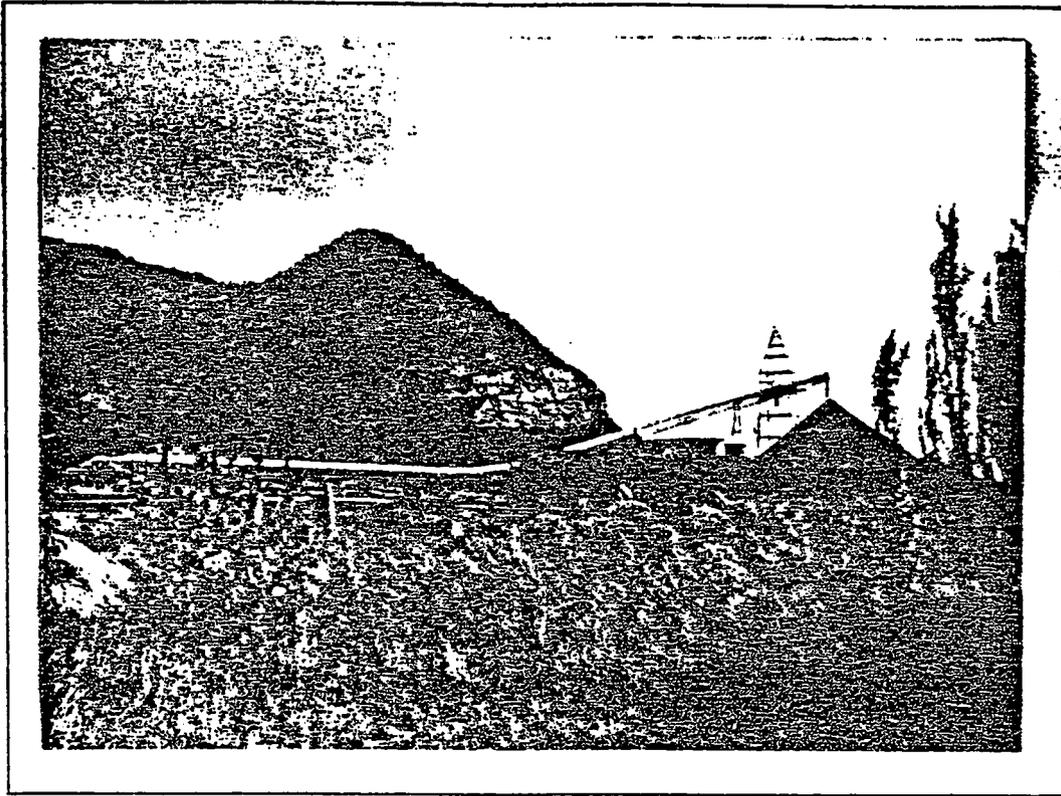
Loadout Area Site  
(Stockpile)

Two pictures of the cut slopes in the area of the Loadout Facility are presented in Figure No. 21. It will be observed from these figures that the existing slopes are relatively steep, and that the material within the slope is predominantly granular type soils. The results of a particle size distribution analysis performed on a representative sample obtained from the cut slope is presented in Figure No. 22. This figure indicates that the sample contains approximately 84 percent material in the granular size range, and about 16 percent in the silt and clay size range. As indicated earlier in this report, the silt and clay size materials throughout the area generally has low-plasticity characteristics.
