# Sunnyside Coal Company

Re: NOV92-32-17-1 Failure To Maintain Diversions

Regarding the abatement of the above NOV, we have flushed and cleared the culvert at the Whitmore Fan B.T.C.A. area and repaired the silt fence.

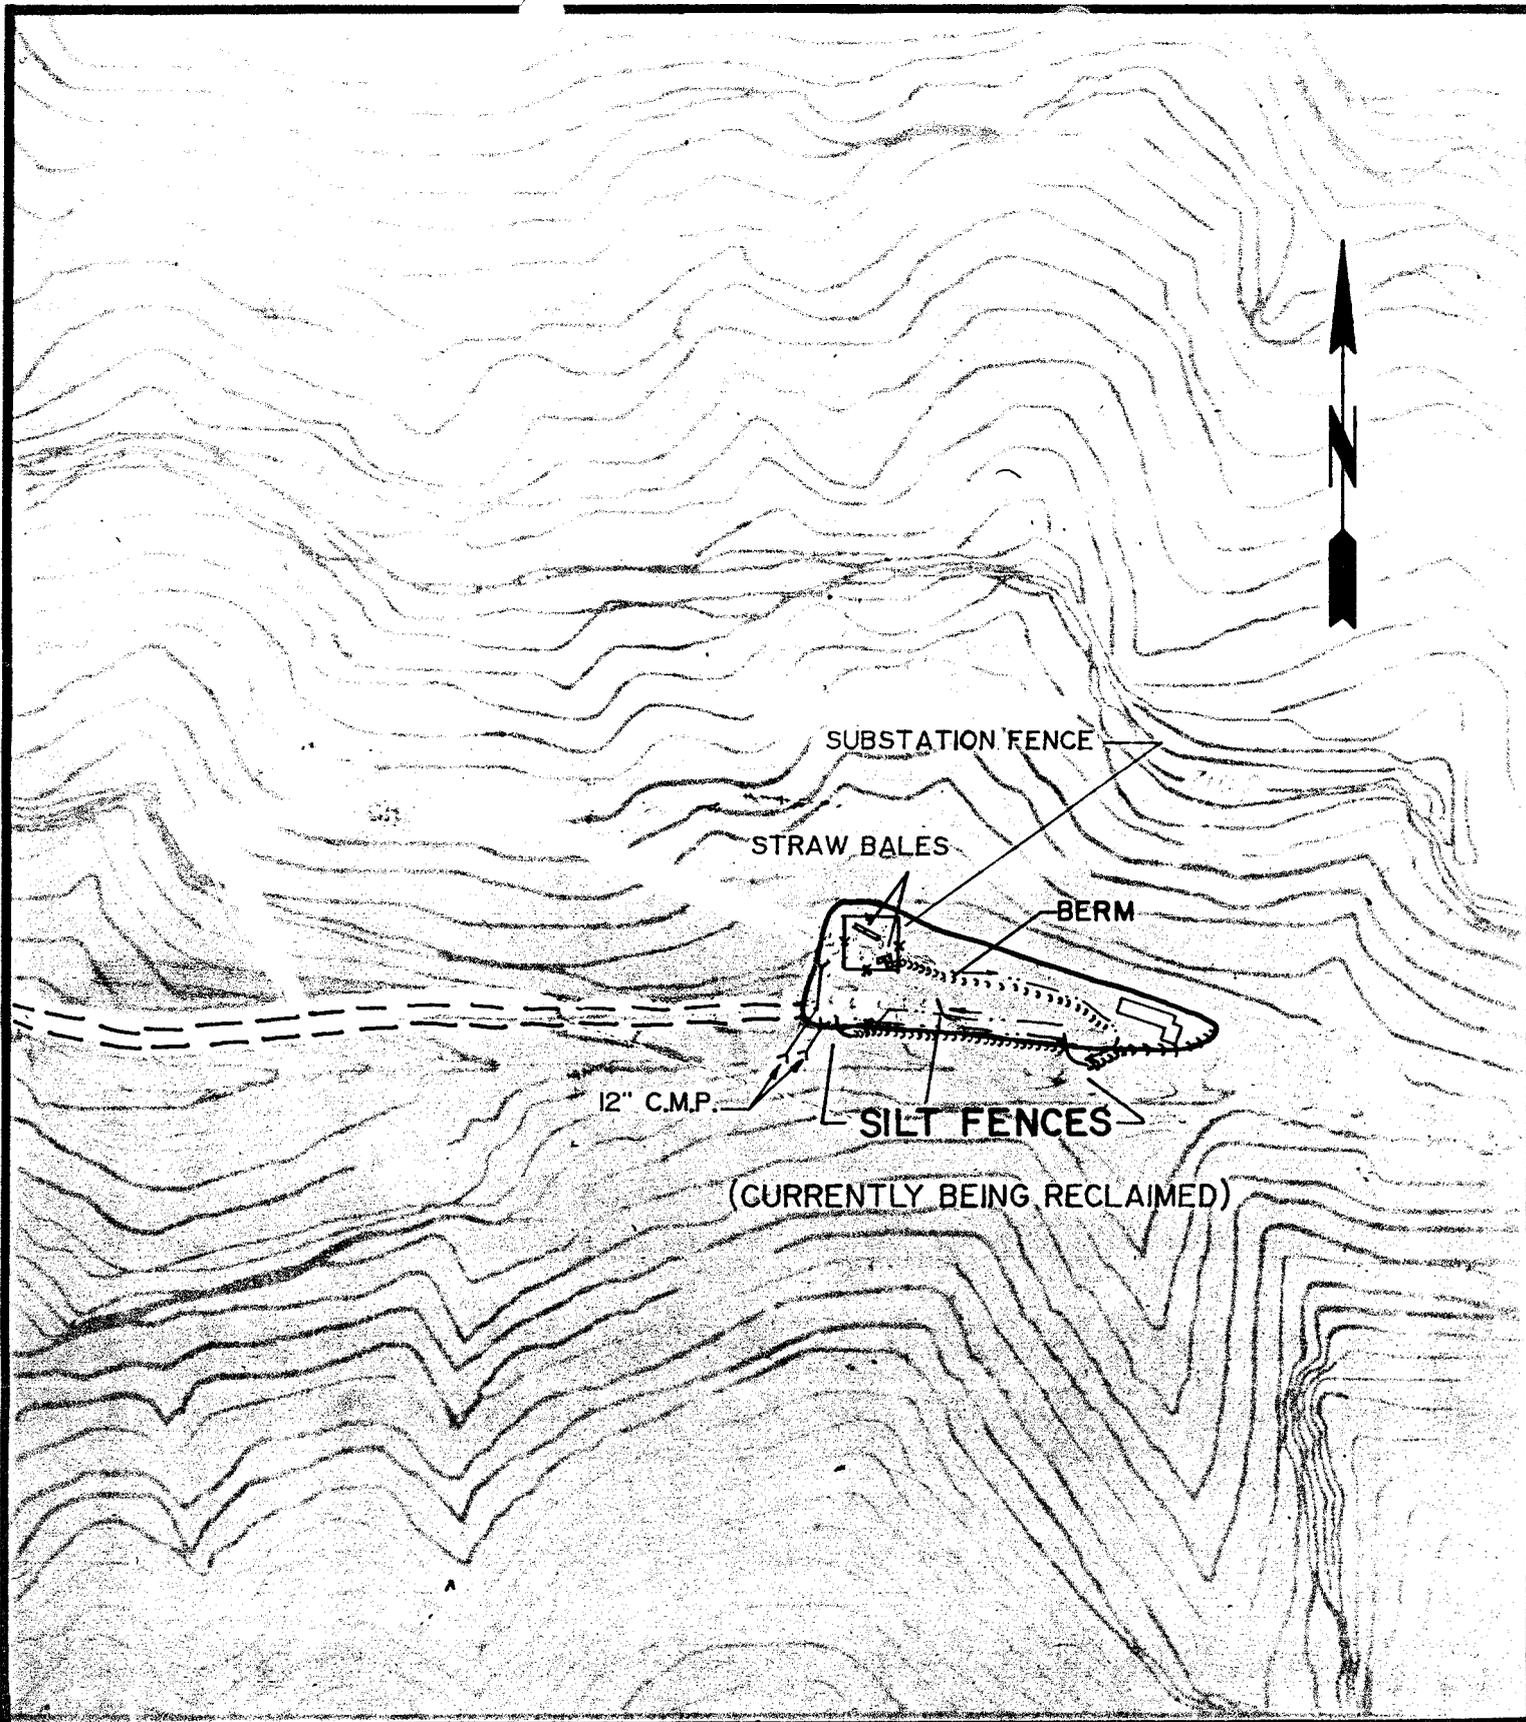
AS-010

The abatement of the area at the Fan Canyon B.T.C.A. presents another problem. We used a backhoe to probe the area west of the old substation searching for the twelve-inch CMP inlet that supposedly drained the undisturbed area to the wash as shown on Plate 5-5, A5-0110. We had no success. The other twelve-inch CMP from the edge of the road to the wash was not located either.

Neither Ernest Monson nor Dale Andrews (who are long-time surface compliance personnel at this operation) remember either culvert. It is our belief that the culverts were never installed.

Due to the hardness of the frozen ground and the limited reach of our backhoe, it would be extremely difficult to reinstall these culverts at this time. For this reason, we ask that abatement be extended until next spring.

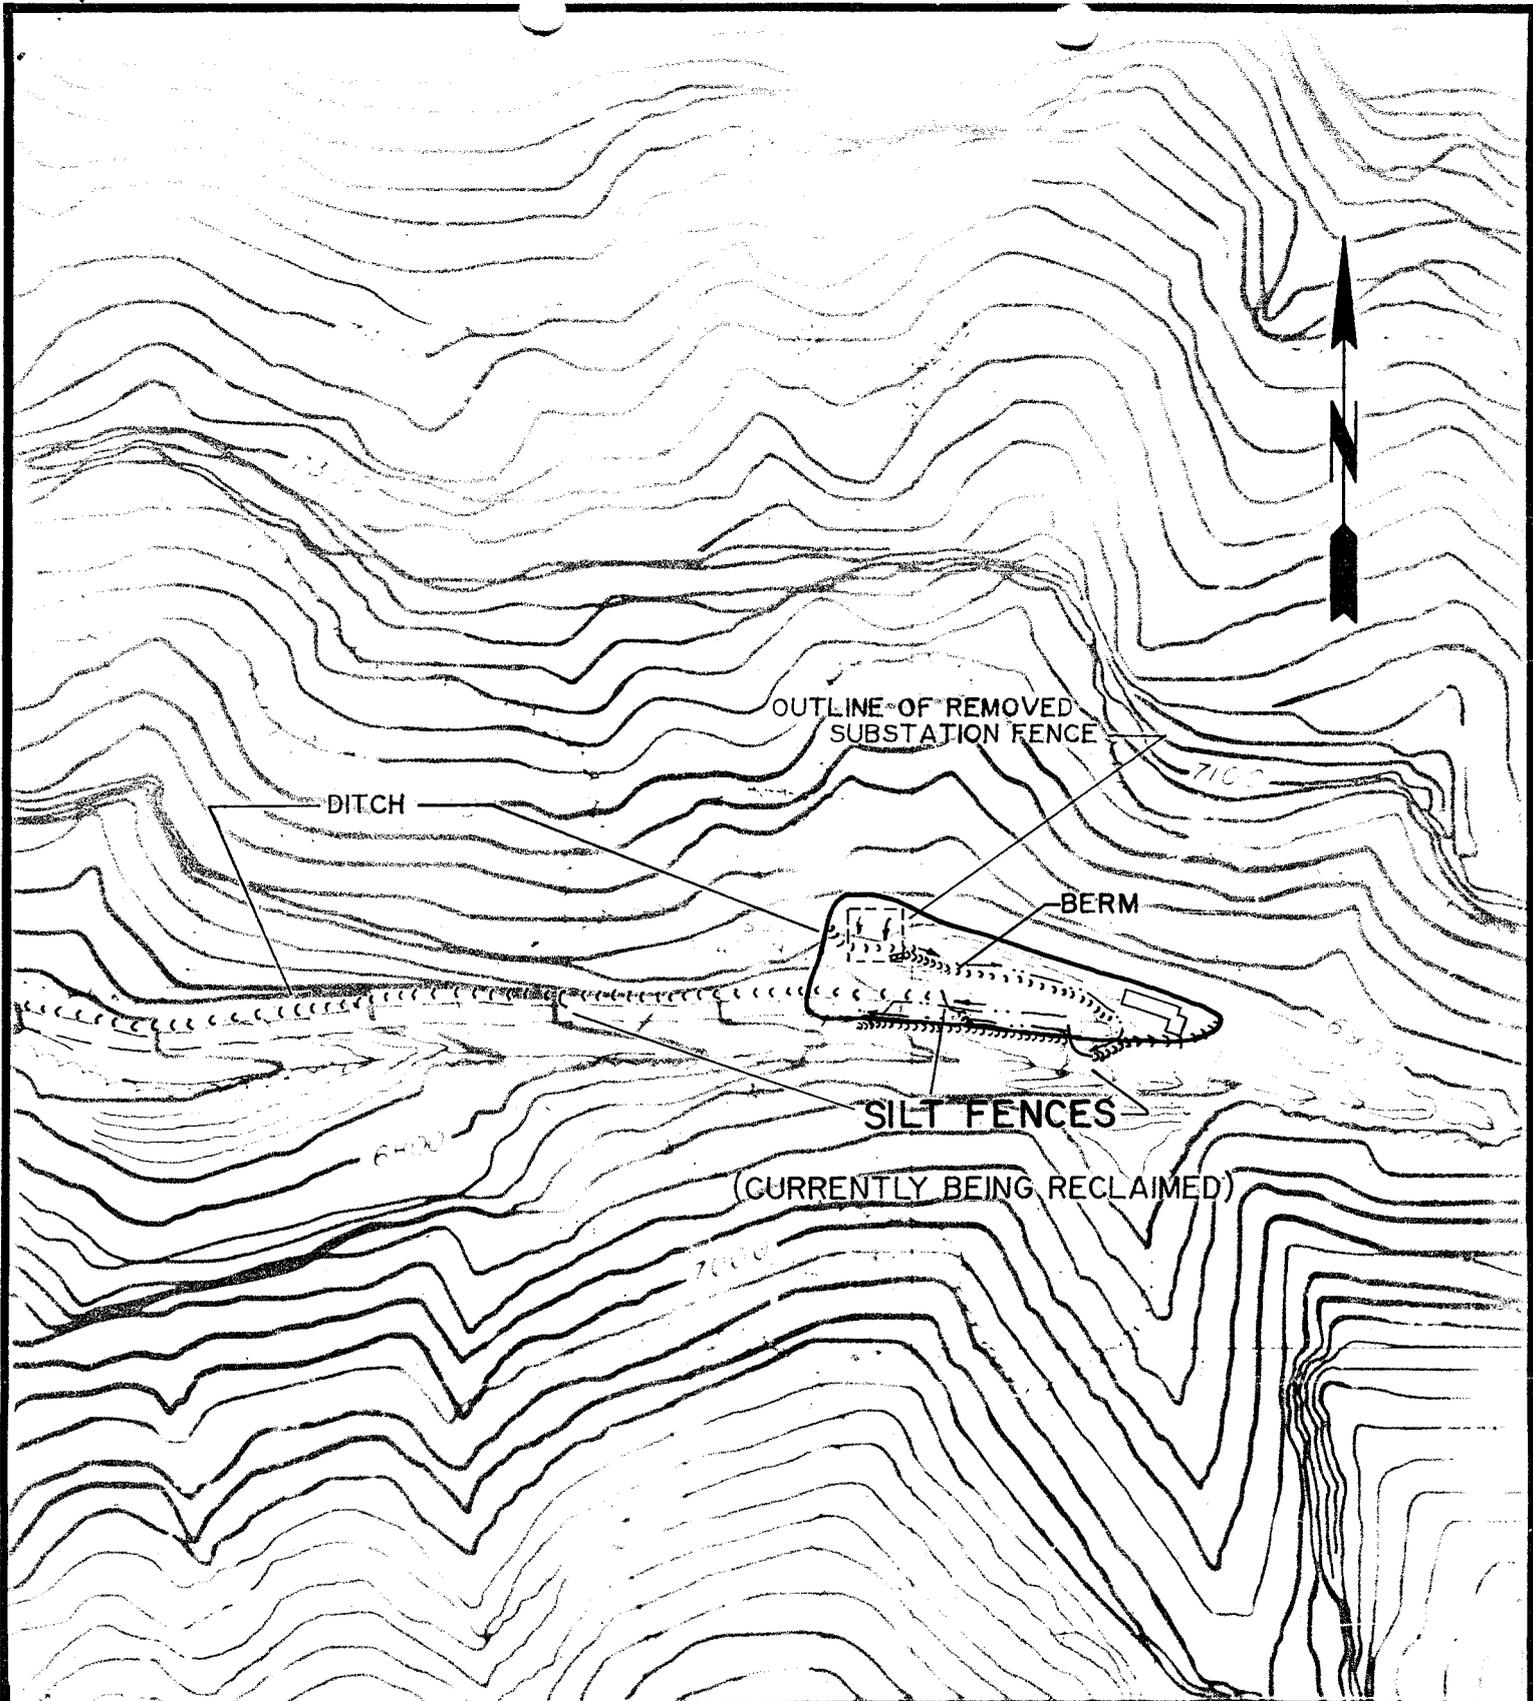
AS-010-R

I have also revised Plate 5-5, A5-0110, to Plate 5-5, A5-0110-R, making the necessary changes. These are enclosed.

In order to provide temporary drainage for the disturbed area of the pad, Sunnyside Coal Company has removed two concrete pads inside the substation perimeter and cut a shallow ditch on an angle from the cliff wall on the west side of the old substation perimeter along the front of the pad and tied it into the berm which parallels the substation access road. All runoff would report to the silt fences below. We have also established a berm at the middle silt fence to the edge of the wash and redefined the ditch to the bottom fence.
