SURFACE HYDROLOGY AND CULVERT ADEQUACY
OF THE HIAWATHA AND MOHRLAND, UTAH AREAS

Prepared for
UNITED STATES FUEL COMPANY

By
VAUGHN HANSEN ASSOCIATES

August 1978

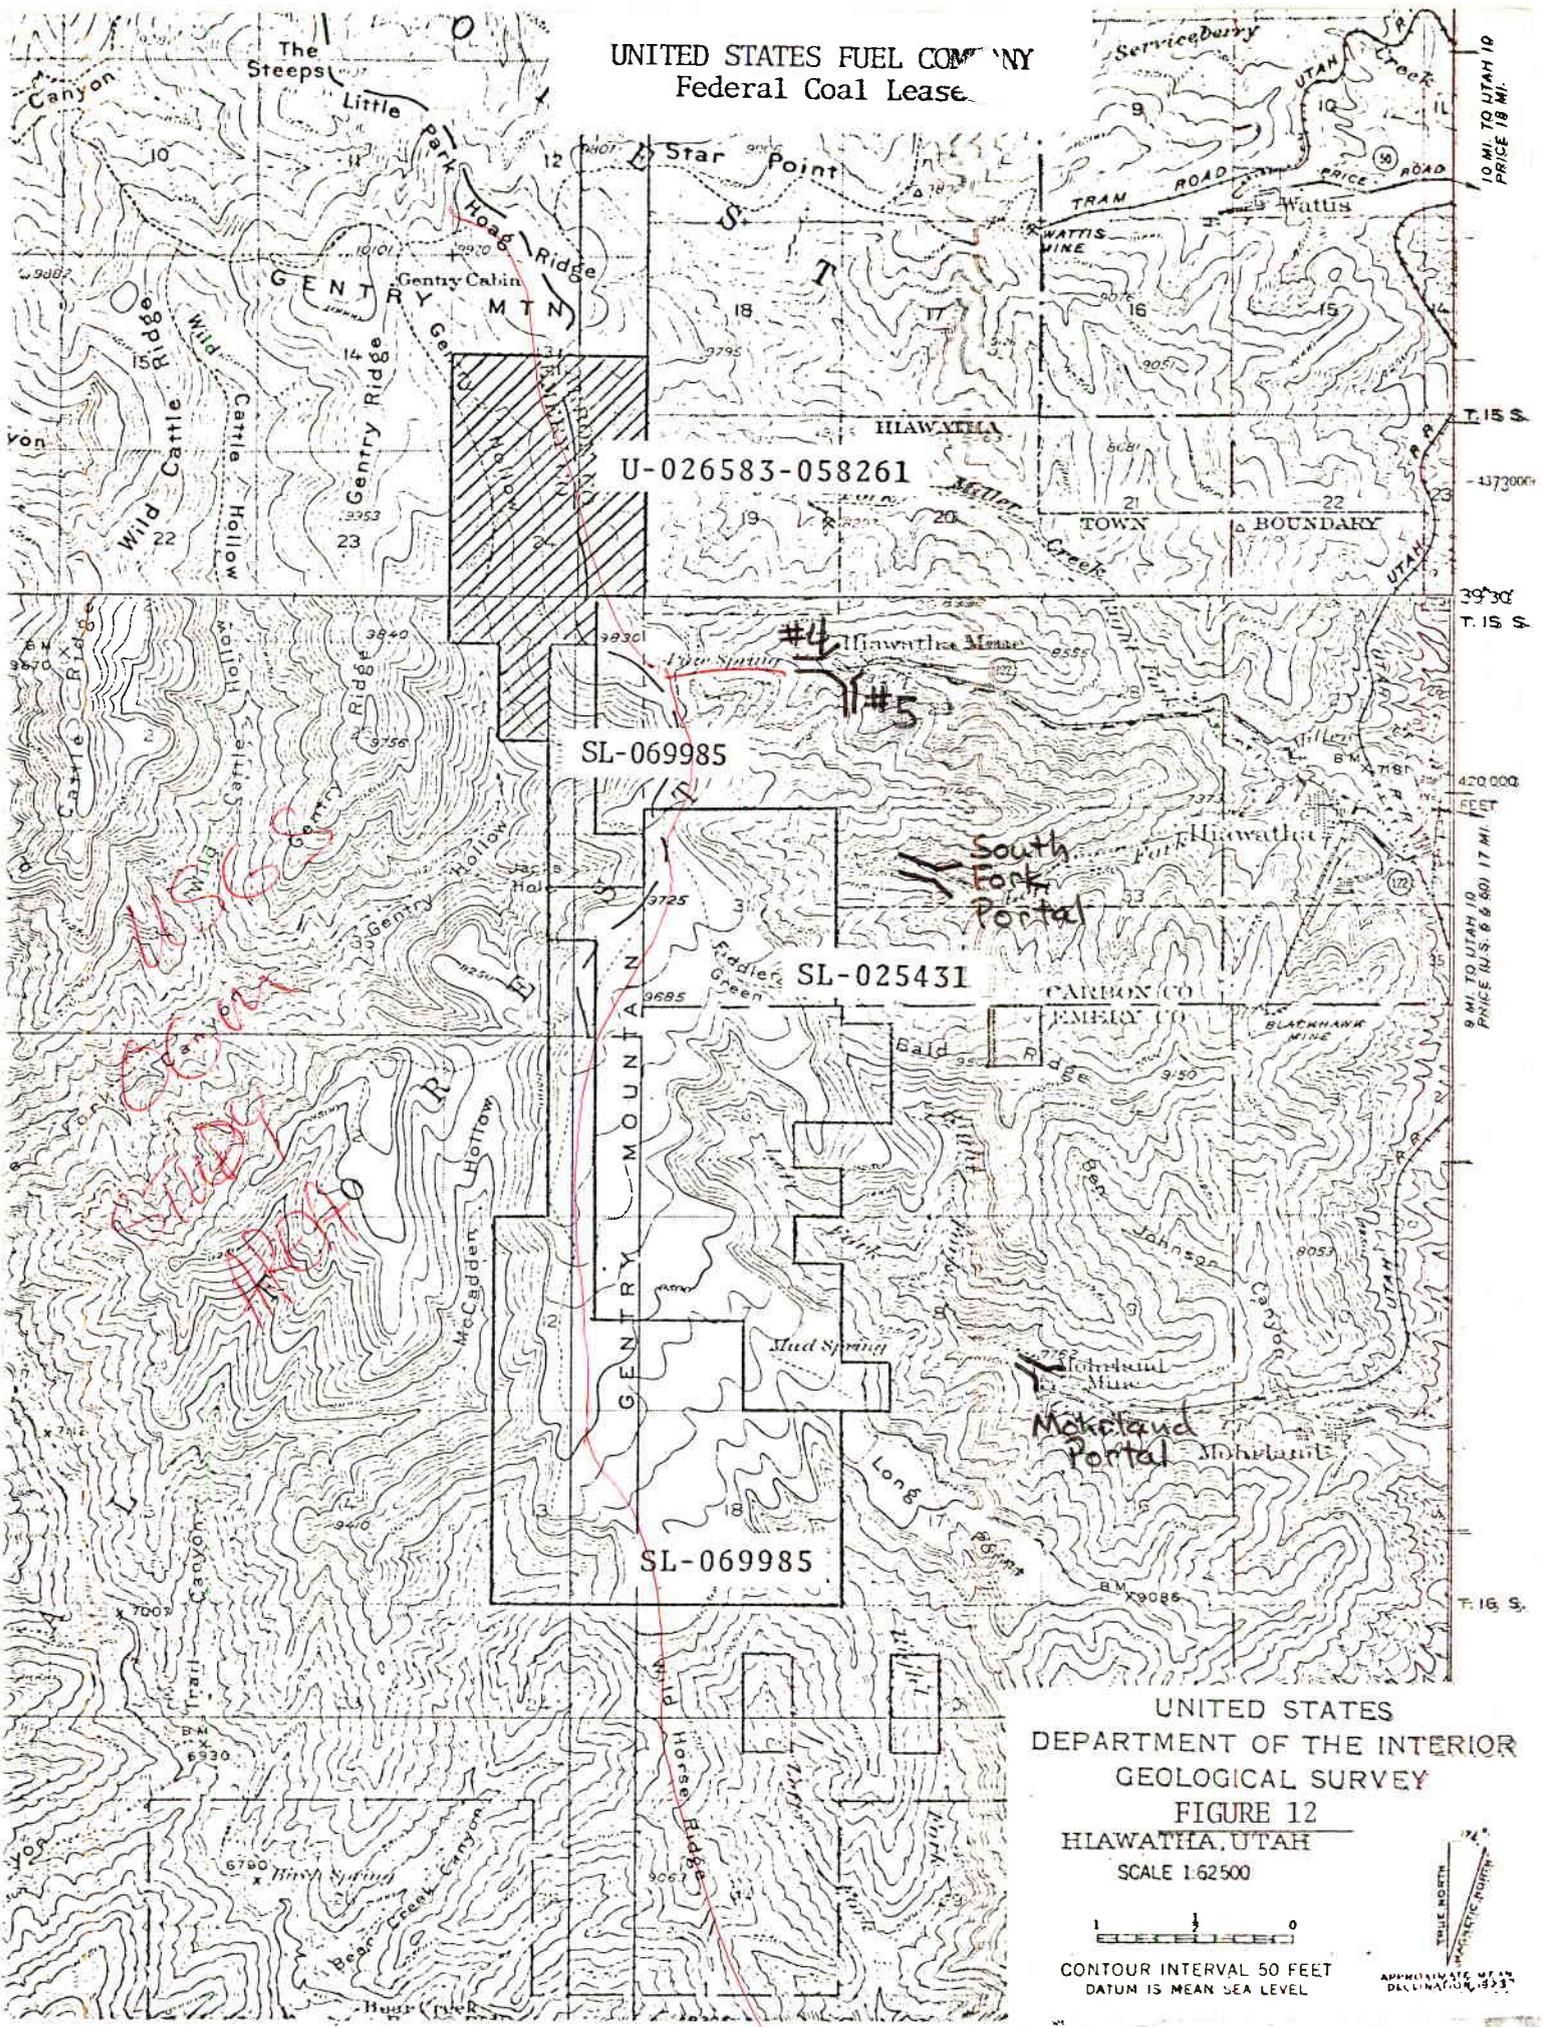
UNITED STATES
DEPARTMENT OF THE INTERIOR
GEOLOGICAL SURVEY
FIGURE 12
HLAWATHA, UTAH
SCALE 1:62500

The water drainage patterns in the area surrounding the discussed land are shown in Figure 12. Of the many drainage channels, most are normally dry or intermittent. Some such as Bear Creek Canyon, McCadden Hollow and Gentry Hollow have small springs or seeps at various points in their channels, but only Cedar and Miller Creeks flow continuously throughout the year from within the property area. Cedar Creek with its tributaries, the left and right forks, are part of the San Rafael River system. Its tributaries include North Fork, Middle Fork, and South Fork. Water volume measurements have been taken at Cedar Creek on a regular basis for many years. This data is shown in Figure 13. No recent measurements have been made on Miller Creek.
