State of Utah
DEPARTMENT OF NATURAL RESOURCES
DIVISION OF OIL, GAS AND MINING

October 6, 1994

TO: James Carter, Director
FROM: Paul Baker, Reclamation Biologist
RE: Violation N94-41-2-2, part 2 of 2

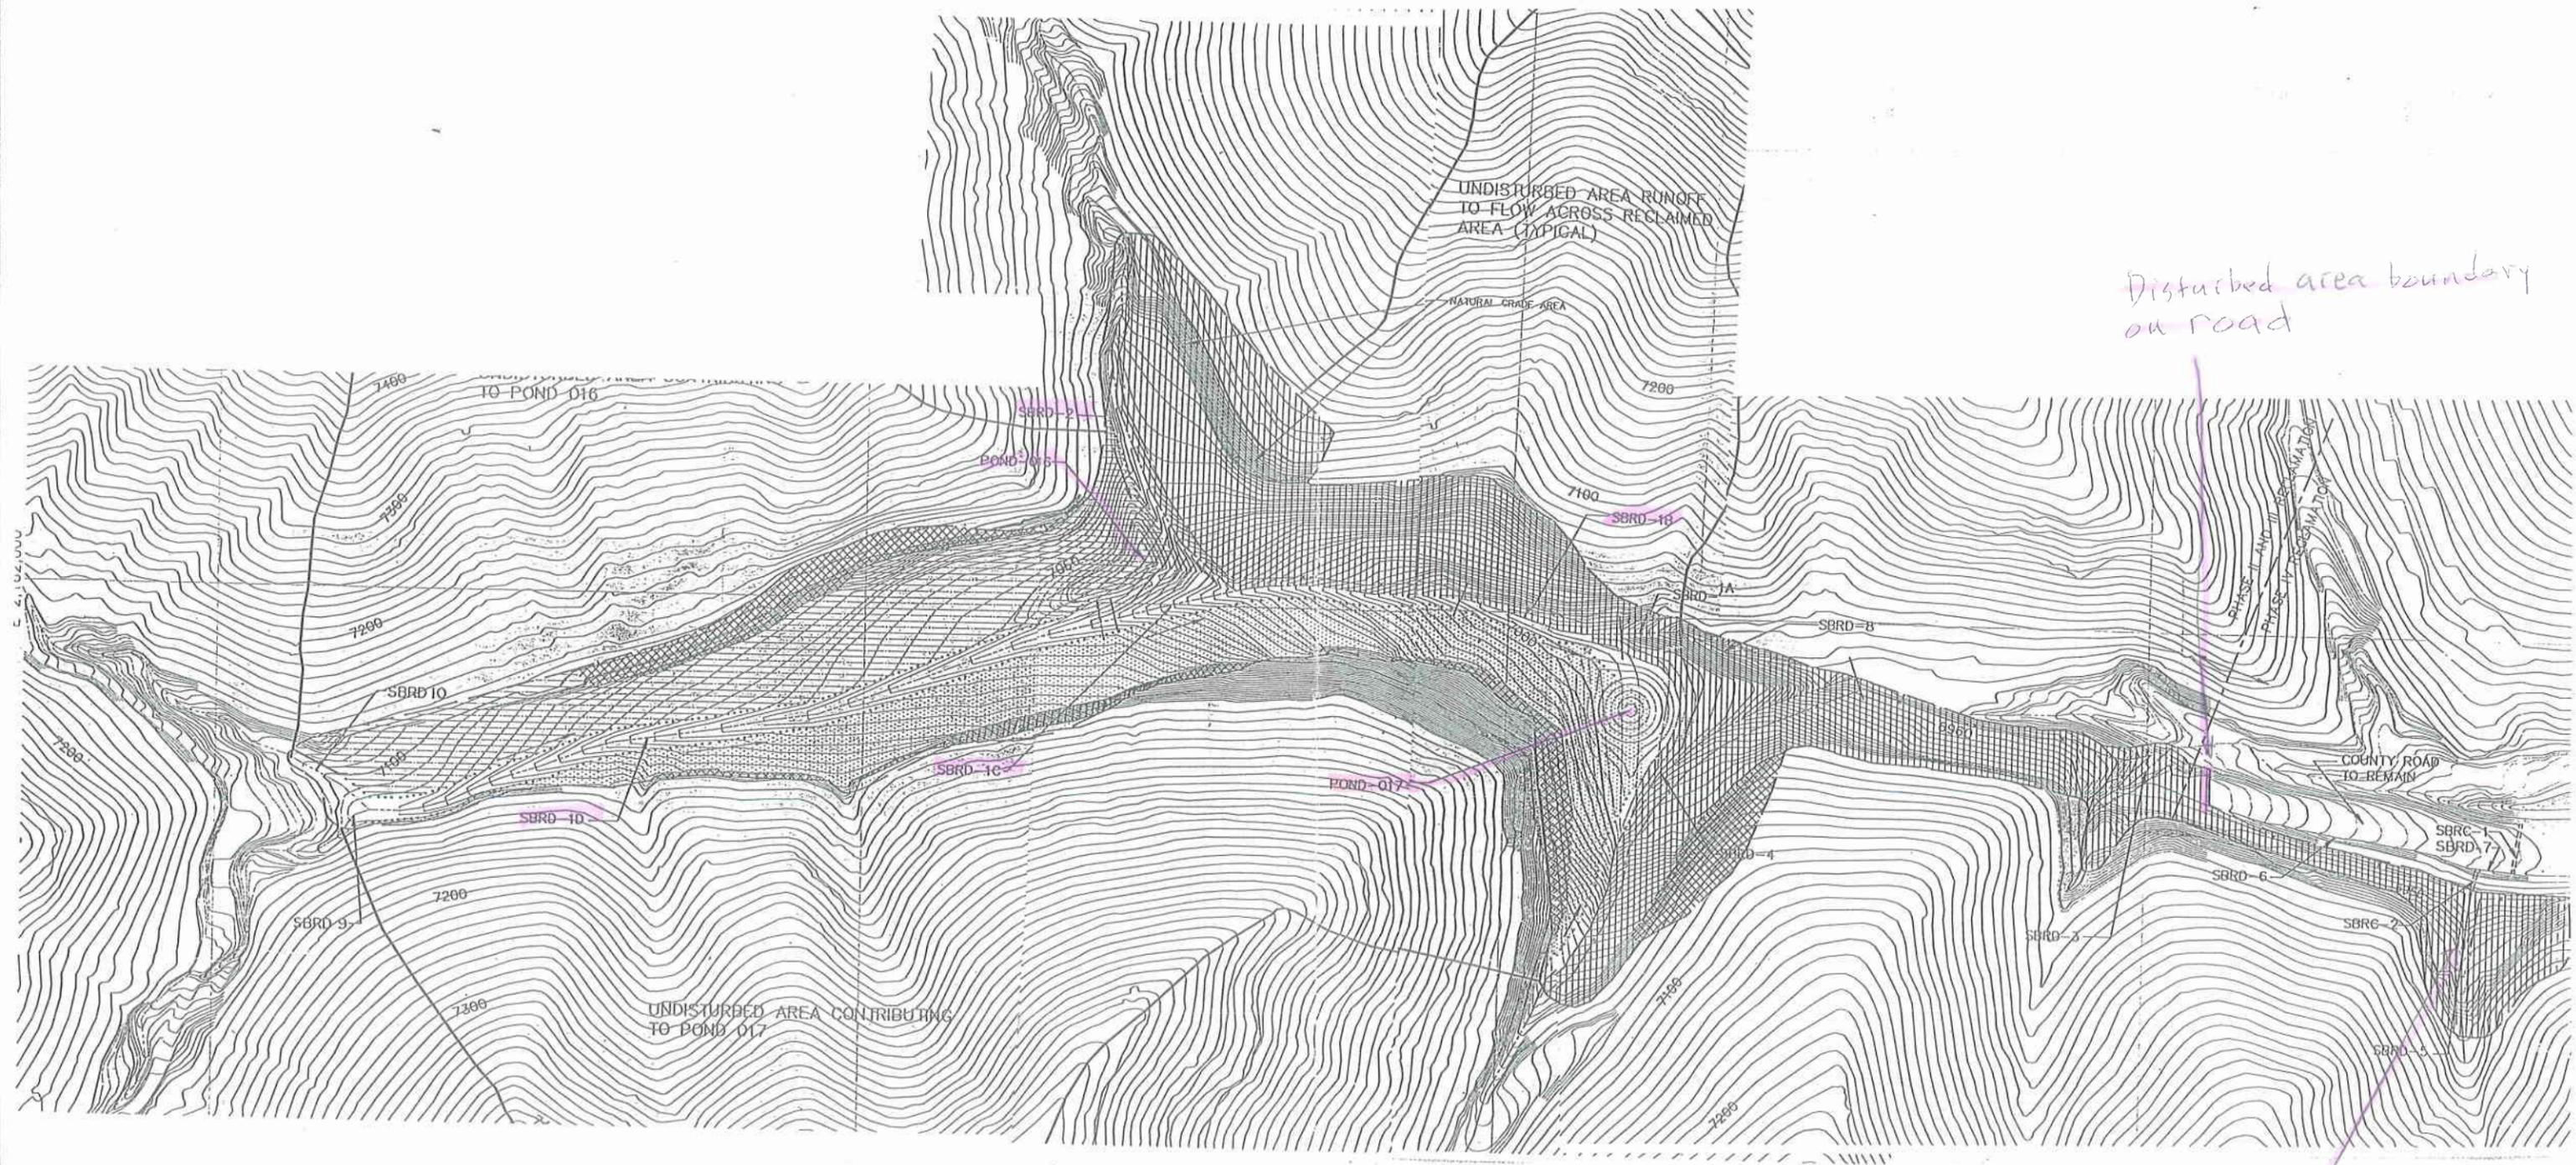
EXHIBIT 1

The portion of the road inside the mine's disturbed area boundary begins where the road to the substation intersect the main access road to the mine. (Please see copy of portions of Exhibit 3.2-4 from the mining and reclamation plan, attached as Exhibit 1.) At the time of the inspection, the area in the side canyon near pond 17 (then pond 5) was being used as a staging area. Most of the grading work was being done in the area to the east of SBRD-1B and south of SBRD-2. The portion of SBRD-1 (main channel) below pond 16 had not yet been riprapped and was being used as a road to transport equipment and rock to riprap the upper portions of SBRD-1. The equipment was raising a lot of dust as it travelled. On the two days when I was inspecting the mine, equipment I saw operating included a semi-trailer truck, a dozer, and a front-end loader.
