From: Priscilla Burton
To: Mark Reynolds
CC: Helfrich, Joe; Nance, Angela
Date: 5/14/2008 5:10 PM
Subject: Hiawatha Technical Inspection Report
Attachments: insp rpt 1621 map_20080507155127.pdf; Insp Rpt 1621_20080512131002.pdf

Inspection Report

InspectionID Report Number: 1621

RE: Soil Cover Depth Evaluation. Phase I Bond Release Slurry Pond 4 and 5. Co-Op Mining Corporation, Hiawatha Mine, C/007/0011, Task 2895

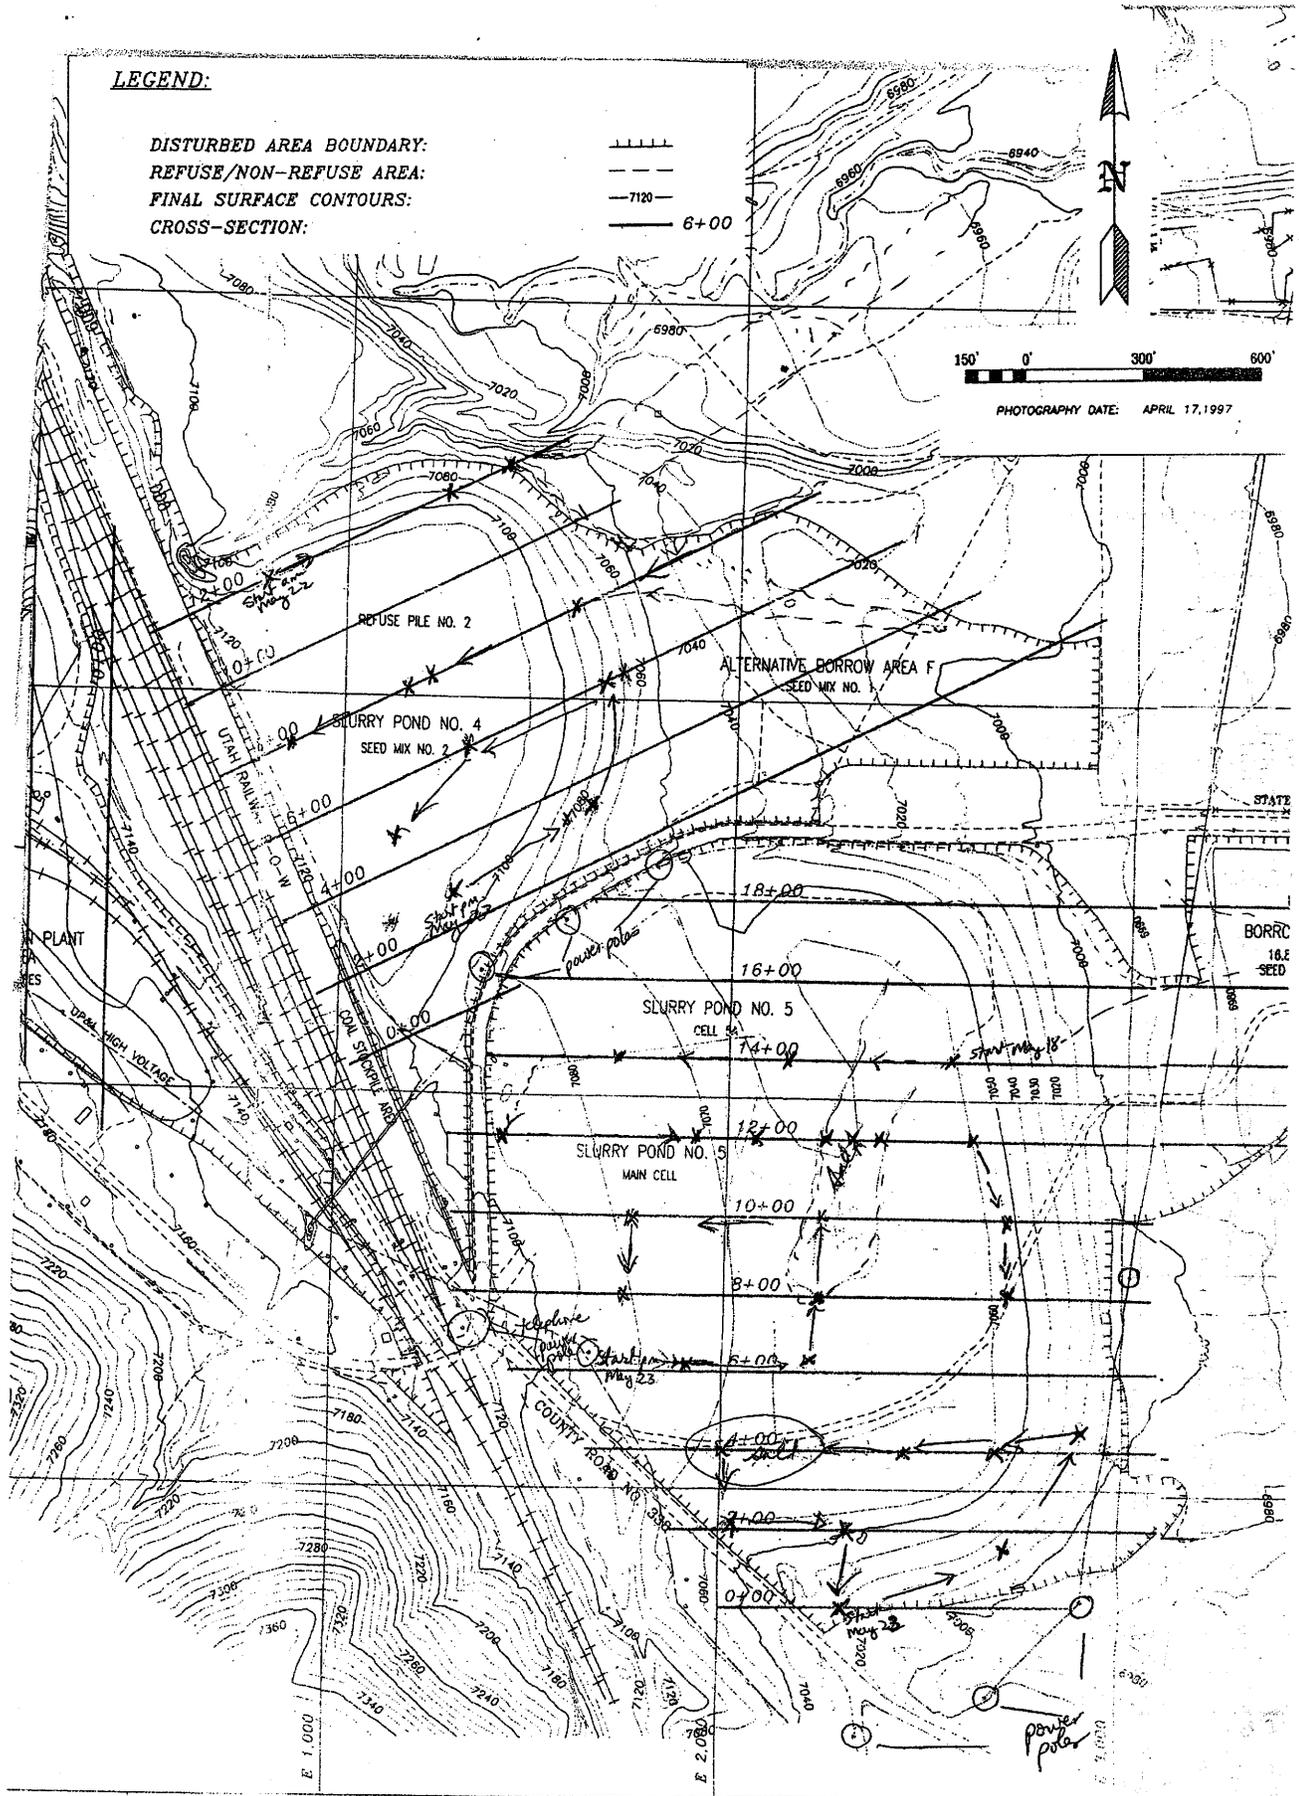
HIAWATHA PROCESSING PLANT
AND WASTE DISPOSAL SITES
Ex. V-13

Notes were taken of 18 auger holes drilled into REFUSE PILE #5 at Stations identified on MRP Ex. V-13. Notes included location description, soil cover depth (inches), brief soil description, brief vegetation description. Photographs were taken. The complete notes are an attachment to this report and are also filed in the 2008/Internal file. The Refuse Pile #5 has an average of 15 inches cover depth over the mine waste, based upon 23 auger holes dug. The Slurry Pond #4/Refuse Pile #2 has an average of 16 inches of cover depth based upon the 11 auger holes dug.

I returned to Hiawatha to take measurements of the soil cover over the refuse in expectation of being asked to make a finding for the revised Phase 1 bond release application. Using Ex. V-13, I walked across the site and augered the soil cover, making notes on cover depth, moisture content, salt accumulation and total live cover in a 3 ft X 3 ft area around each soil auger site. Photographs were taken of most auger sites.

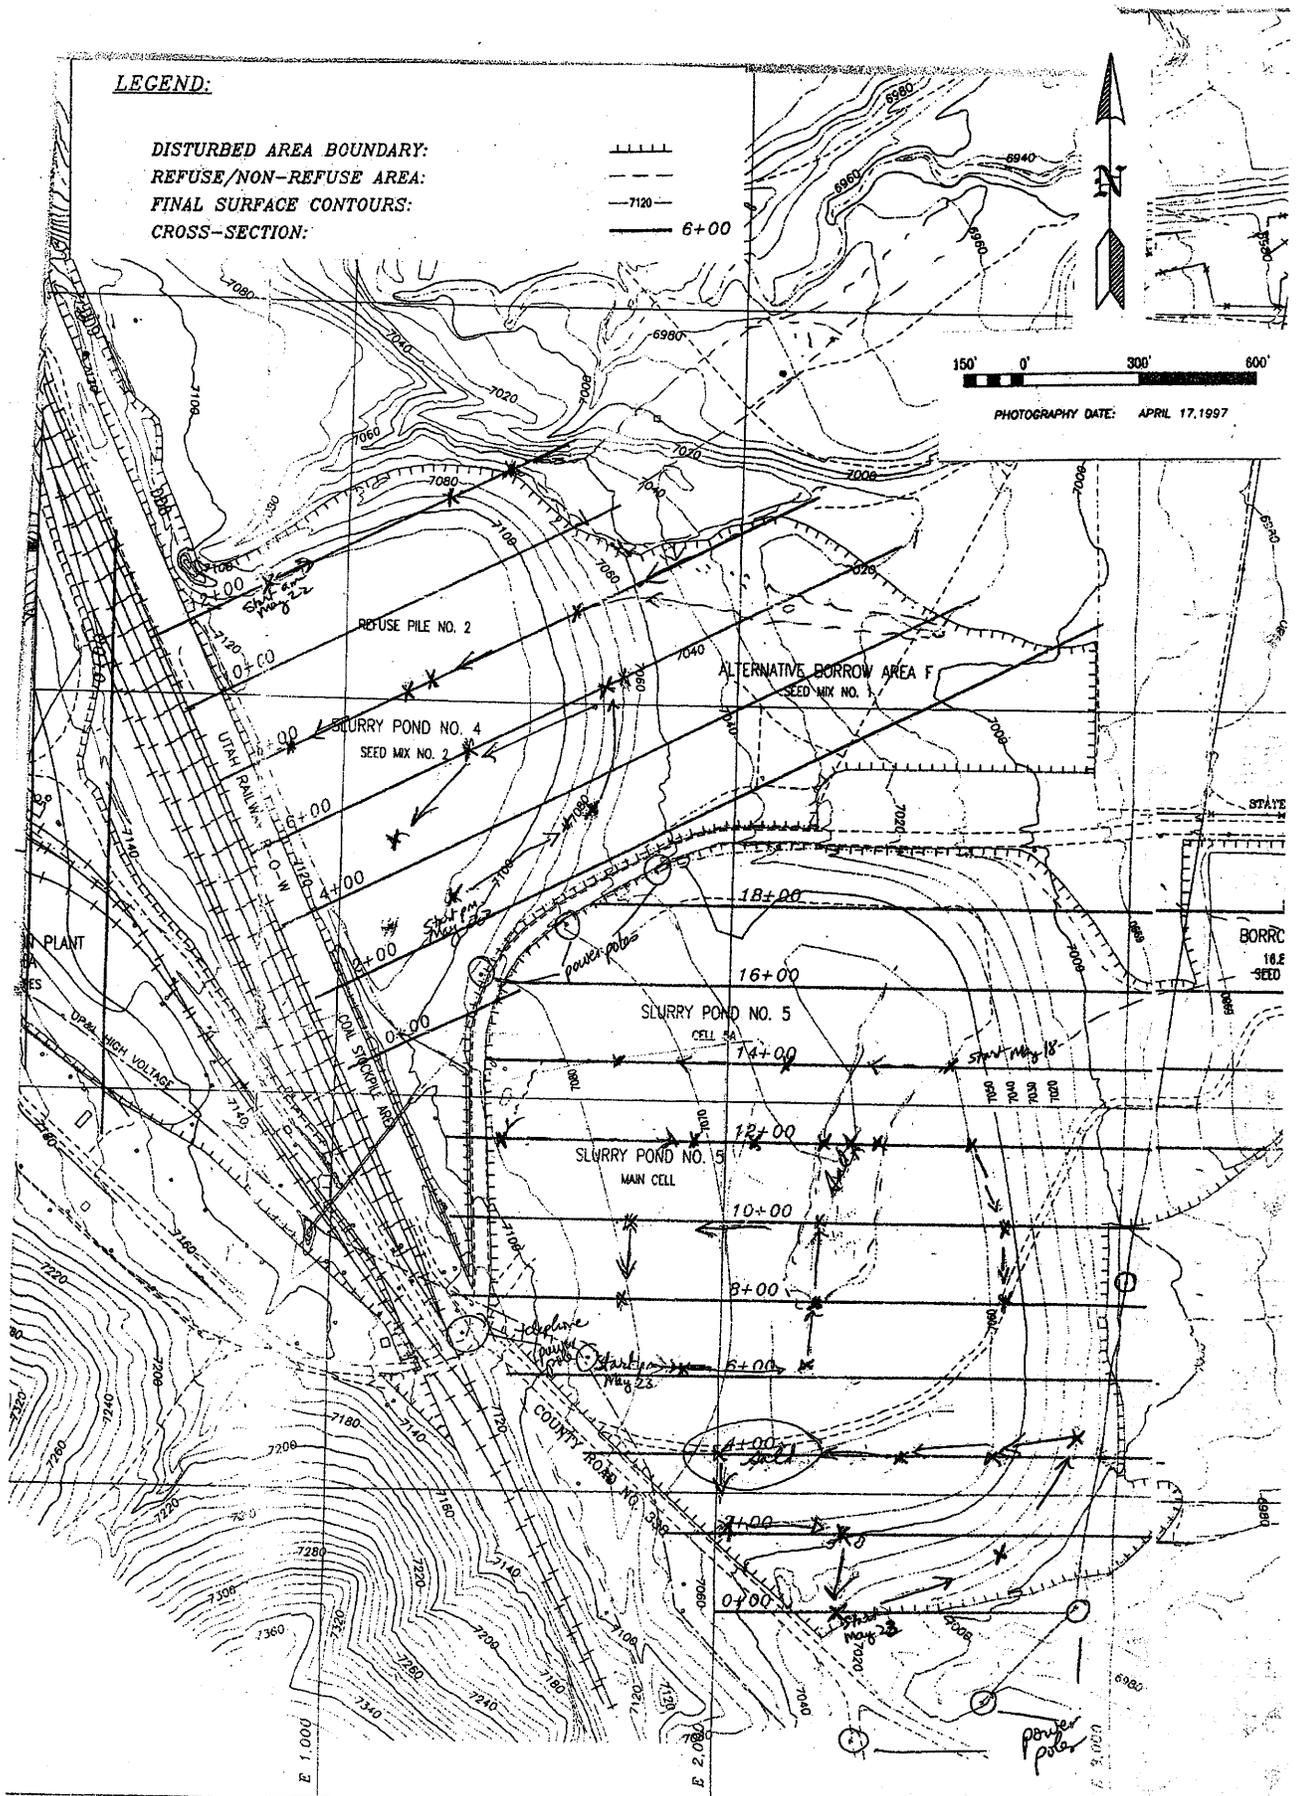
HIAWATHA PROCESSING PLANT
AND WASTE DISPOSAL SITES
Ex. V-13

Inspection Report #1621 summarizes the technical site visit. There is an average of 15 inches of cover over Refuse Pile #5 and an average of 16 inches of cover over Slurry Pond #4/Refuse Pile #2. This Attachment provides the details of the cover depth analysis. Auger sites were plotted along the stations shown on Exhibit V-13, Hiawatha Processing Plant and Waste Disposal Sites. A copy of that map is attached. The following tables summarize the notes taken over three days at the site. Photographs are available in the database.
