Inspection Report

Permit Number:	C0070011
Inspection Type:	COMPLETE
Inspection Report Date:	Mon Aug 15, 2022
Start Date/Time:	08/04/2022 09:00:00
End Date/Time:	08/04/2022 14:00:00
Last Inspection:	Wed Jul 6, 2022

Permittee: **HIAWATHA COAL CO INC**
 Operator: **HIAWATHA COAL CO INC**
 Site: **HIAWATHA MINE**
 Address: **PO BOX 1240 HUNTINGTON UT 84528**
 County: **07 CARBON**
 Permit Type: **PMT**
 Permit Status: **ACT**

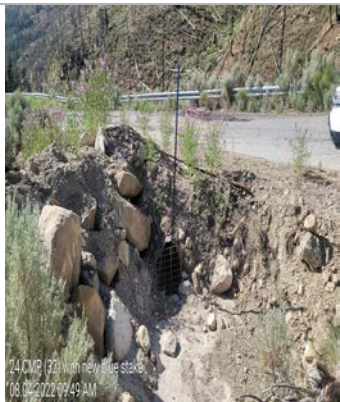
The Permittee has been working on restoring the culverts and ditches throughout the property. Culvert inlets are marked with a stake painted blue. Trash racks are being restored as well. In Middle Fork, water enters bypass culvert 25 at approximately 35 GPM. There is also a seep that has formed on the shoulder of the ANR Road (not within permit boundary). The bypass does not capture the flow running down the ANR road above Middle Fork, and there is evidence of that flow channeling across the Middle Fork pad. Bypass culvert 17 is plugged with log debris at its inlet, and damaged along its length. This culvert will need to be repaired as Middle Fork is restored.

Photo 1
24 CMP (32) with new blue stake

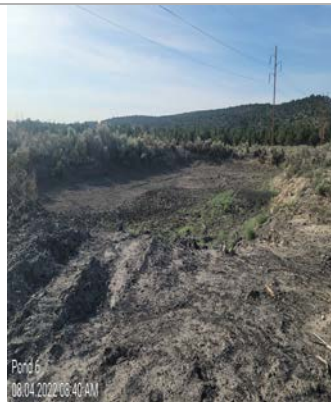
Photo 2
Pond 6

Inspection Report #8194 tasked the Permittee with cleaning all of the ponds that were severely impacted by last year's flood event before July 15th, 2022. All of the ponds have been cleaned successfully with the exception of Pond 8. Repairs to the Middle Fork Road as called out in the previous inspection needed to be made prior to having heavy equipment travel the roadway to safely access Pond 8. Once Middle Fork Road is safe for heavy equipment to travel, the Permittee will finish the cleanup of Pond 8. Sediment cleaned from Pond 9 was placed on the South Fork Bathhouse pad. Sediment cleaned from Pond 011 was placed on the Coal Loadout Pad in South Fork. Sediment from the Middle Fork Pond 008 will be stockpiled on the Middle Fork pad and used to stabilize road ditches. 2nd Quarter sediment pond inspections were completed 6-22-22. The Permittee plans on surveying the ponds after they are all cleaned and repaired. Sediment markers will be replaced when the ponds are surveyed. After the ponds are surveyed, the Permittee plans to submit As-Builts to the Division. Pond 003 – Upper Rail Yard – 60%=7212.0' Estimated Sediment level = 7210.0'. Pond was dry at time of inspection, but showed signs of recent storm water. Pond 004 – North of Slurry Pond #1 – 60%=7087.8' Estimated Sediment level= 7087'. Pond was dry at time of inspection. Decant has been restored. Pond 006 – East of Slurry Pond 5a – 60%=6990.0' Estimated sediment level = 6988.5'. Pond was dry at time on inspection. Decant has been replaced. Pond 008 – Middle Fork – 60%=8034.8' Estimated sediment level = 8043'. Pond will be cleaned after Middle Fork Road has been repaired. Pond 009 – South Fork Upper – 60%=7902.2' Estimated sediment level =7902'. Decant has been replaced, but will be cut off to correct level when the pond is surveyed. Pond 011 – South Fork Lower – 60%= 7711.4' Estimated sediment level = 7709'. Decant will be replaced when surveyed. ACTION ITEMS: Clean Pond 8 when Middle Fork Road is repaired.

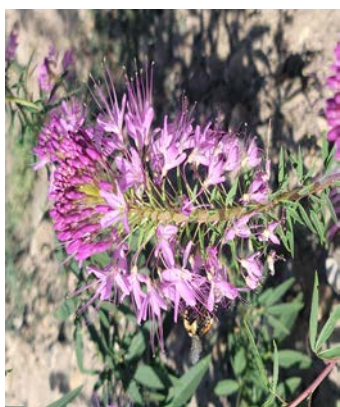
The Permittee has applied seed to the property including in areas of flood debris storage. Rocky Mountain Bee Plant is abundant across Middle Fork.

Photo 3
Rocky Mountain Bee Plant

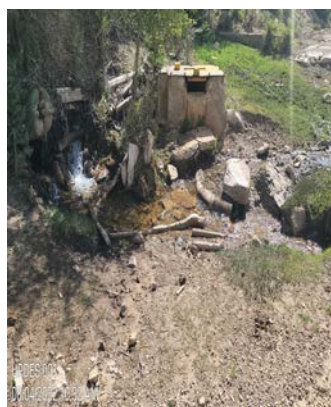
During the field inspection, the Mohrland area was visited, and the UPDES point was observed. It was flowing into the pipeline as intended. While the Mohrland area and pipeline are no longer incorporated into the MRP, the pipeline follows the railroad ROW back to the town of Hiawatha, into a holding tank and is used in the residences. Excess water overflows from the tank into a ditch on the permitted area, which is sampled as UPDES 002.

Photo 4
UPDES 001 at Mohrland portal

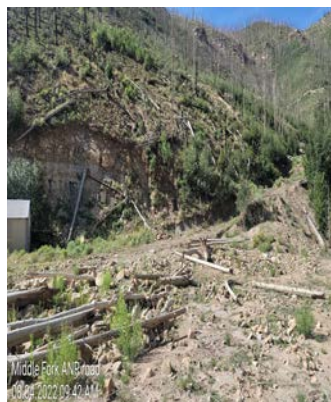
The Middle Fork access road has received significant damage due to the August 2021 flood event. The road surface has deteriorated, and UD-6 ditch that runs along the side of the Middle Fork road is severely eroded, causing numerous cuts several feet deep, and undercutting and sloughing of the asphalt surface. This primary road must be maintained in accordance with R645-301-534.330. Page 5-72 of the approved Hiawatha MRP states that “Primary roads that have been damaged by catastrophic events such as floods or earthquakes will not be used until reconstruction of damaged road elements. The reconstruction will be completed as soon as practicable after the damage has occurred”. The Permittee was instructed during the last inspection to barricade the damaged road and close the gate to restrict access, which was done. Road cones have been placed around the erosion of the road surface to warn potential traffic of the hazards. Rock from flood debris has been separated out and is being used to fill the majority of the ditch to prep it for fill material from Pond 8. ACTION ITEMS: Restore the road surface and drainage control along the Middle Fork access road.

Photo 6
Middle Fork ANR road

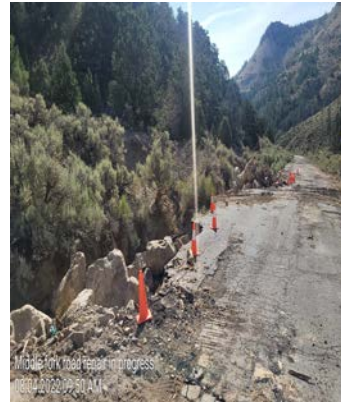
Photo 8
Middle fork road repair in progress, rock fill taken from flood debris

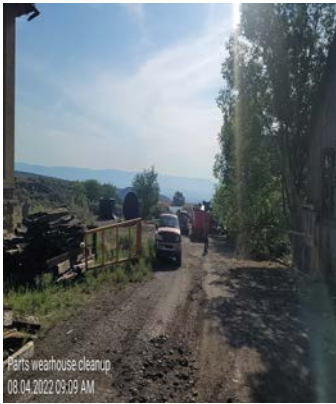
The four designated storage yards within the Hiawatha area shown on Exhibit V-9 were well organized and stored appropriate mining materials as designated within the MRP. The Permittee has been deploying further organization efforts within these storage areas to make the spaces even more functional. The Permittee has begun cleaning out the Parts Warehouse area located in the lower portion of the city.

Photo 9
Parts warehouse cleanup

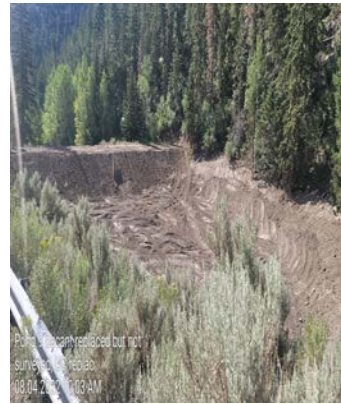
Photo 10
Pond 9 decant replaced but not surveyed or cut to height yet, 42in CMP UC replaced
