**U. S. Steel  
Mining Co., Inc.**

RE: Catch Basin Below Slurry Pipeline for Abatement of NOV #N84-2-13-1

# EXHIBIT B

RE: Review Based on Plans Submitted July 21, 1984 and a Site Visit July 18, 1984 Regarding NOV N84-2-13-1, Wellington Preparation Plant, ACT/007/012, #3 and #7, Carbon County, Utah

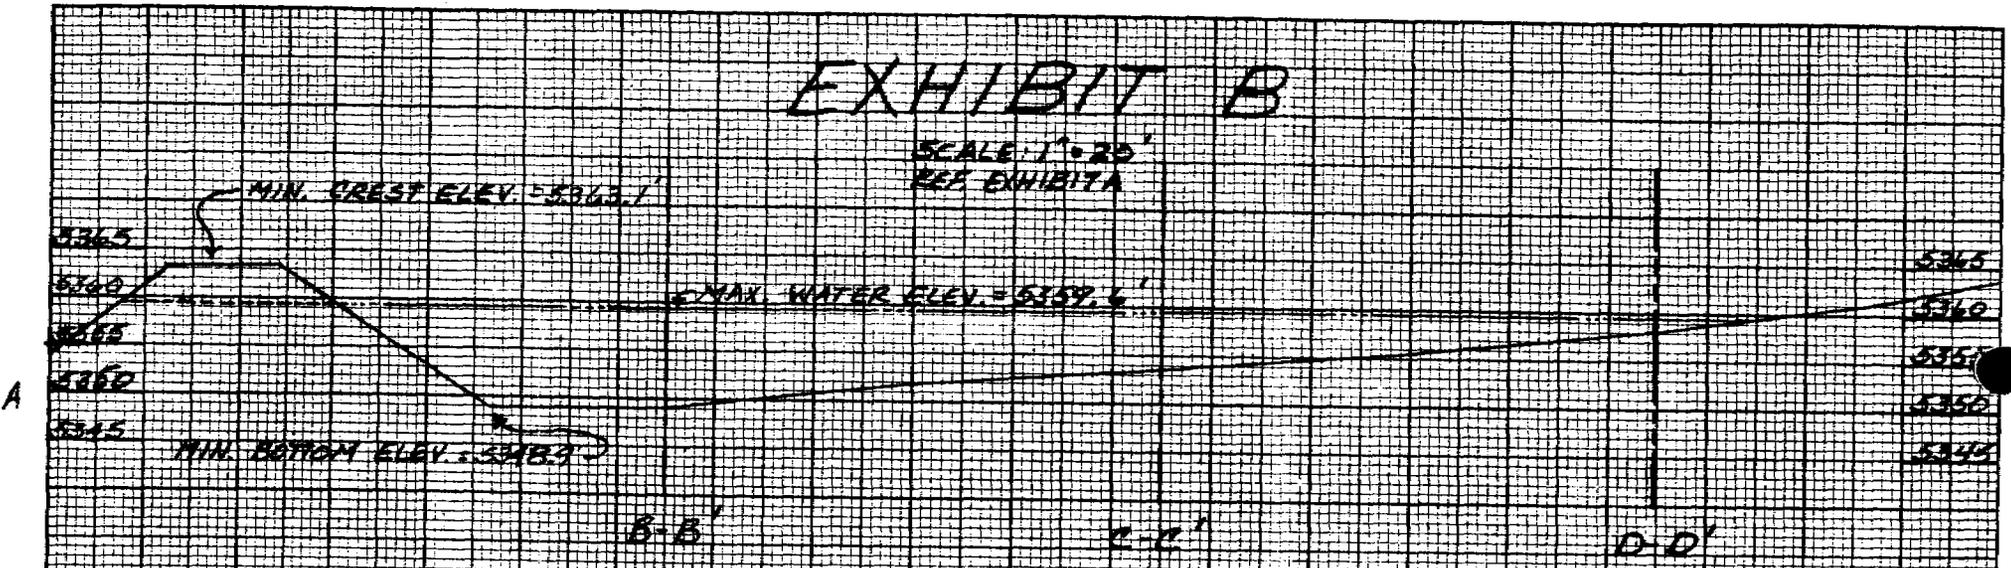
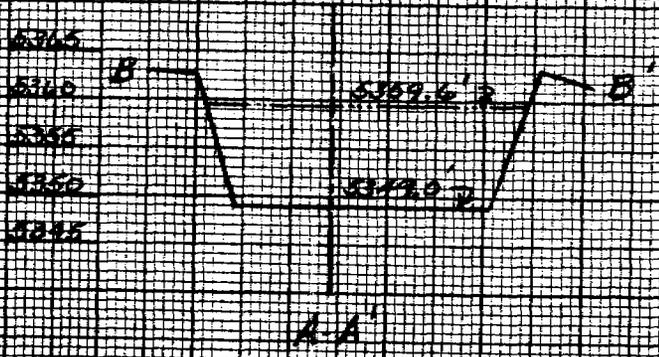
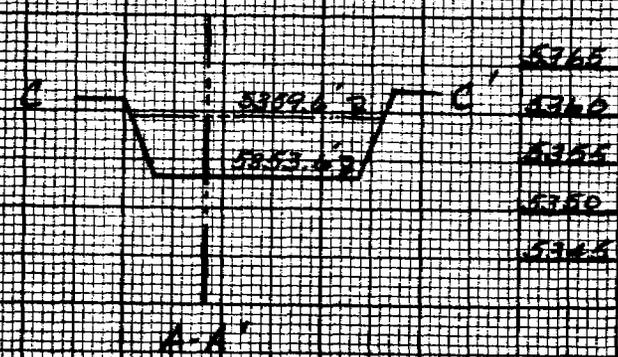
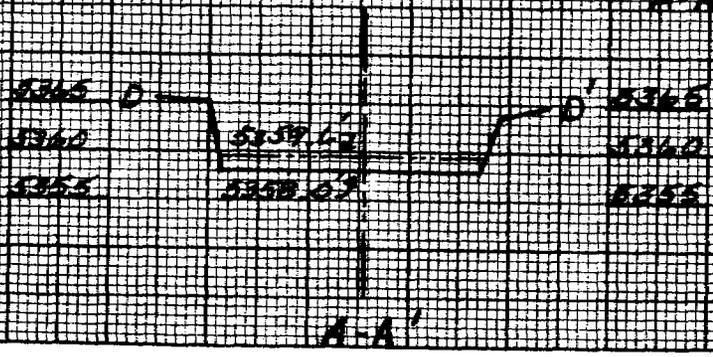
EXHIBIT B: This is a new exhibit showing basin cross sections which were surveyed on August 1, 1984. The capacity based on these sections is 0.57 AF (25,000 cu. ft.)

NOTE: MAX. WATER ELEV. 5359.6' IS AT ELEV. OF SILT FENCE UNDERLINER OF GABION

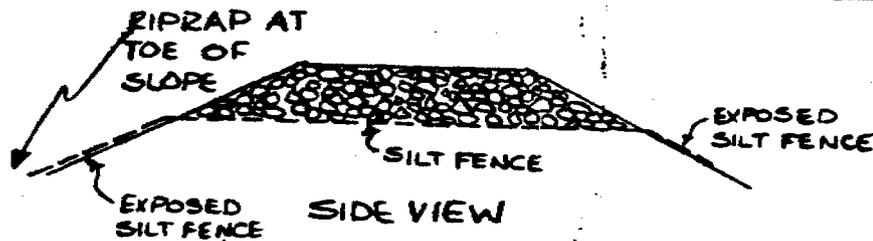
GABION OVERFLOW  
SCALE: 1" = 10'

EXHIBIT A: This exhibit has been revised to locate the cross sections referenced on Exhibit B. Also, note the scale change on the gabion detail. The 1" = 5' scale shown on the June 28, 1984 submittal was in error.
