State of Utah
DEPARTMENT OF NATURAL RESOURCES
DIVISION OF OIL, GAS AND MINING

June 5, 1998

FROM: Paul Baker, Reclamation Biologist

Re: N98-41-2-1 ACT/007/012 #2

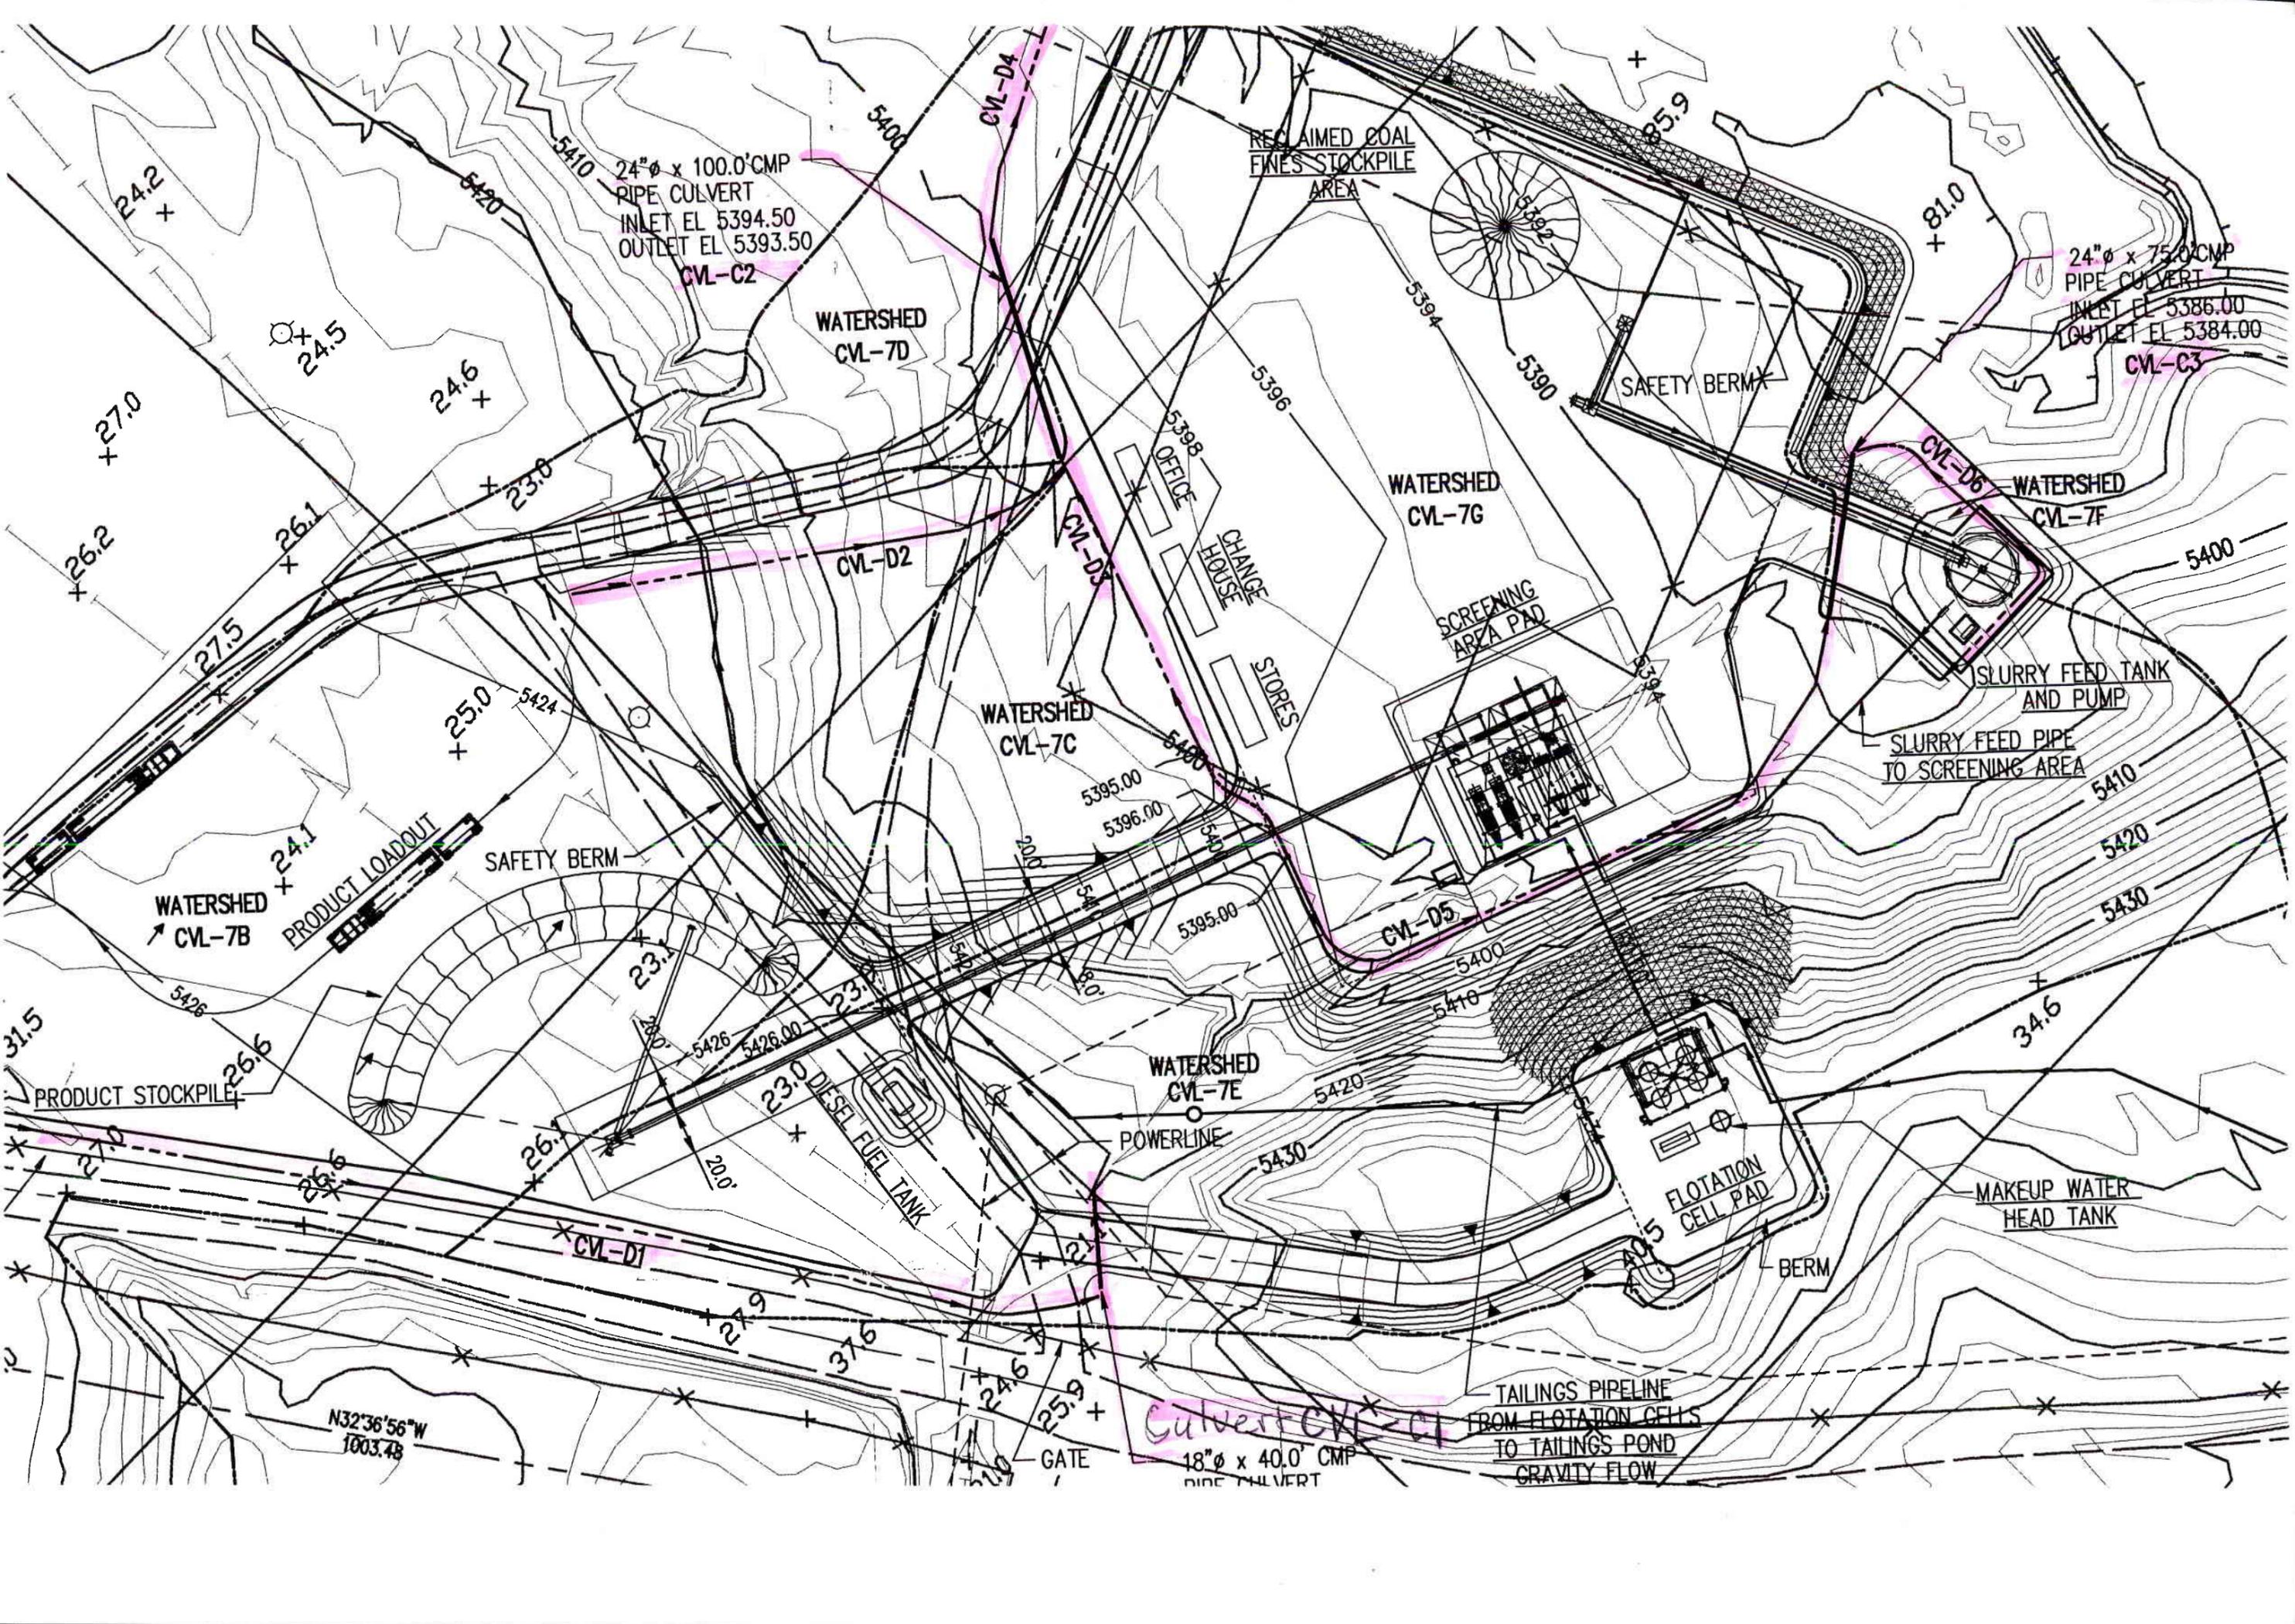
For the following discussion, please refer to the attached copy of a portion of map T1-9597 from the operation and reclamation plan. I have attempted to highlight ditches and culverts on this copy.

During the inspection, water was being drained from the slurry feed tank into an undesigned ditch leading to the slurry pond. I estimated about 1-2 cfs was flowing through this ditch, and it had eroded about two feet deep.

The designs show culvert CVL-C3 being 24 inches in diameter, but the culvert that was installed had a diameter of 12 inches. It appeared water from the operations had been flowing through the lowermost part of ditch CVL-D5 to this culvert, and there was black foam at least one foot deep on the upstream side of the culvert. It appeared the culvert had not been able to handle the flow and that water and foam had backed up. The operation and reclamation plan does not indicate any of the diversions would be used for water from the operations; they were to be used strictly for precipitation runoff control. Therefore, these diversions were not designed with all aspects of the operation in mind.

Ditches CVL-D1, CVL-D4, CVL-D3, and the part of CVL-D5 below the flotation cell pad were not built. In the place where CVL-D4 was supposed to be was a coal stockpile. In the relatively flat areas of CVL-D1 and CVL-D3, there was no real drainage control other than sheet flow.

There was no culvert installed where CVL-C2 was supposed to be. Instead, a 12-inch culvert (rather than 24) had been installed under the road paralleling where ditch CVL-D3 was supposed to be. Culvert CVL-C1 was not installed.

The drainage designs failed to take into account a culvert under the county road near the gate at the main entrance. This eventually led to water being diverted to the ditch along the slurry pipeline road to the west and this ditch failing. Straw bales were present in the area to treat the runoff.
