WATER QUALITY MEMORANDUM

Utah Coal Regulatory Program

RE: 2009 Second Quarter Water Monitoring, Nevada Electric Investment Corporation, Wellington Preparation Plant, C/007/0012, Task ID #3315

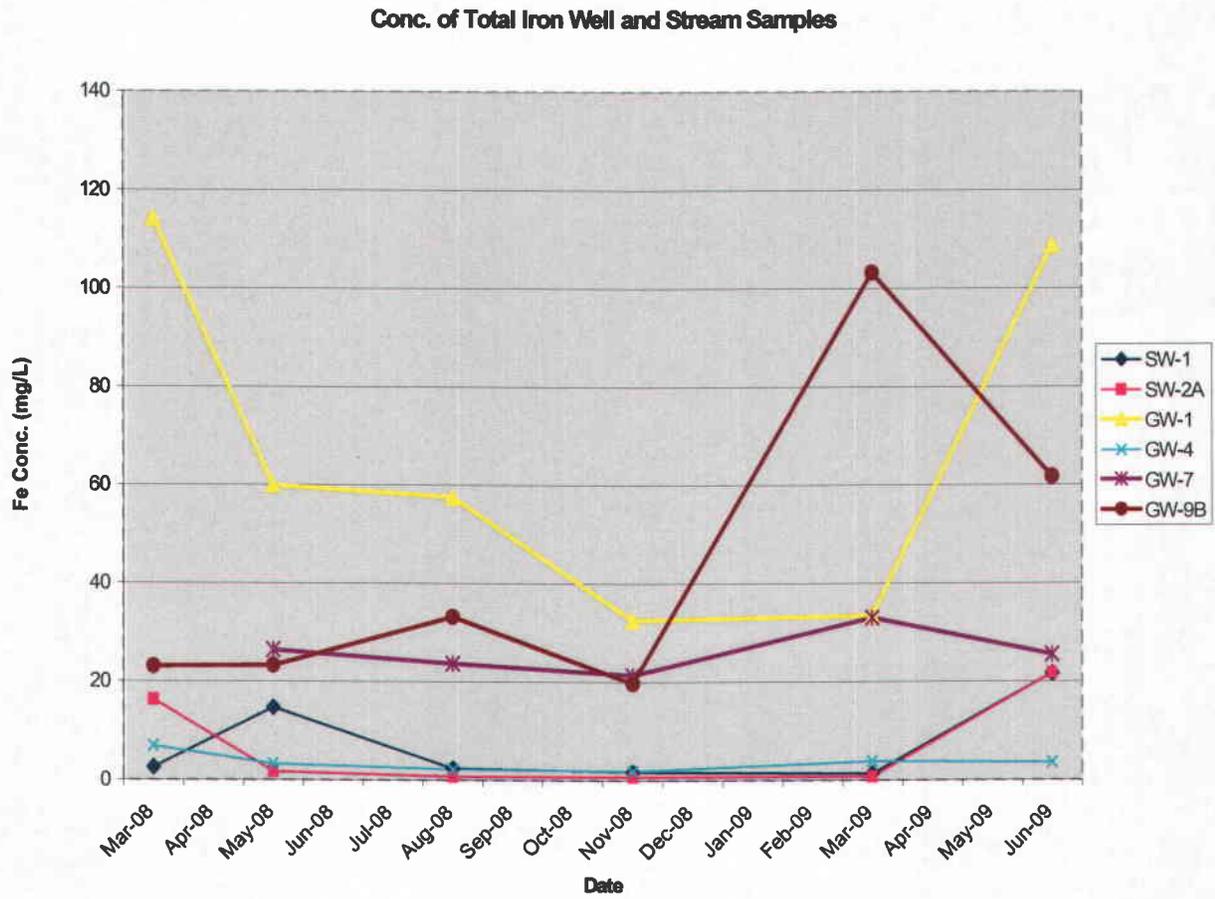
Total iron concentrations were lower in some of the groundwater samples from last quarter but spiked in GW-1. All other parameters appeared to be within their historical normal ranges. Chart 1 shows the total iron concentrations during the June 2009 sampling event for all select monitoring wells.

- Total iron levels appear to be elevated in most of the groundwater monitoring wells at the site. Total iron concentrations for most of the wells were in line with previous results for each respective well. Surface water samples were also slightly elevated. Surface water samples collected during the second quarter and select groundwater samples are shown on Chart 1.

Spikes in total iron were shown in monitoring well MW-9B and MW-15A during the first quarter 2009. Second quarter 2009 sampling results for total iron in these wells did show a decrease. However, GW-1 showed an increase in total iron. The pattern of total iron flowing through the surface and groundwater in the permit area appears to be very dynamic. No state-mandated numeric groundwater or surface water standards exist for total iron. A total iron standard is in place for the Wellington UPDES discharge permit for all discharge monitoring points at a limit of 1.0 mg/L.
