# WATER QUALITY MEMORANDUM

Utah Coal Regulatory Program

RE: 2011 Second Quarter Water Monitoring, Nevada Electric Investment Corporation, Wellington Preparation Plant, C/007/0012, Task ID #3848

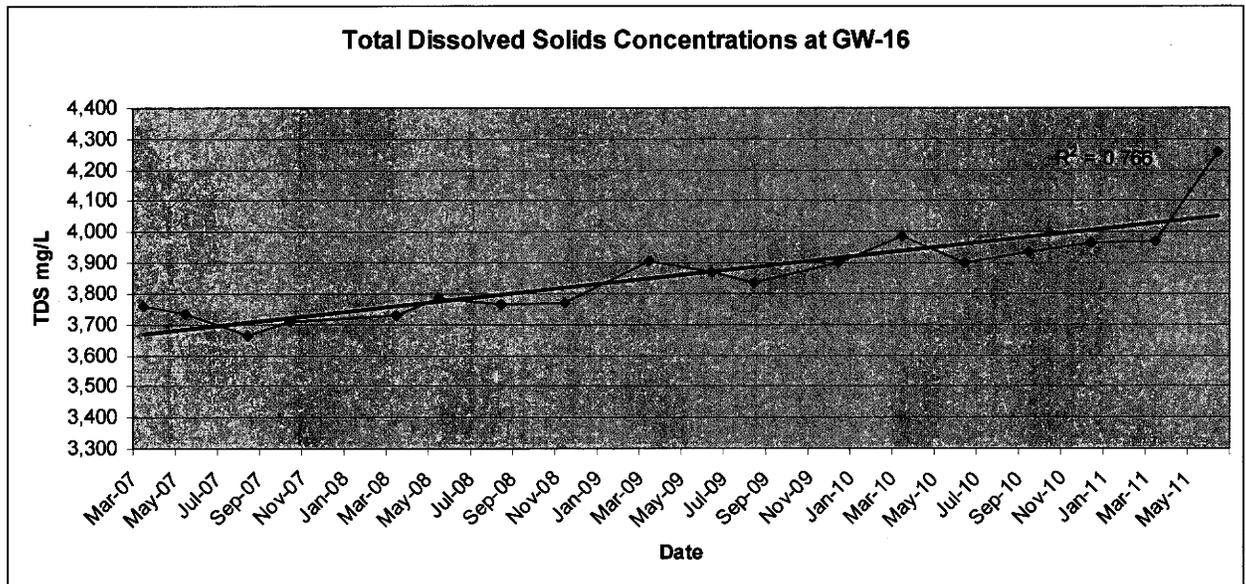
GW-16: represents groundwater at the Clear Water Dike. TDS was reported at a higher than average concentration this quarter of 4,248 mg/L. There is no state standard for TDS in groundwater.
