Inspection Report

Permit Number:	C0070013
Inspection Type:	TECHNICAL
Inspection Date:	Tuesday, May 02, 2006
Start Date/Time:	5/2/2006 9:00:00 AM
End Date/Time:	5/2/2006 4:30:00 PM
Last Inspection:	Thursday, April 20, 2006

Site: **HORSE CANYON MINE**

The Permittee has recently applied for Phase III bond release. In conjunction with the review of that application, a joint inspection by representatives from the BLM, DOGM, and the Permittee was undertaken to evaluate the closure of the Lila Canyon portals and to photograph the archeological sites (to be evaluated by experts in the near future).

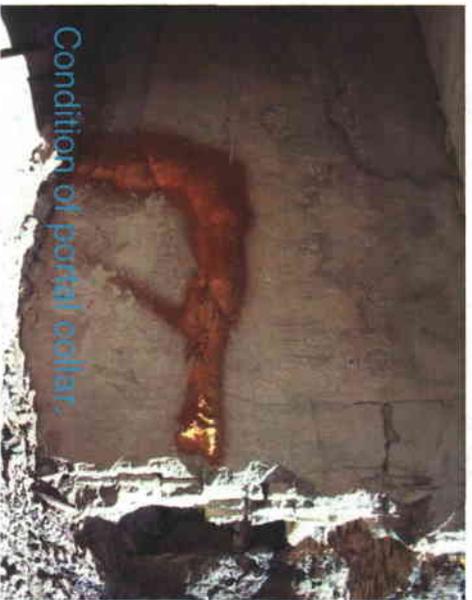
Condition of portal cellar.

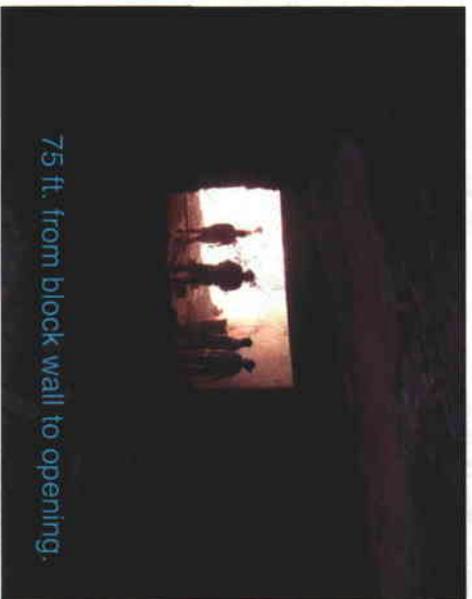
75 ft. from block wall to opening.

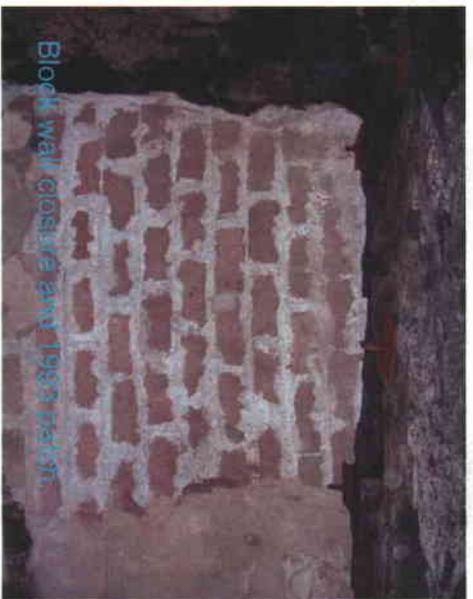
The original cement block seal was overseen by Mel Coonrod of Environmental Industrial Supply (Helper, UT) (personal communication 5/5/06 with Priscilla Burton). According to Mr. Coonrod, mules were used to pack cement block up the stream bed to the base of the steep grade just below the portals. From that point, people carried the blocks up to the portal openings. Mr. Coonrod indicated that a 55-gal drum of water was already inside the portals, so no water was portaged. A visit to the portals by Mr. Coonrod is documented by his initials with the date of 11/12/89 on the cement portal collar wall (photographed). This date is three years later than the date of initial closure described in the MRP.

Block wall closure and 1983 pattern.

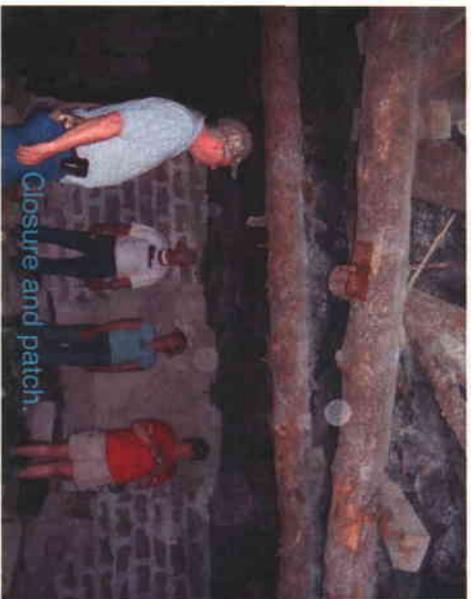
Closure and patch.

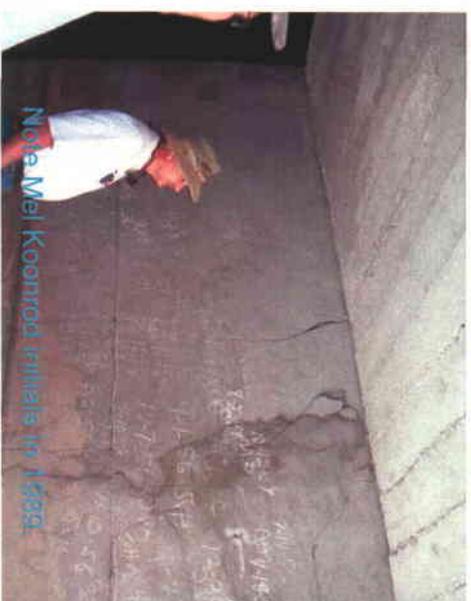
Note Mel Kourrod initials for 1889.

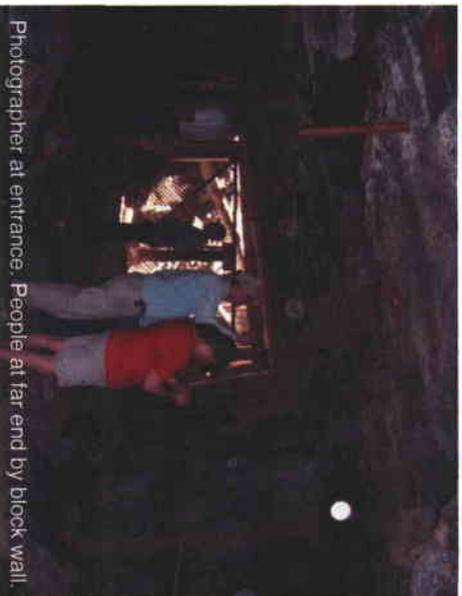
Photographer at entrance. People at far end by block wall.

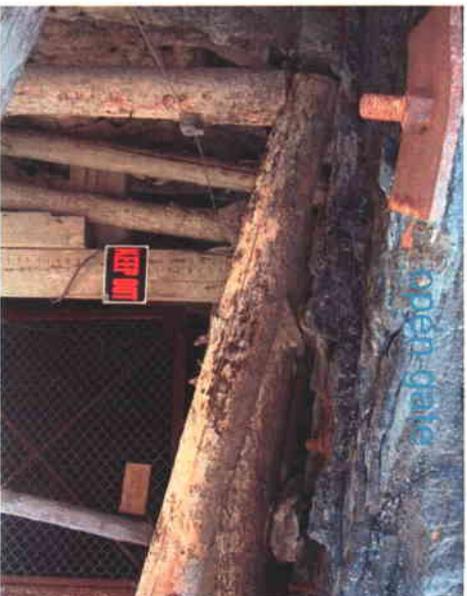
The east fan portal (up canyon) did not have a concrete liner and had caved at its entrance, leaving roof bolts dangling at the entrance. Beyond the rubble of coal, rock and roof timbers, the opening was gated, although the gate was not secured. The air in the portal was tested for black damp and was found to be safe. Beyond the gate, there was a chamber approximately 25 ft X 40ft. In the chamber, the roof was supported by timber which showed no sign of loading. A bat was roosting from the roof timbers inside the gate. There is a 30 ' length of 3 in. diameter copper wire inside the gate. The seals were in good shape and are 40 feet from the unsecured gate.

open gate

No consensus was reached by the field party. The site was well photographed. The possibilities for closure should be discussed with DOGM-AMR.

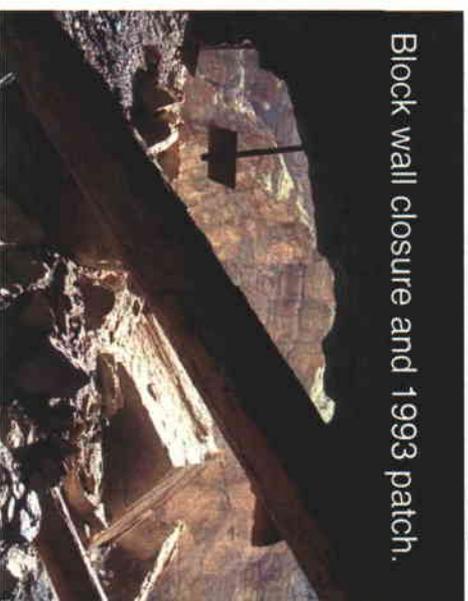
Block wall closure and 1993 patch.
