# Inspection Report

Permit Number:	C0070013
Inspection Type:	COMPLETE
Inspection Date:	Tuesday, December 28, 2010
Start Date/Time:	12/28/2010 10:00:00 AM
End Date/Time:	12/28/2010 1:00:00 PM
Last Inspection:	Tuesday, November 30, 2010

Permitee: **UTAHAMERICAN ENERGY INC**  
 Operator: **UTAHAMERICAN ENERGY INC**  
 Site: **HORSE CANYON MINE**  
 Address: **PO BOX 910, EAST CARBON UT 84520-0910**  
 County: **CARBON**  
 Permit Type: **PERMANENT COAL PROGRAM**  
 Permit Status: **ACTIVE**

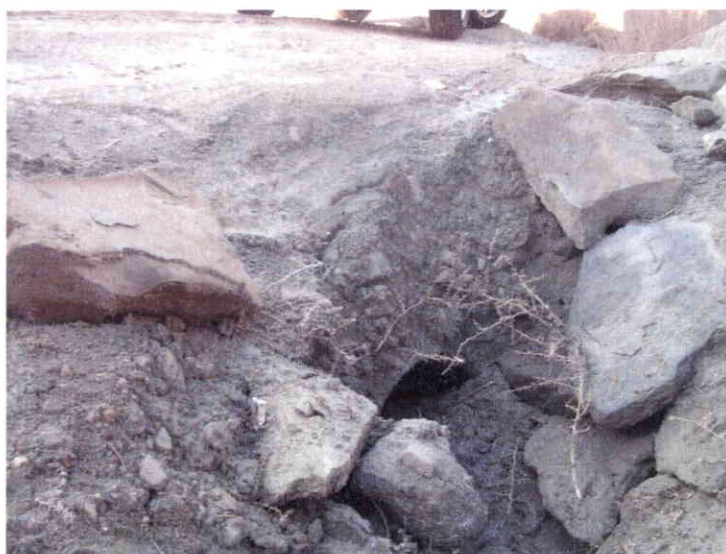
The inlet to culvert in ditch DD-2a was observed to be partially blocked by sediment and rocks. This culvert is not shown on Plate 7-5 (Sediment Control). The operator committed to performing maintenance on this culvert immediately.

Photo 1. Partially blocked inlet to culvert in ditch DD-2a

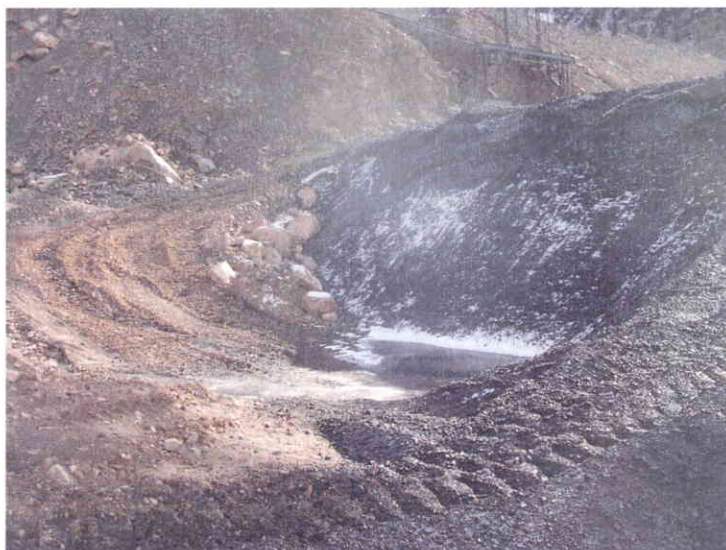
Pooled water and sediment / coal fines were observed in a depression west of the access road to the ROM coal pad. Plate 7-5 (Sediment Control) identified culverts DC-5 and DC-6 as draining this area. The operator needs to locate these culverts and provide maintenance, as necessary, to ensure their proper functioning.

Photo 2. Pondered water and sediment/coal fines at NE corner of ROM coal pad. Neither culverts DC-5 nor DC-6 were visible.

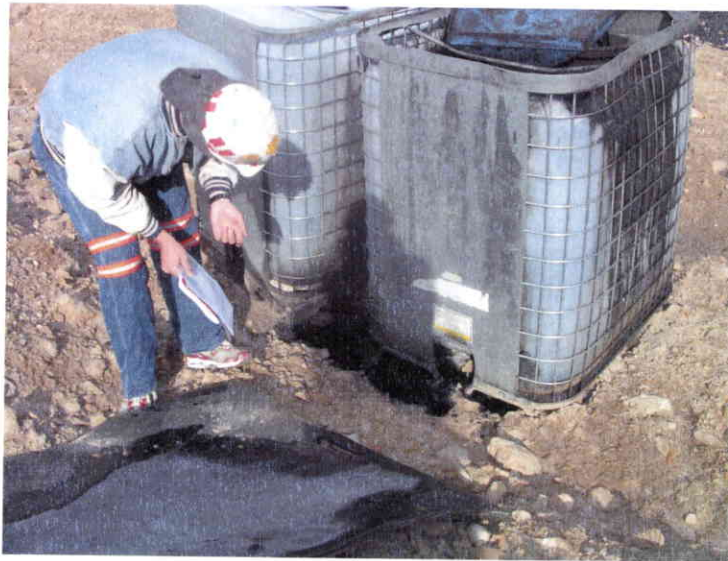
Two empty chemical totes were observed at the south edge of the ROM coal pad. The valve at the bottom of one tote was open and an unknown black liquid had drained from the tote onto the soil. The tote from which the waste had been released was un-labeled except for a hand-written "GEOTEX LA-30". A petroleum hydrocarbon odor was noted at the totes. The operator needs to identify what the spilled black chemical is, and manage appropriately.

Photo 3. Chemical totes and unknown black liquid released to ground surface at south edge of ROM coal pad.

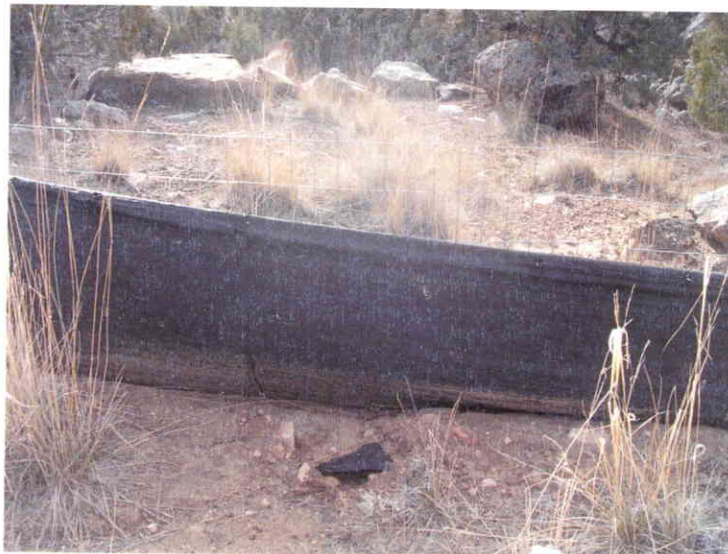
Silt fence installed below the south bank of the ROM coal pad was observed to be in a state of disrepair. Evidence was observed of runoff and associated sediment flowing beneath the silt fence and into undisturbed area. MRP Plate 7-5 (Sediment Control) shows that sediment/runoff from the south bank of the ROM coal pad are controlled by ditch DD-8b; however, no ditch was observed. The operator needs to either repair the silt fence or install/rehabilitate DD-8b to control sediment from the ROM coal pad.

Photo 4. Unmaintained silt fence at location where runoff and sediment have flowed under silt fence and onto undisturbed area.

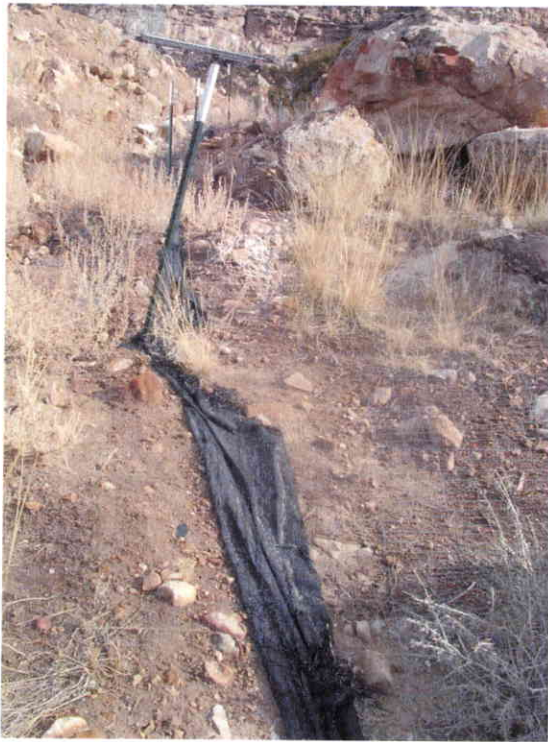
Photo 5. Unmaintained silt fence at toe of south bank of ROM coal pad. Ditch DD-8b is not evident at the toe of the bank. This area is not an ASCA per MRP Plate 7-5, and Ditch DD-8b has a design of 1 ft bottom width, 2:1 side slopes with minimum depth of 0.87 ft (0.37 ft flow depth plus 0.5 ft freeboard) (MRP Appendix 7-4).

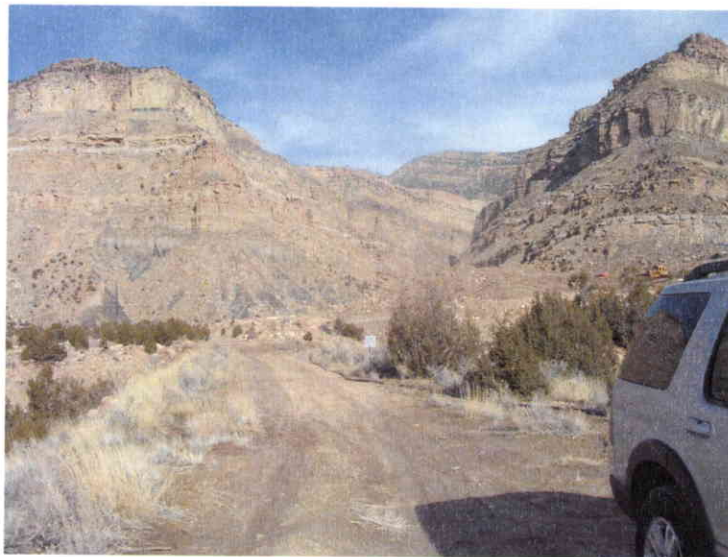
A black plastic pipe has been fused for future use as a water line at the site. The pipe is staged on the ground, beginning near the current equipment yard and ending south of sediment pond 1. The pipe extends off the permit area south of sediment pond 1. The operator needs to cease storage of fused water pipe outside permit area by moving the entire pipe into permit area.

Photo 6. Black plastic fused pipe being staged outside the permit area. Permit boundary sign is visible to the right of road next to bushes.

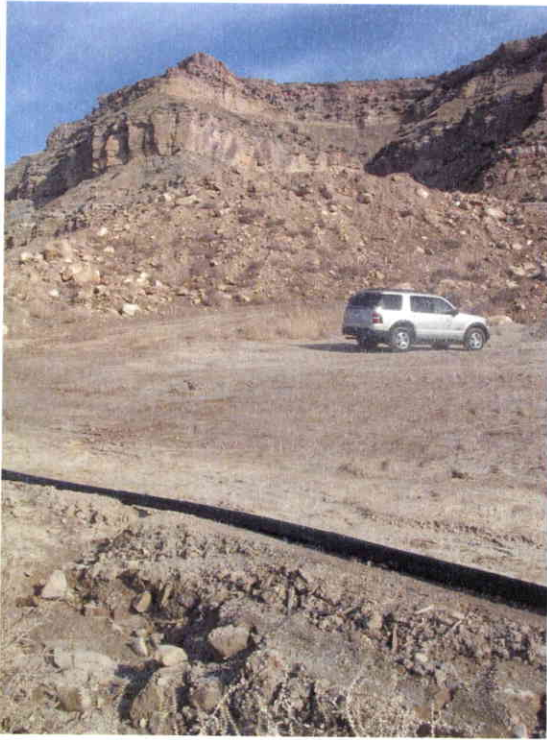
End-dumped soil piles previously south of the topsoil pile have been consolidated onto the topsoil pile. The topsoil pile still requires a berm or silt fence at its southwest corner to control erosion from the pile. Evidence was observed of runoff from the topsoil pile resulting from recent rainfall. Operator committed to providing Division by December 31, 2010 a schedule for the completion of the berm or silt fence around the topsoil pile.

Photo 7. Southwest corner of topsoil pile. Operator has not constructed a berm/silt fence to prevent erosion of topsoil. Runoff from pile is visible along left side of photo.
