Re: **NOV N97-47-1-1**
Abatement Plans
Gordon Creek No. 2/7/8 Mines
ACT / 007 / 016
Carbon County, Utah

**Proposed Pond Reconstruction Plan
Gordon Creek 2/7/8 Mine
Sediment Pond**

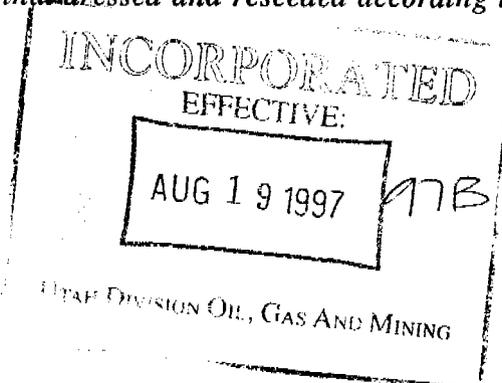
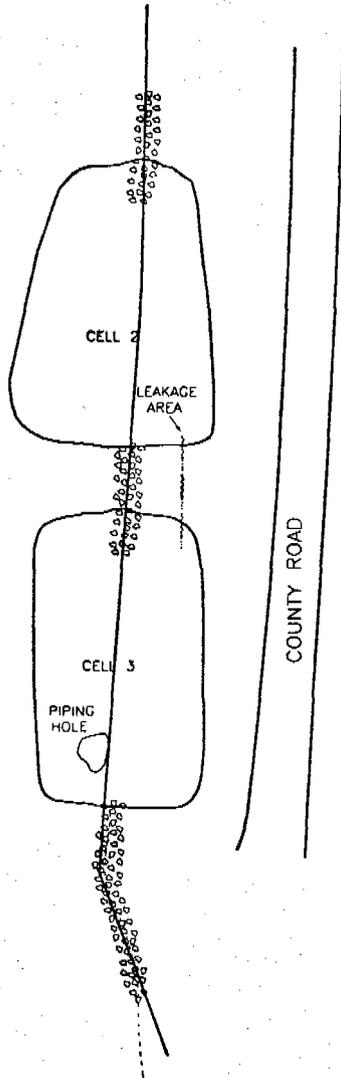
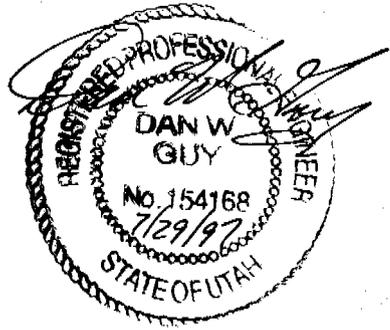
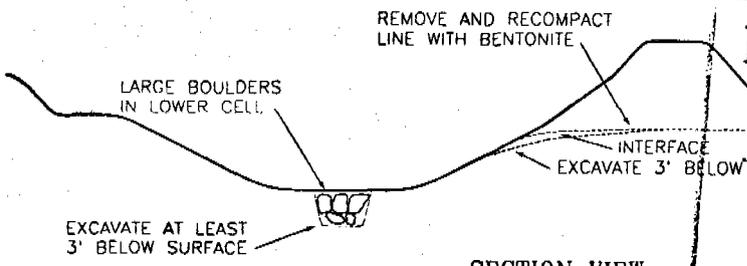
FIGURE 1
PROPOSED POND RECONSTRUCTION

The lower 2 cells of the newly constructed Gordon Creek No. 2/7/8 Sediment Pond have developed a leak which allowed short circuiting of runoff. Runoff was being treated in the first cell of the pond, and samples taken showed the discharge to be within limits of the UPDES Permit.

The area of leakage in the No. 2 cell appears to be along the interface of the excavated pond and the old road fill. The leakage in the 3rd or lower cell appears to be where the excavated pond came into close proximity of the old channel, allowing water to pipe through the large rocks and travel underground for a moderate distance before surfacing.

The attached Figure 1 will show a typical plan and section of the pond and proposed reconstruction. The proposed reconstruction steps are as follows:

- (1) The road side of the pond will be excavated with a trackhoe to a depth at least 3' below the area of leakage;*
- (2) Excessive coal or other non-compactible debris will be removed from the excavated material;*
- (3) The excavated material will then be recompacted in lifts not to exceed 12" up to the elevation of the dam;*
- (4) Bentonite clay will be mixed at a ratio of approximately 50/50 with the top 6" of fill material from the edge of the spillway to the bank along the road;*
- (5) The piping hole in the lower cell will also be excavated to a depth of at least 3' below the surface (or a greater distance as needed to remove the large rocks);*
- (6) The area will then be recompacted with soil material with approximately 50% bentonite;*
- (7) The redisturbed area will be final dressed and reseeded according to the reclamation plan.*
