WATER QUALITY MEMORANDUM

Utah Coal Regulatory Program

RE: 2007 Third Quarter Water Monitoring, Mountain Coal Company, Gordon Creek 2, 7, & 8 Mine, C/007/0016-WQ07-3, Task ID #2733

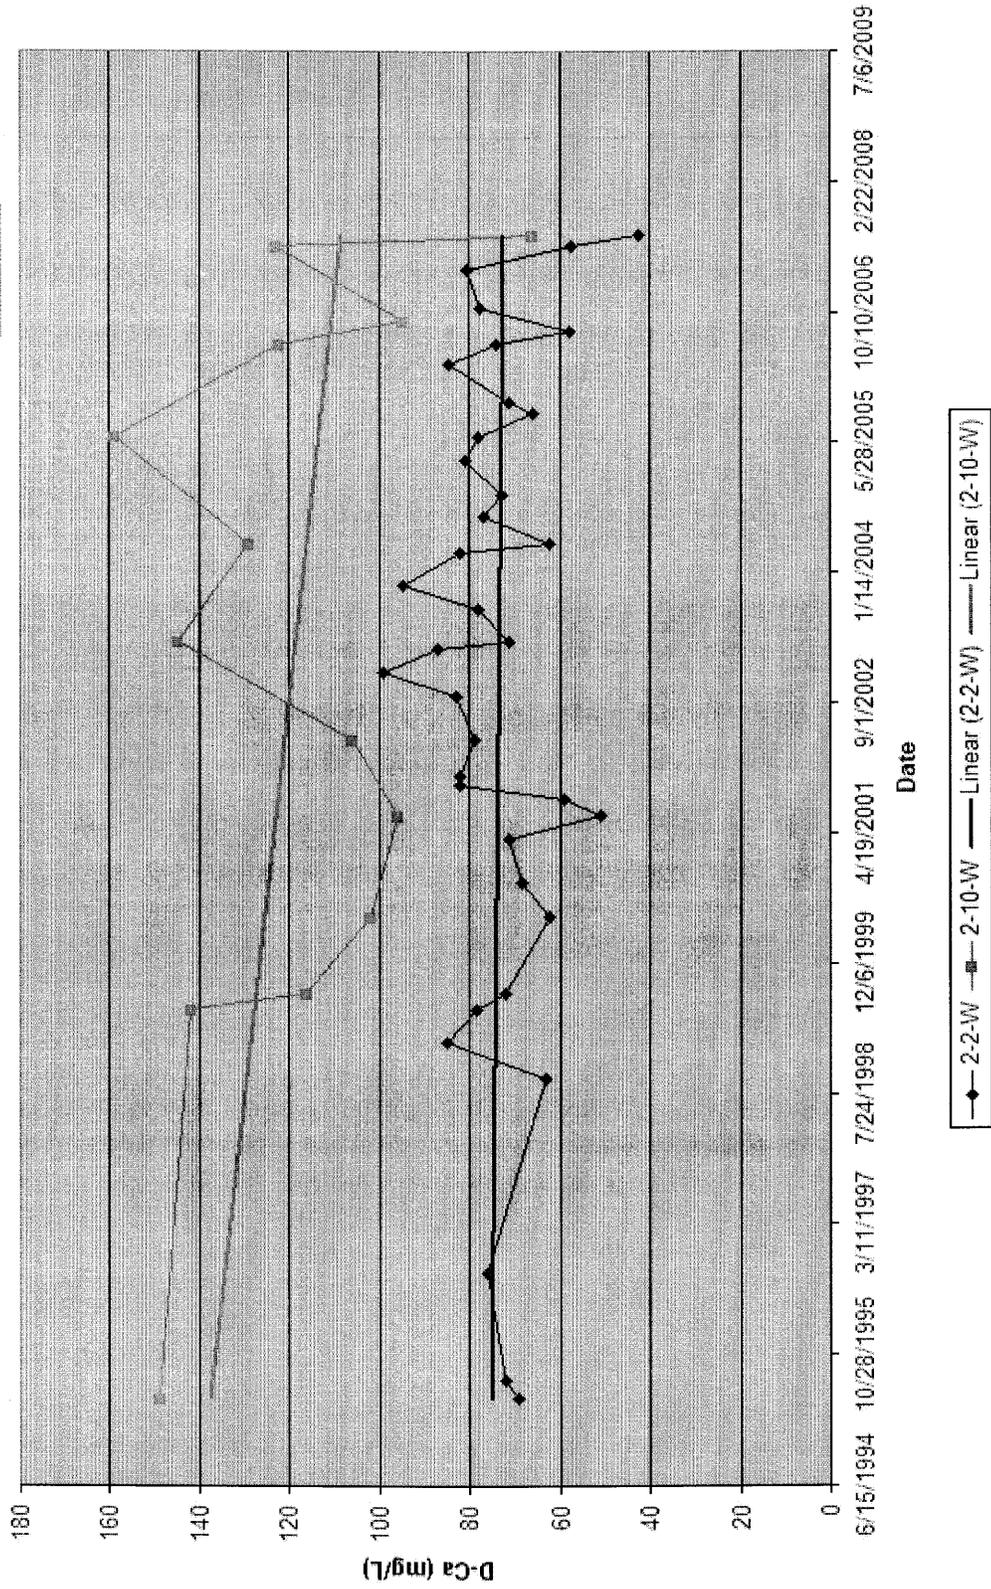
Dissolved Calcium

The dissolved calcium was outside 2 standard deviations lower than the mean at 2-2-W and 2-10-W. There is no trend in dissolved calcium at either site.

$R^2 = 0.0032$

$R^2 = 0.1155$
