Annual Report

Company Name	Canyon Fuel Company, LLC	Mine Name	Gordon Creek 2, 7, & 8 Mines
Permit Number	C/007/0016	Permit expiration Date	August 27, 2019
Operator Name	Canyon Fuel Company, LLC	Phone Number	+1 (970) 261-1425
Mailing Address	225 North 5th Street, Suite 900	Email	chansen@bowieresources.com
City	Grand Junction		
State	Colorado	Zip Code	81501

Subject: Inspection of Gordon Creek Sedimentation Pond

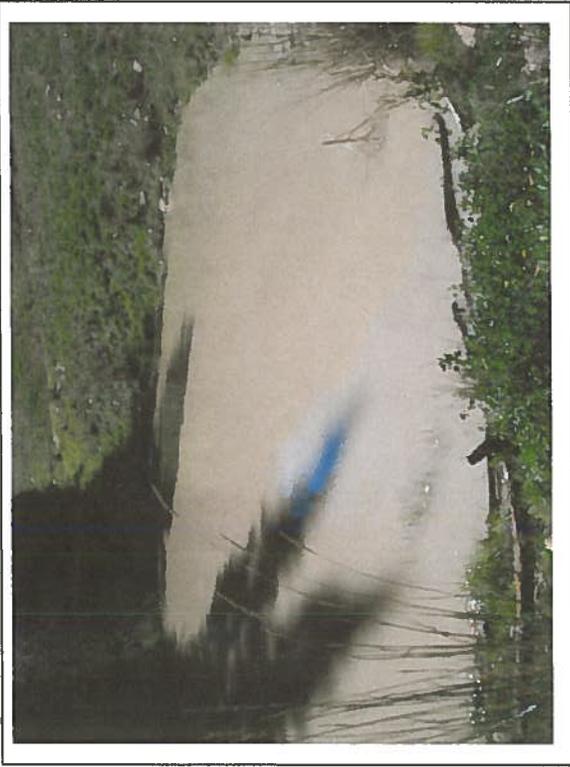
I observed no signs of instability in the embankment or the spillway. It appeared from my observations of the downstream channel that the pond had recently discharged, but the outflow was sufficiently low that the discharge extended only about 100 feet downstream from the spillway.

Photo 1: View of pond area from spillway.

It is my opinion that you may continue to use the pond in its current state.

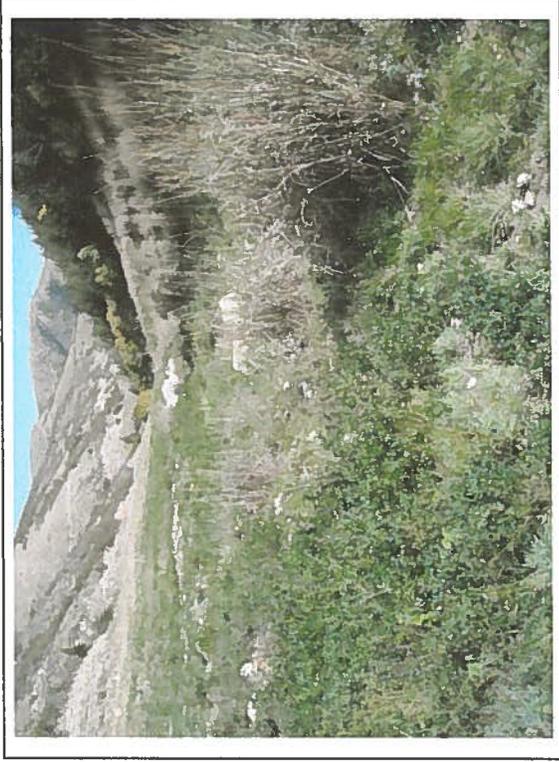
Photo 2: Channel downstream from spillway

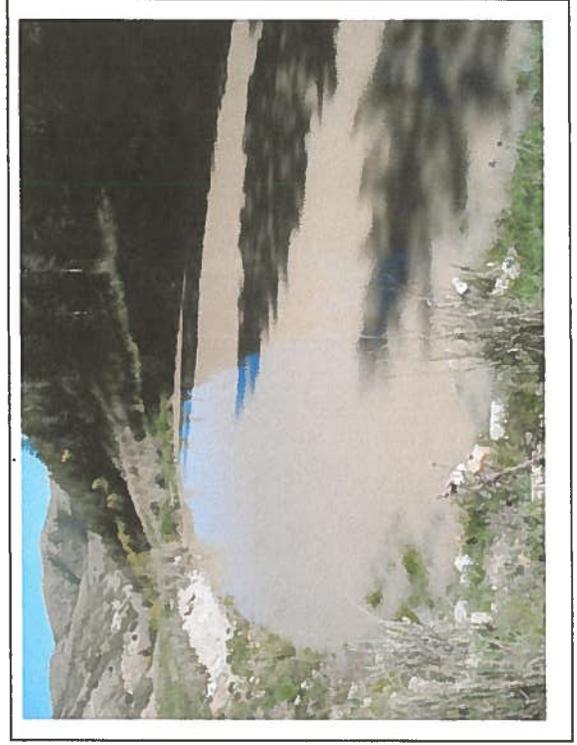
On October 2, 2014 I conducted an inspection of the sedimentation pond at the Gordon Creek No. 2/7/8 Mine. The pond was full of water at the time of my inspection due to recent precipitation in the area. However, no water was flowing into or out of the pond at the time of my inspection.

Photo 3: View of pond from upstream end.
