Gordon Creek 2, 7 & 8 Mines pond inspection 1st and 2nd qtrs

Jacob's Pond

Quarterly Inspection Form

Subject: Inspection of Gordon Creek Sedimentation Pond

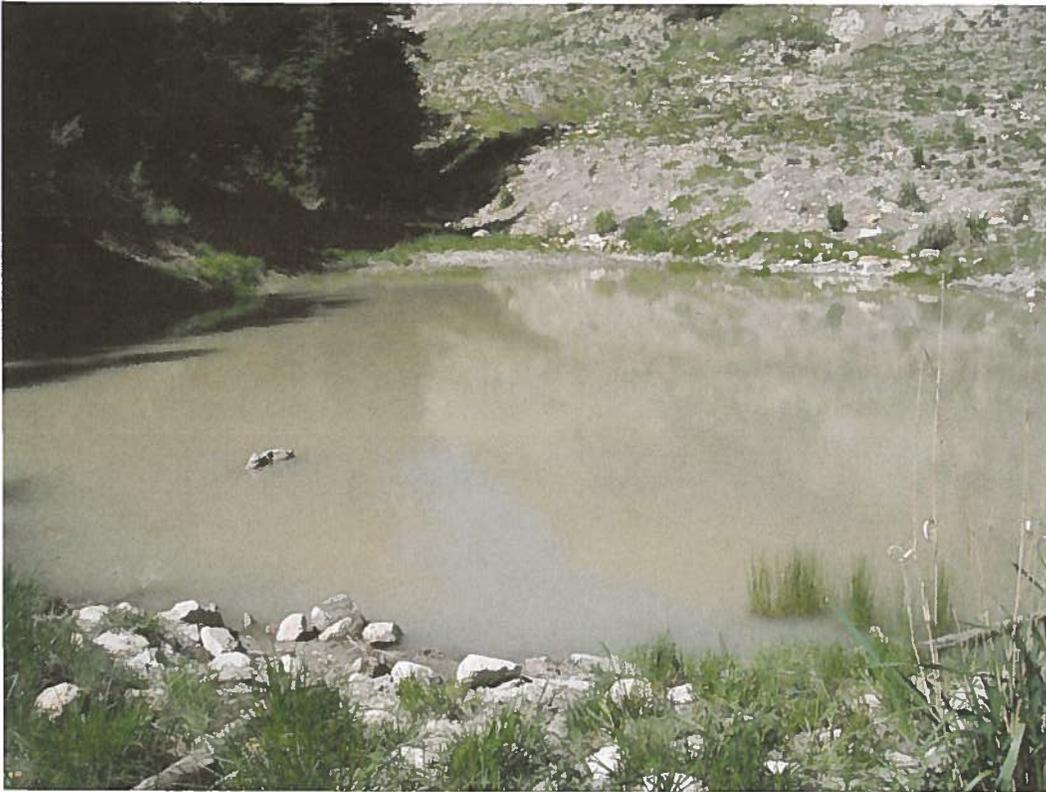
On June 2, 2015 I conducted an inspection of the sedimentation pond at the Gordon Creek No. 2/7/8 Mine. The pond (also known as Jacob's Pond) was impounding water at the time of my inspection but was not discharging. I observed no signs of instability in the embankment or the spillway, nor did I observe any sign of recent outflow from the pond.

Photo 1 - View of pond from downstream embankment

It is my opinion that you may continue to use the pond in its current state.

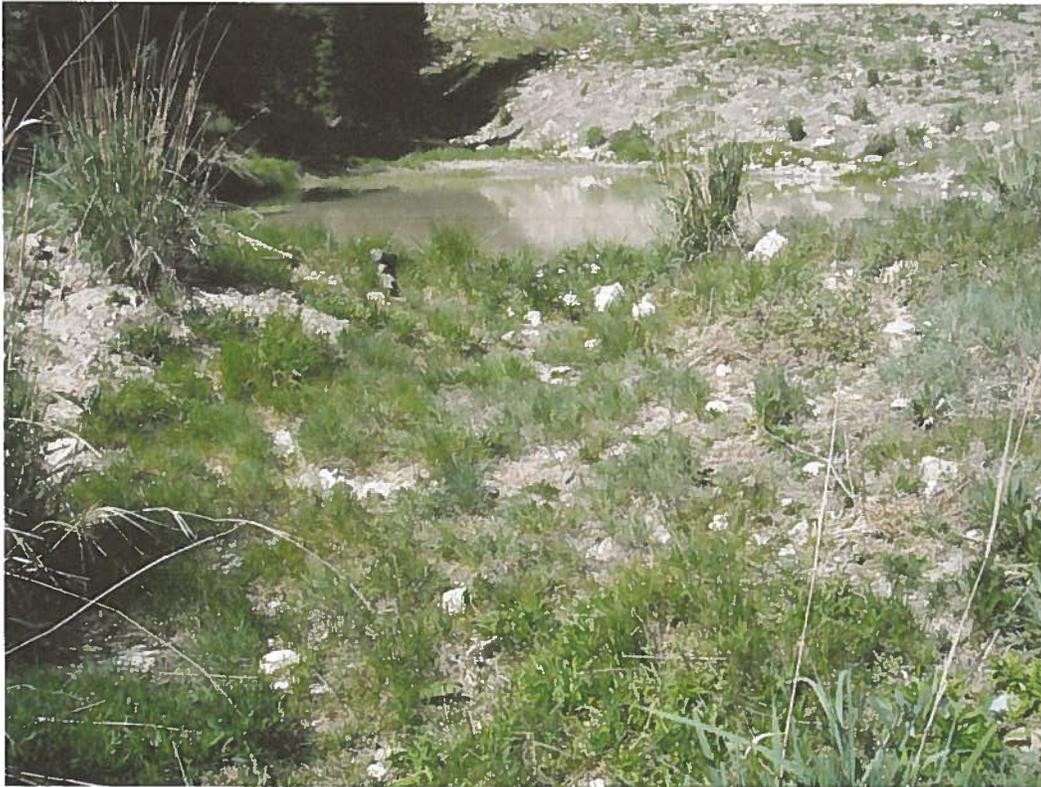
Photo 2 - View of spillway with pond in background
