## Inspection Report

Permit Number:	<b>C0070016</b>
Inspection Type:	IND COMP OVERSITE
Inspection Date:	Wednesday, March 16, 2016
Start Date/Time:	3/16/2016 8:00:00 AM
End Date/Time:	3/16/2016 12:00:00 PM
Last Inspection:	Tuesday, March 01, 2016

Permitee: **CANYON FUEL COMPANY**  
 Operator: **CANYON FUEL COMPANY**  
 Site: **GORDON CREEK 2, 7 & 8 MINES**  
 Address: **HC 35 BOX 380, HELPER UT 84526**  
 County: **CARBON**  
 Permit Type: **PERMANENT COAL PROGRAM**  
 Permit Status: **ACTIVE**

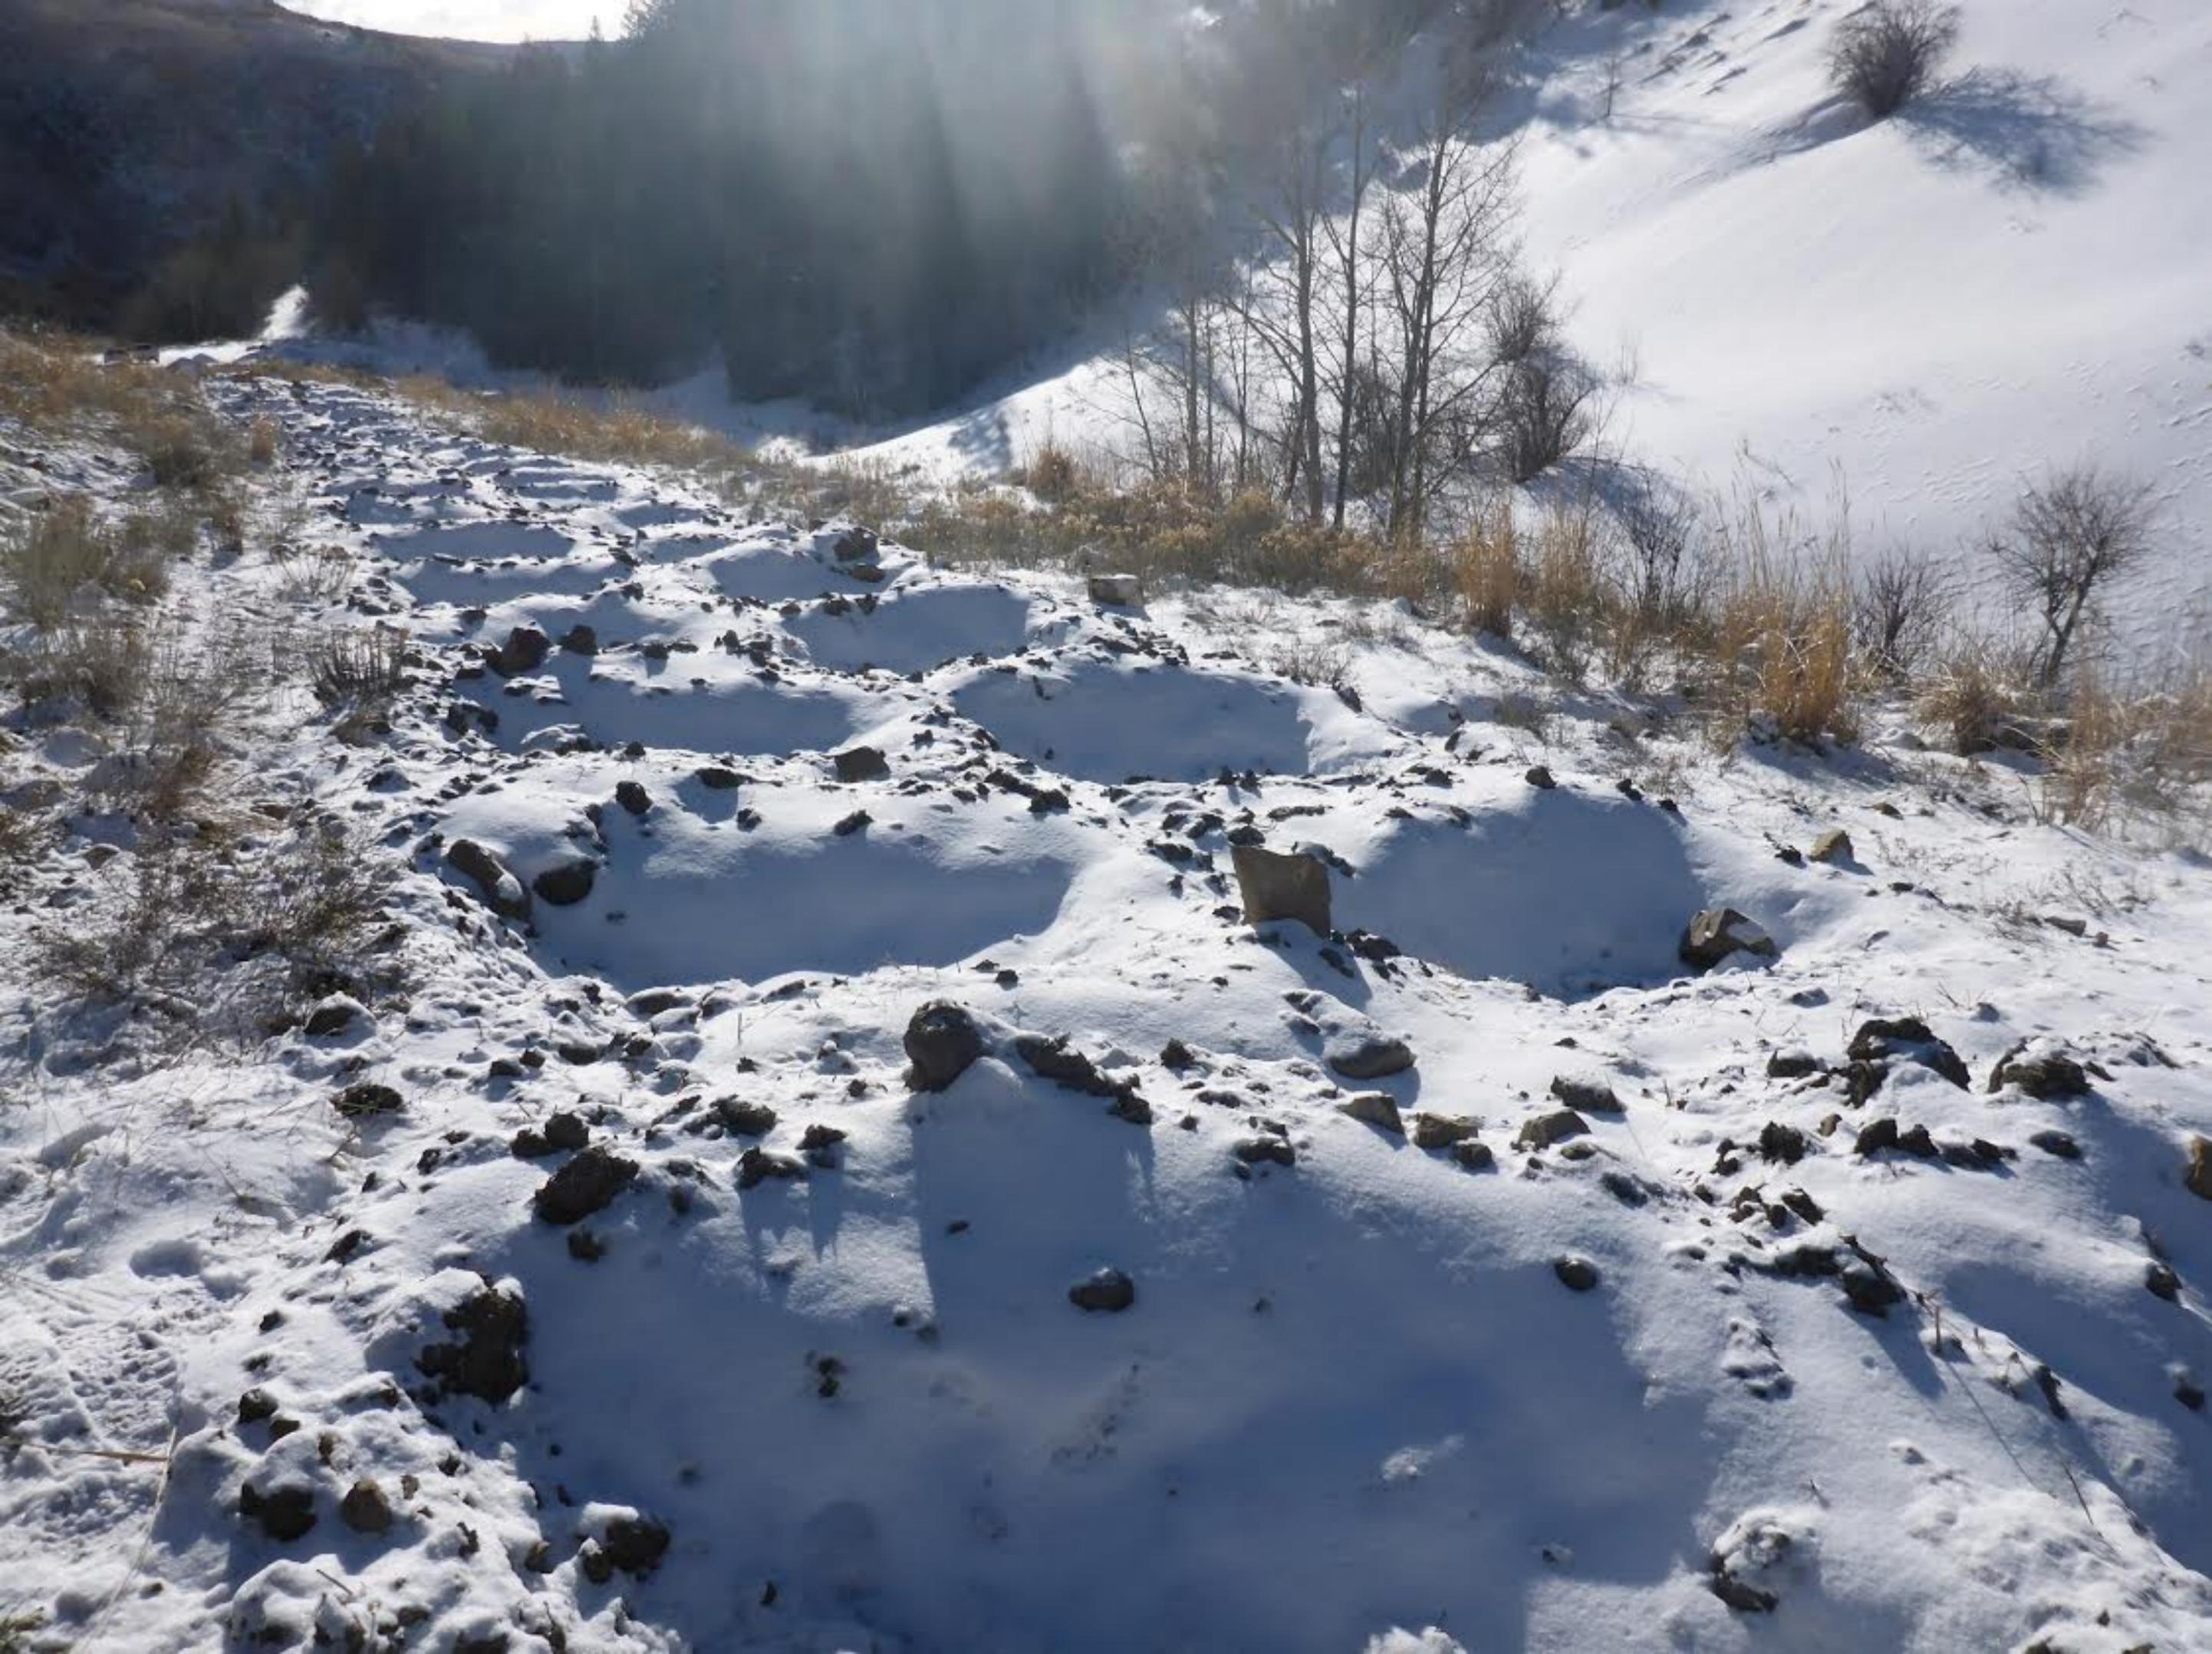
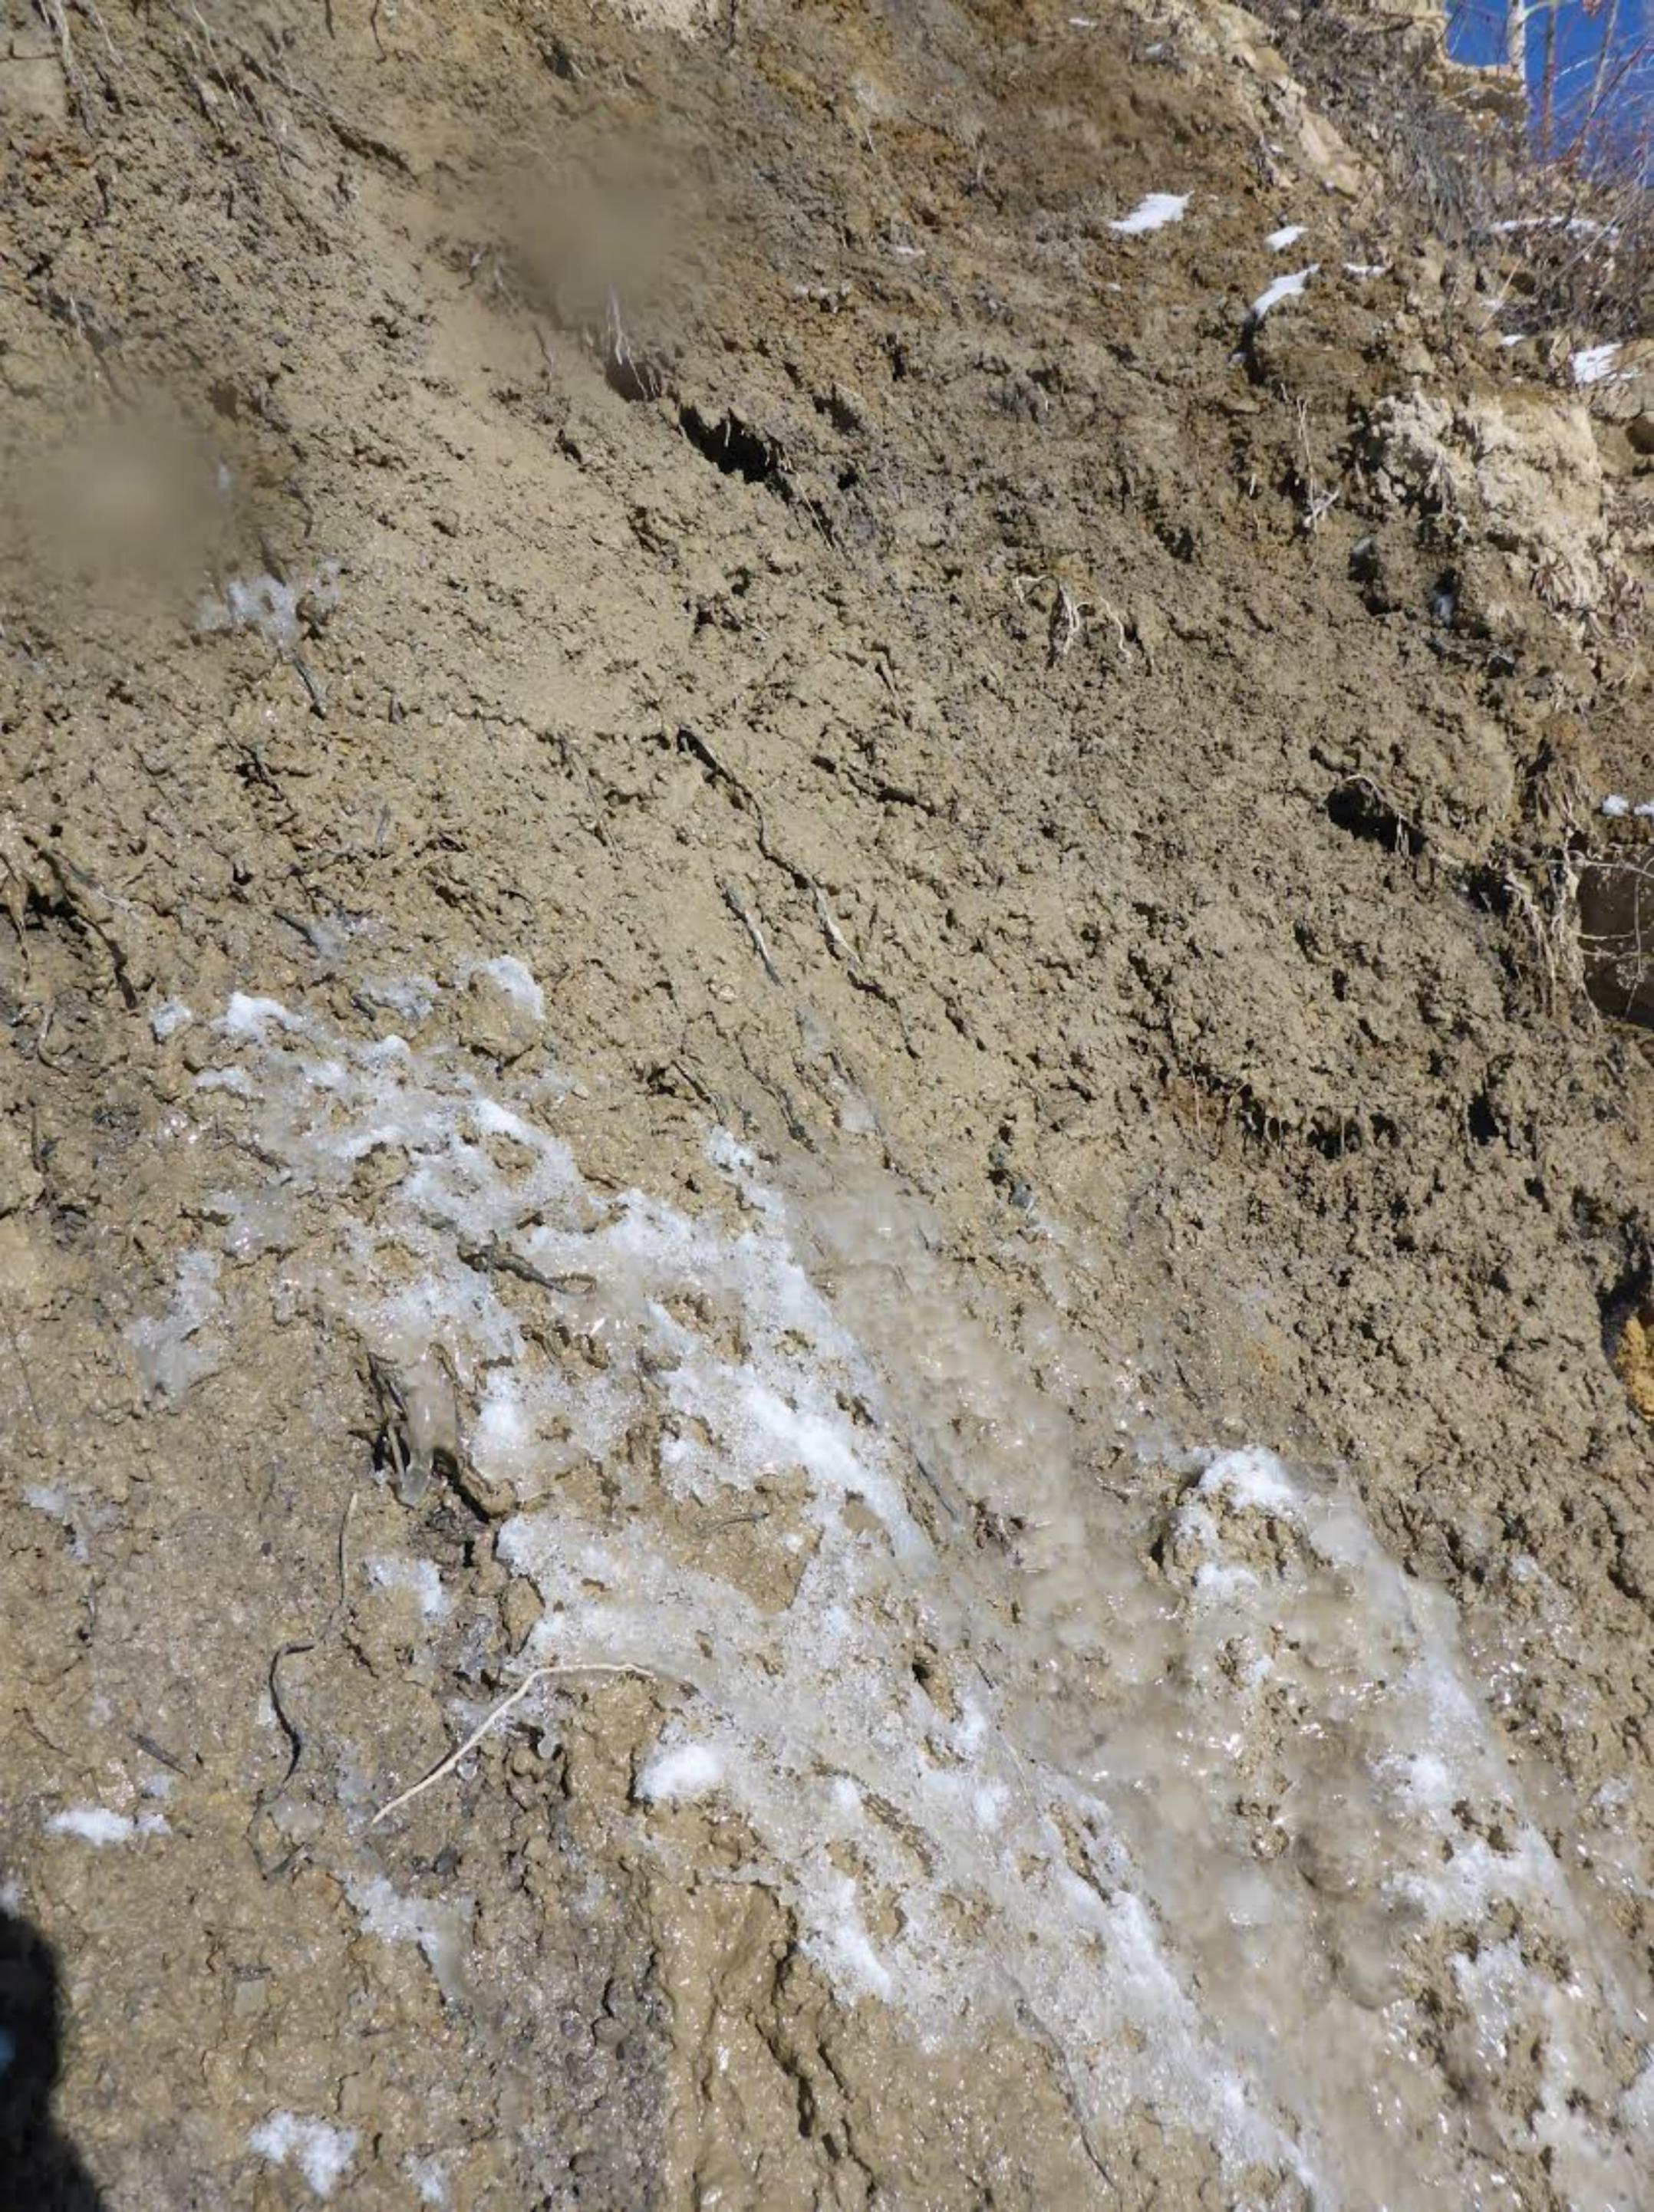
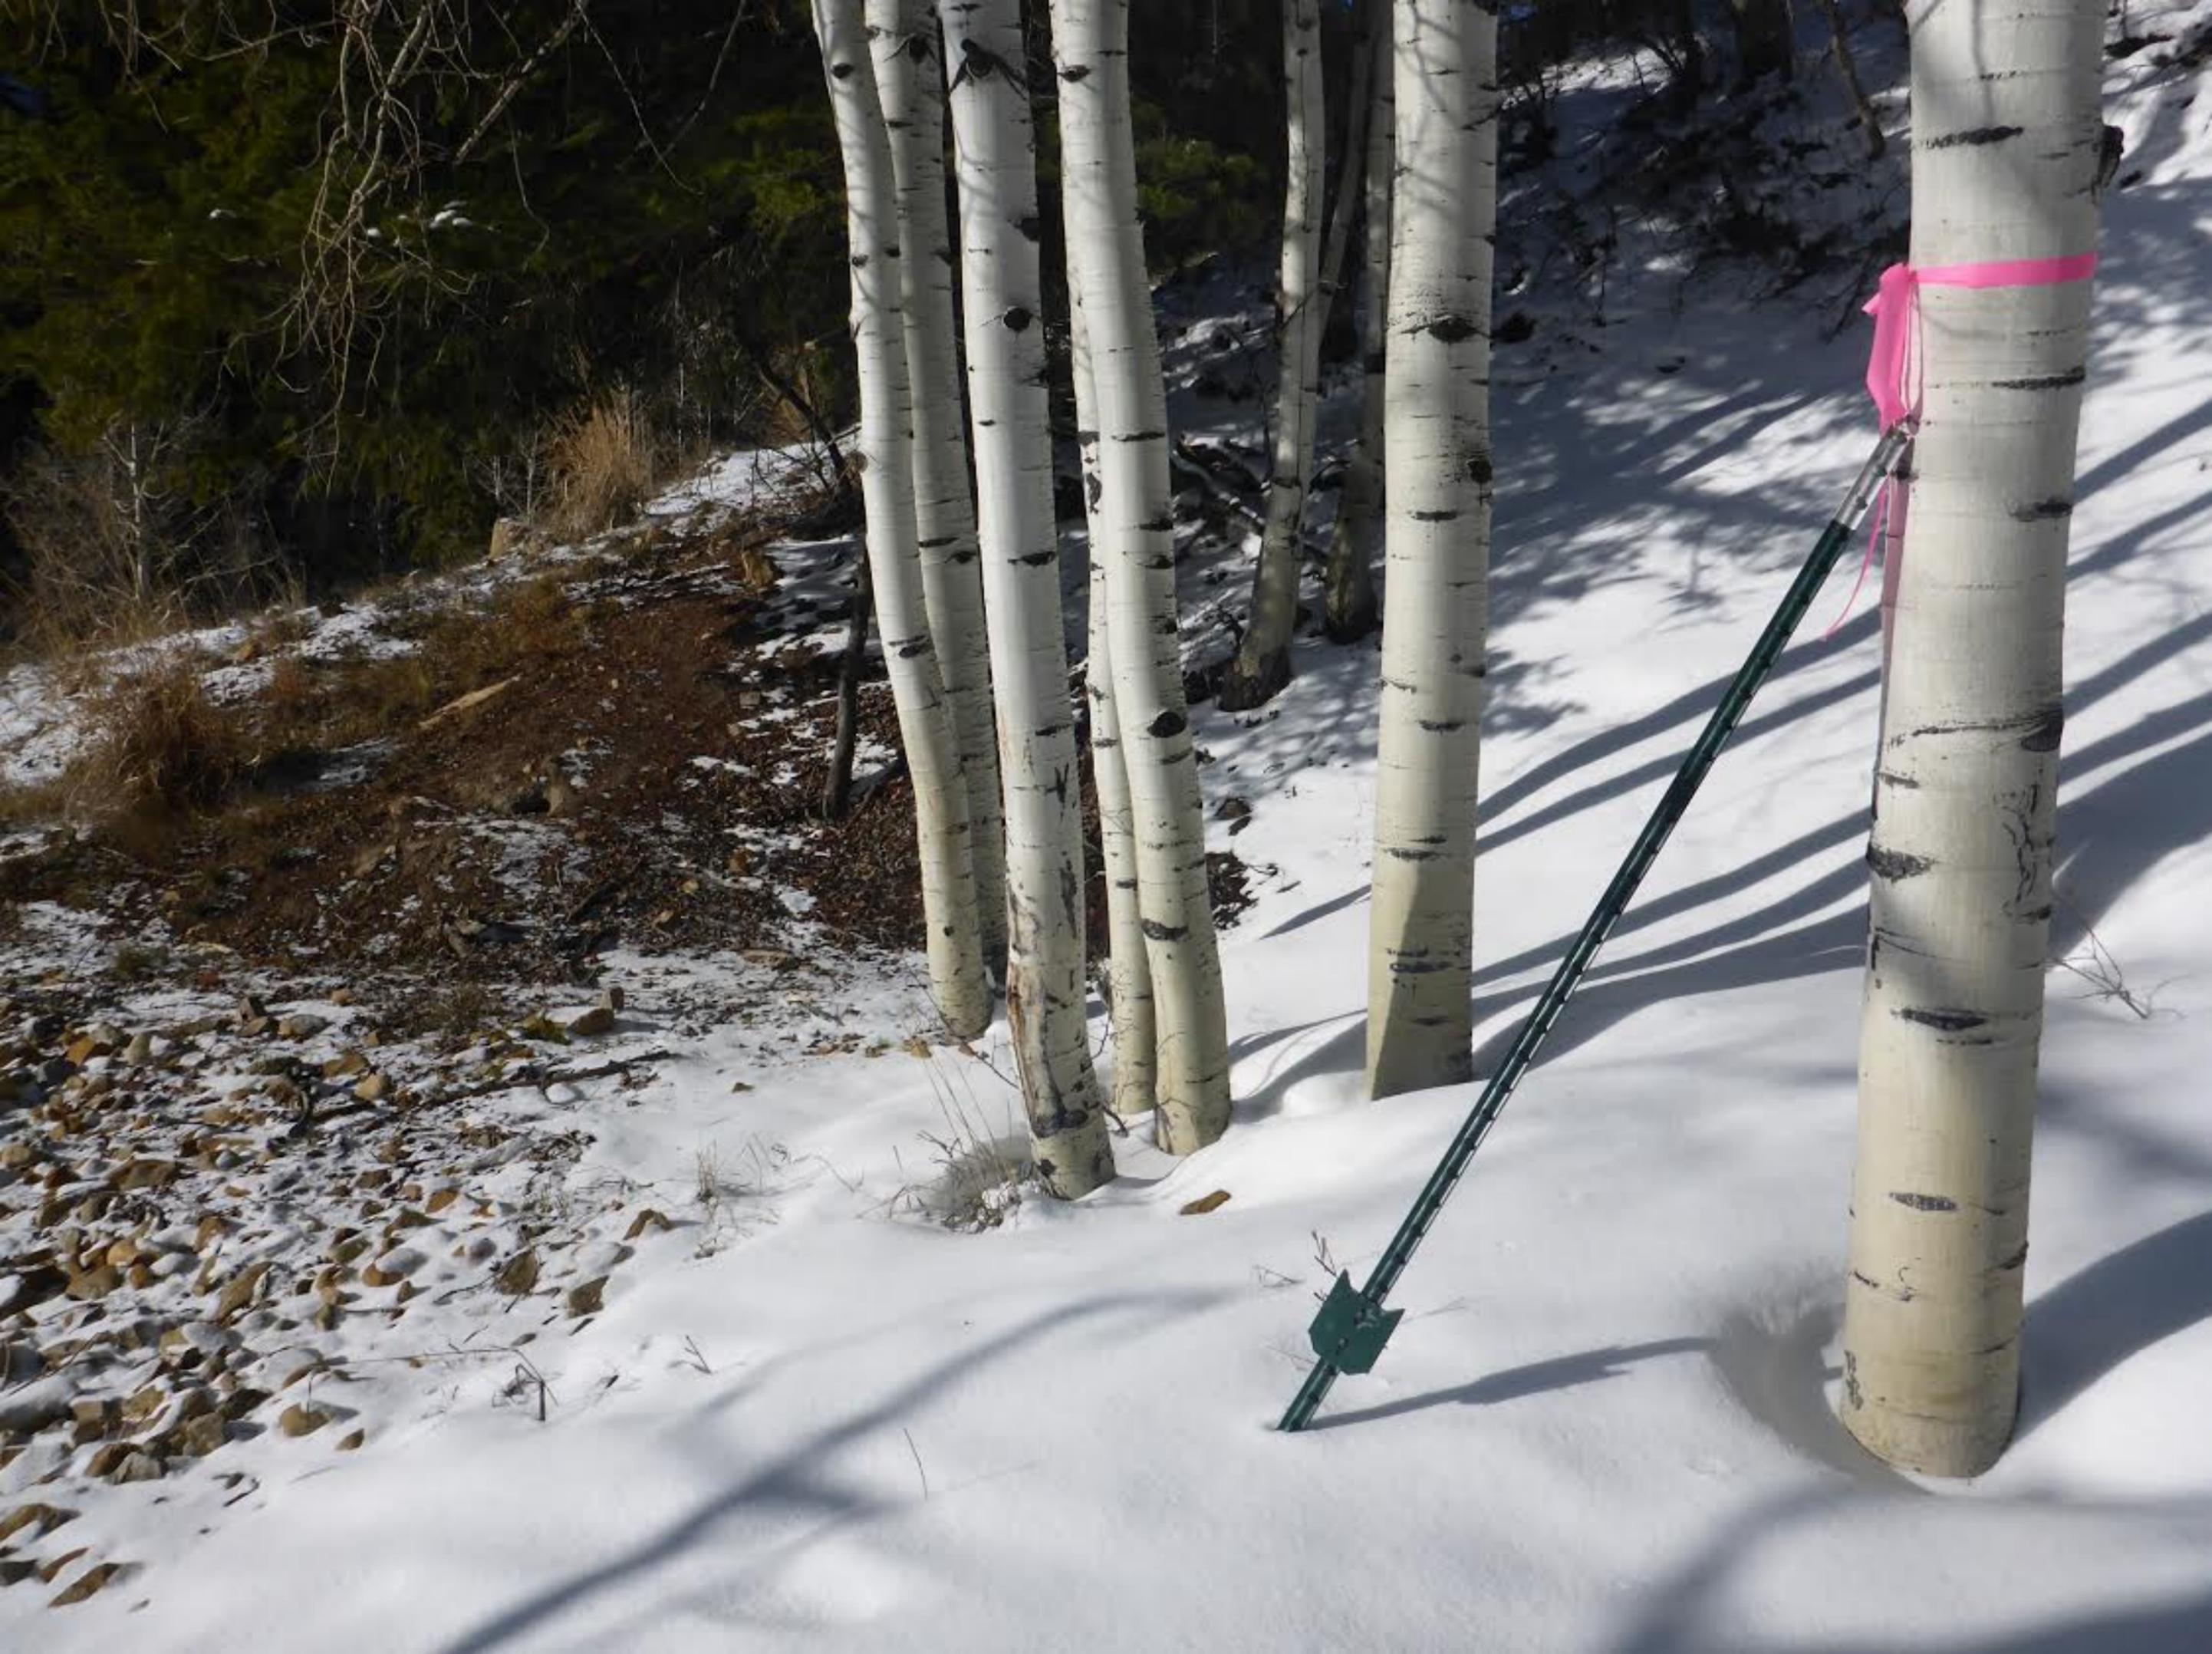
The reclamation site is pocked to prevent sediment from leaving the site. The pocks hold water and help with vegetation growth. See pictures.
