# Inspection Report

Permit Number:	C0070016
Inspection Type:	COMPLETE
Inspection Date:	Wednesday, April 06, 2016
Start Date/Time:	4/6/2016 12:30:00 PM
End Date/Time:	4/6/2016 4:00:00 PM
Last Inspection:	Tuesday, March 01, 2016

Permittee: **CANYON FUEL COMPANY**  
 Operator: **CANYON FUEL COMPANY**  
 Site: **GORDON CREEK 2, 7 & 8 MINES**  
 Address: **HC 35 BOX 380, HELPER UT 84526**  
 County: **CARBON**  
 Permit Type: **PERMANENT COAL PROGRAM**  
 Permit Status: **ACTIVE**

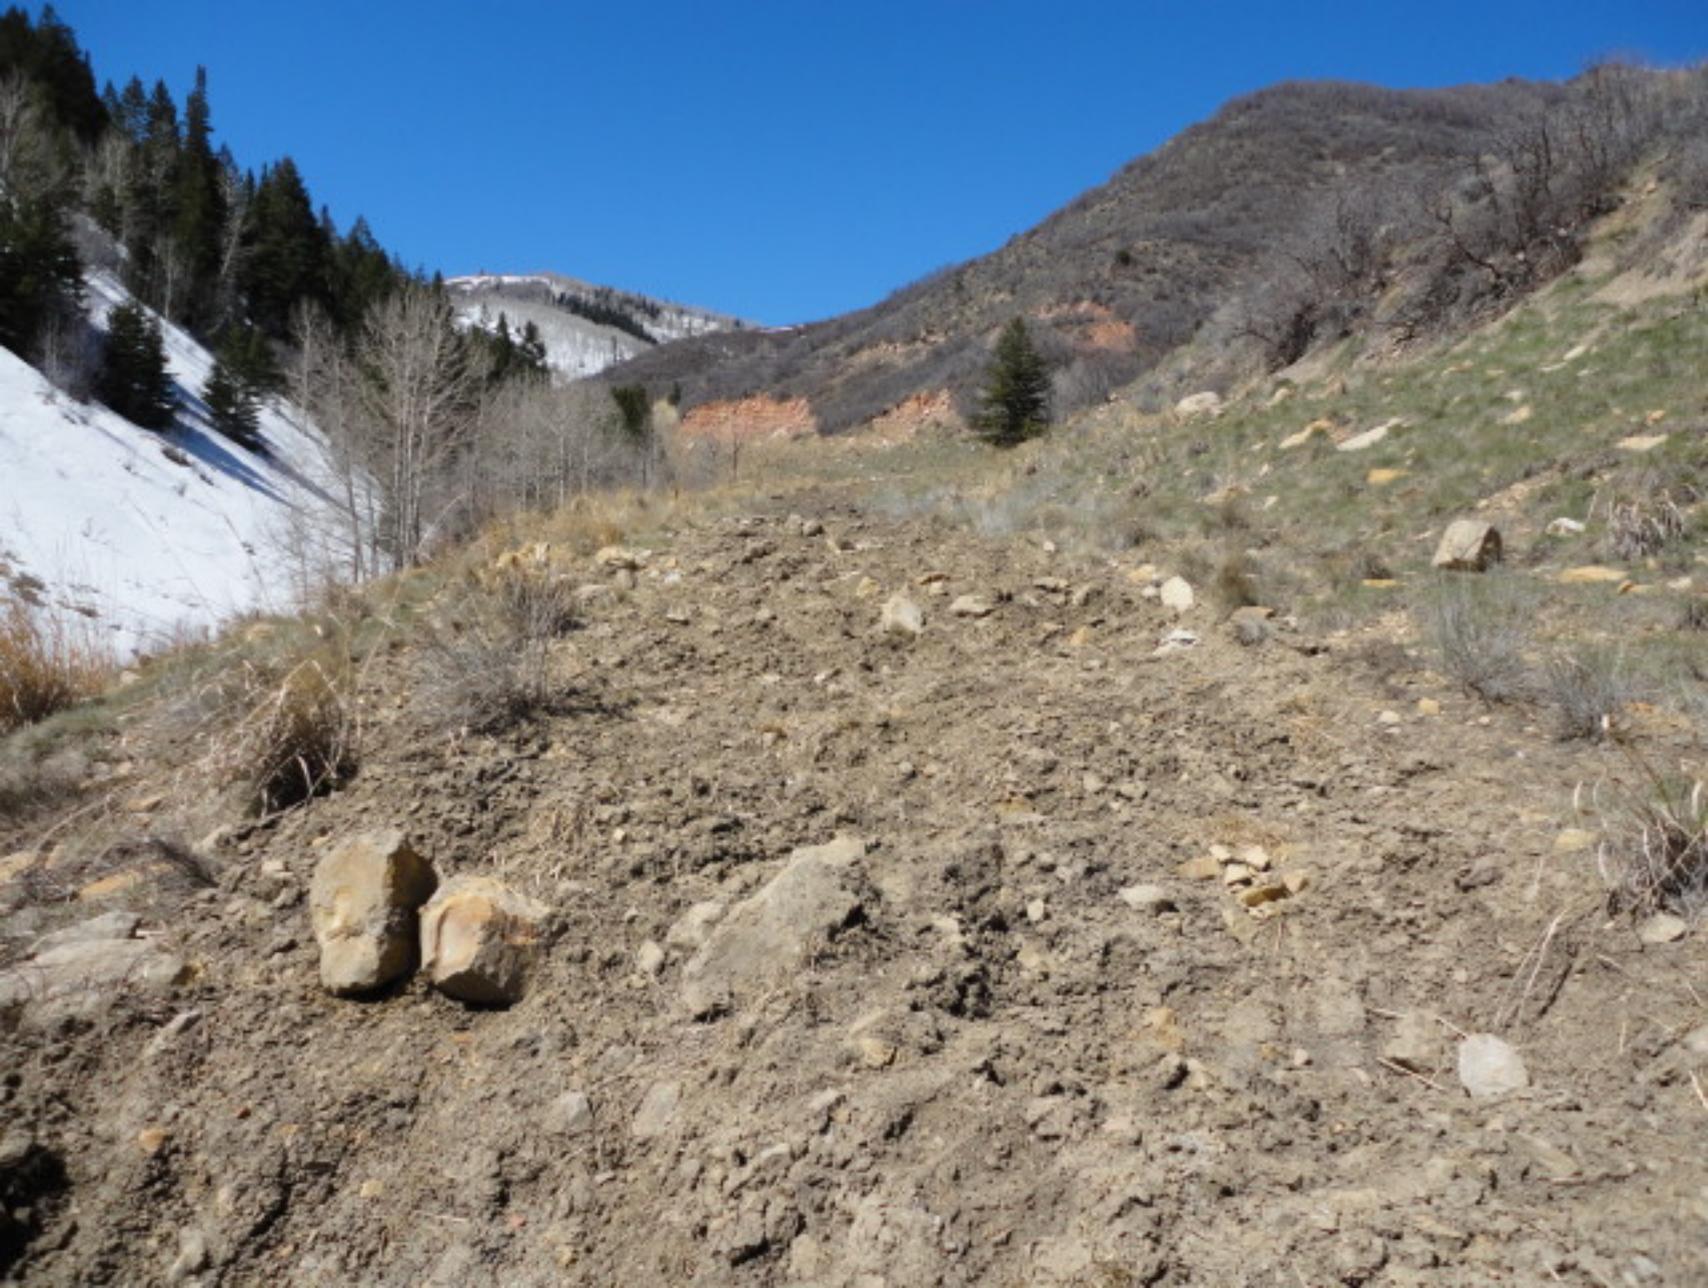
The identification is located at the main gate. All information was correct and complies with the R645 Coal Rules. A couple of letters had fallen off from the sign. The permittee will add new letters when the weather warms up, so the letters will adhere to the sign. See Picture The permittee will be adding new perimeter markers around the disturbed area once the weather conditions are warmer. See Pictures
