# United States Department of the Interior

RE: Soldier Canyon Mine Resource Recovery and Protection Plan  
(R2P2) Modification, 3rd West Pillars Section

SOLDIER CREEK COAL COMPANY  
SOLDIER CANYON MINE  
ROCK CANOYN SEAM  
APPROVED MINE MAP

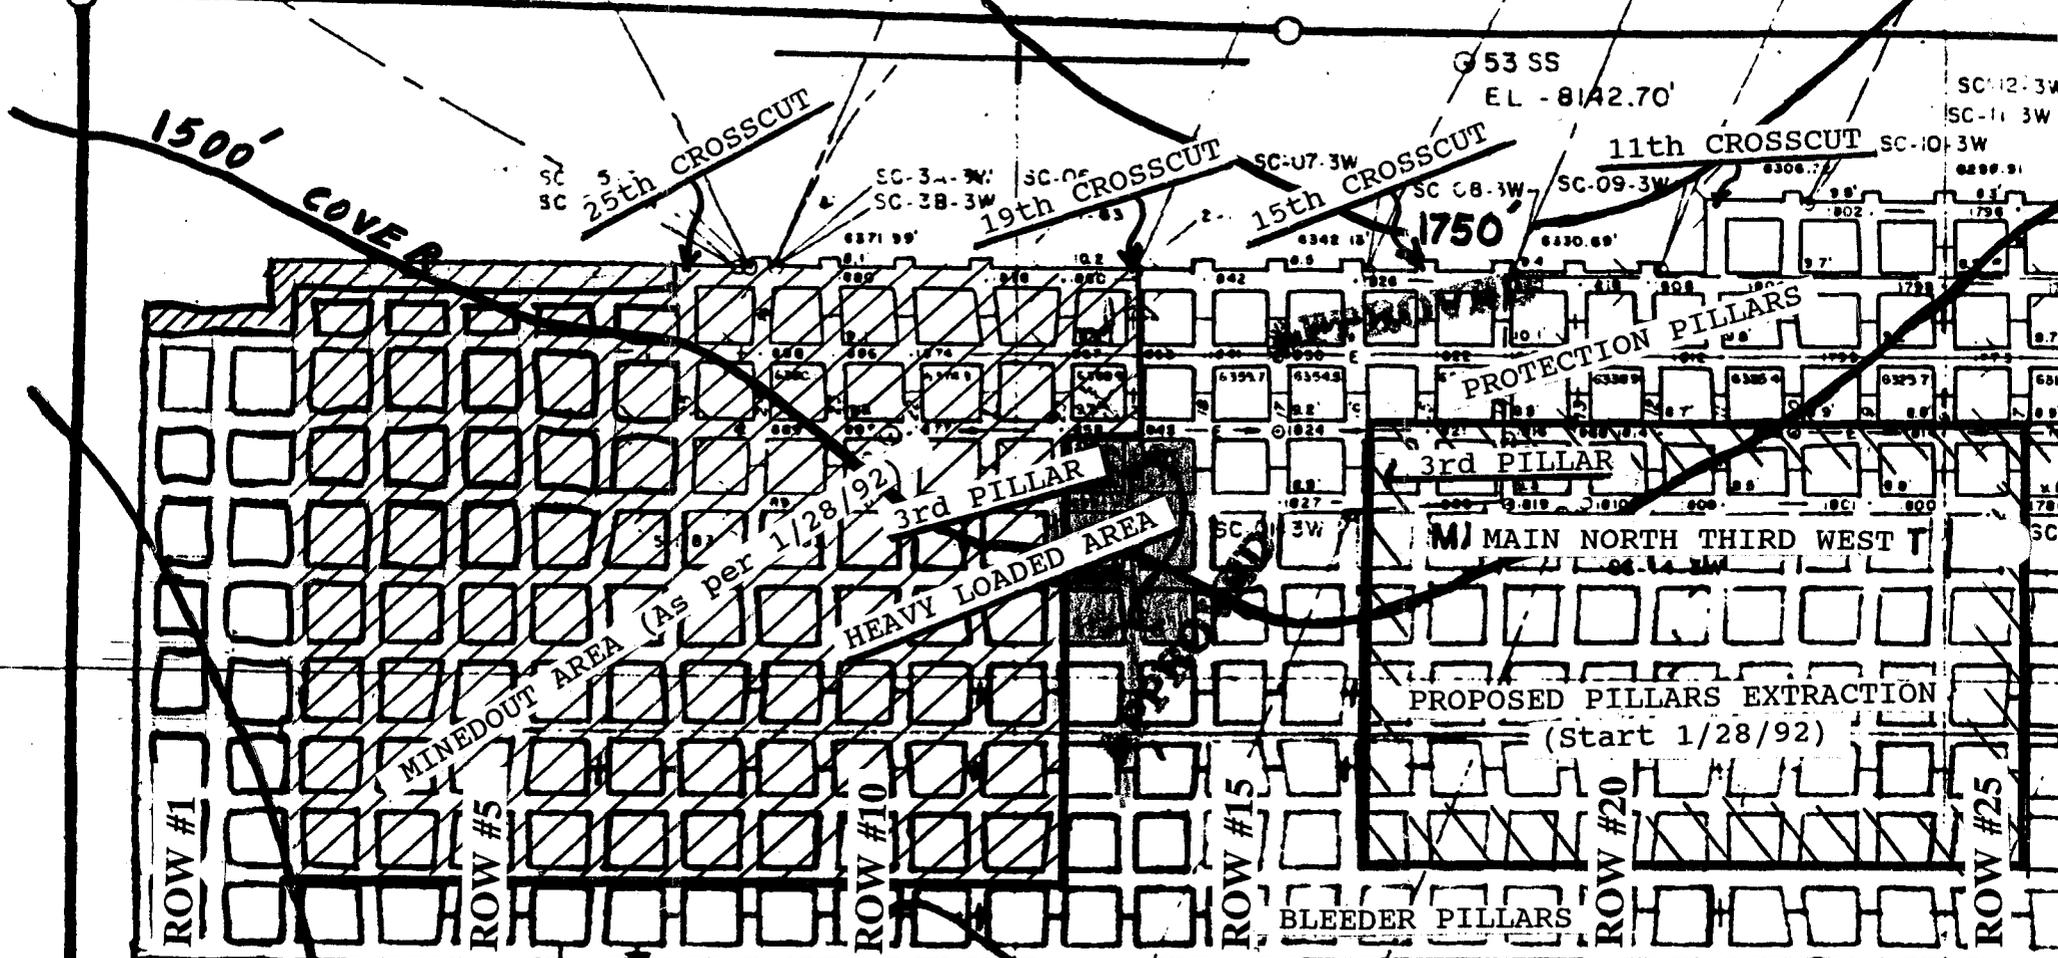
The approved plan for pillar retreat mining in the 3rd West Pillars section was to mine pillar rows from west to east with each row consisting of eight pillars. One pillar in each row was left on the south side for a bleeder. Presently, the continuous miner is mining in the 3rd pillar of pillar row #13 inby the 19th crosscut. Due to severe bouncing activities, the company proposed to abandon this row and the other three pillar rows to the east (rows #14 - #16). Starting with row #17, SCCC plans to pull only six pillars across the panel instead of the eight originally planned. This would leave two pillars on the north side and one pillar on the south side for protection and a bleeder (please see enclosure).

to delete the north pillar at the 11th crosscut and reduce the pillar size at the 25th crosscut. Steve Falk, a BLM mining engineer from the Price Coal Office, inspected the mine on January 28, 1992. During the mine inspection, a major floor heave, roof fractures, severe rib bursts and pillar failure were observed along the 19th crosscut. A sandstone top of 5 to 10 feet of weak laminated roof was also observed behind the mined-out pillars. A discussion with a SCCC mining engineer indicates that the company is in close communication with a rock mechanics engineer at U. S. Bureau of Mines (Spokane Office) regarding this matter. Independent calculations conducted by Abe Elias, BLM engineer, indicate that pillar sizes on 80X80-foot centers is marginal for 1500 to 1750 feet of cover, even with fair geologic conditions.

The combination of a shale roof, the sandstone formation above the shale, and marginal pillar sizes have created an unsafe condition. The proposed plan of leaving three complete rows and one partial row (30 pillars) should be an adequate barrier to support the overriding stresses. Leaving two pillars on the north side will move mining activities to a location under lower overburden as additional precaution against further bounces. Under the present circumstances, Price Coal Office personnel agree with this proposal to abandon these pillars to reduce safety risks to the mining crew. Geologic study and adequate pillar design by SCCC is strongly encouraged in the future to ensure maximum economic recovery.

BLM has determined that the mine plan change is in compliance with the Mineral Leasing Act of 1920, as amended, the regulations at 43 CFR 3400, the lease terms and stipulations, and will achieve maximum economic recovery of the Federal coal. Therefore, the BLM will allow the mine plan change. This confirms the verbal approval given to Soldier Creek Mine personnel on January 28, 1992. An estimated 58,000 tons of coal reserves will now be deemed unrecoverable. A copy of the approved mine map is enclosed.
