# United States Department of the Interior

BUREAU OF LAND MANAGEMENT

Re: Minor Modification to Soldier Canyon Mine - Severe Bouncing in the Fifth North Section

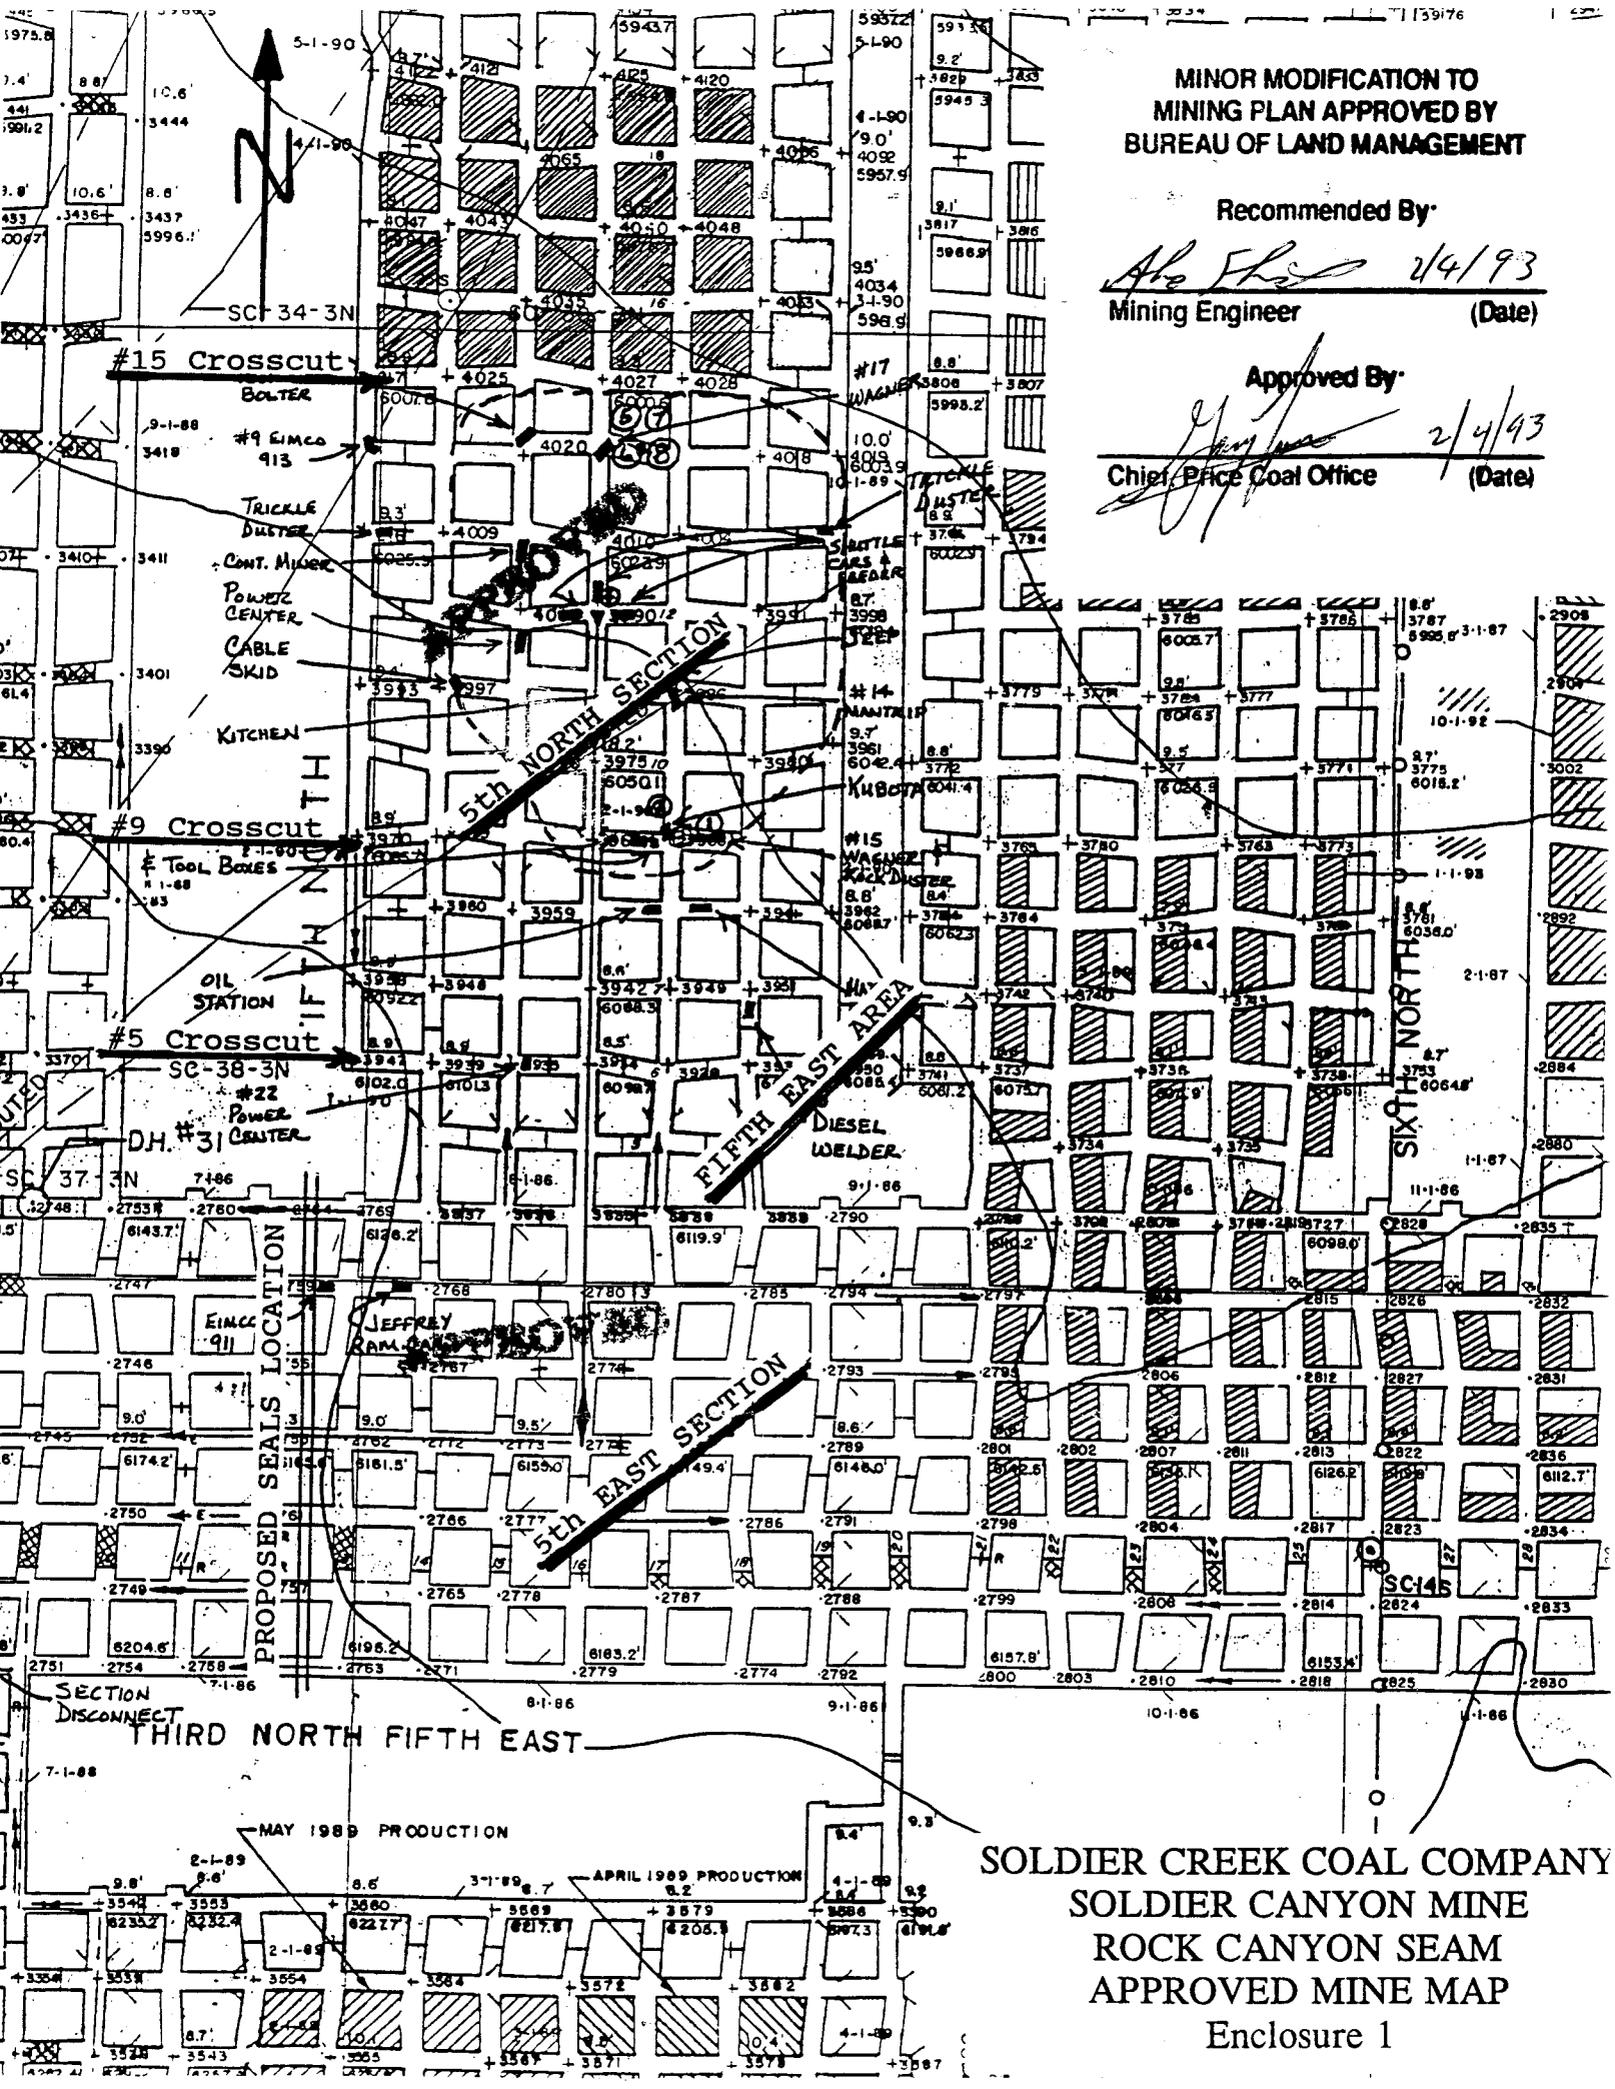
SOLDIER CREEK COAL COMPANY  
SOLDIER CANYON MINE  
ROCK CANYON SEAM  
APPROVED MINE MAP  
Enclosure 1

BLM personnel inspected the Soldier Creek Mine on January 28, 1993. During this inspection it was noted that the 5th North section of the Rock Canyon Seam had been retreat mined to #15 crosscut. The area between the #15 and #9 crosscuts was completely deteriorated and

machinery was turned over. Evidence of pillar bursts were encountered between the #9 and #5 crosscuts. About 2 feet of rib sloughage was also seen at #4 crosscut, this was gradually reduced and changed to floor heave in the 5th East section.

Under these circumstances, the BLM has authorized SCCC to stop retreat mining the 5th North section at the #15 crosscut. This confirms the verbal approval given to Soldier Creek Mine personnel on January 28, 1993. In addition, SCCC may abandon the remaining reserves and seal the 5th East area of the Rock Canyon Seam (enclosure 1) and the 1st South section of the Sunnyside Seam (enclosure 2). An estimated 40,000 tons of coal reserves are now considered unrecoverable.

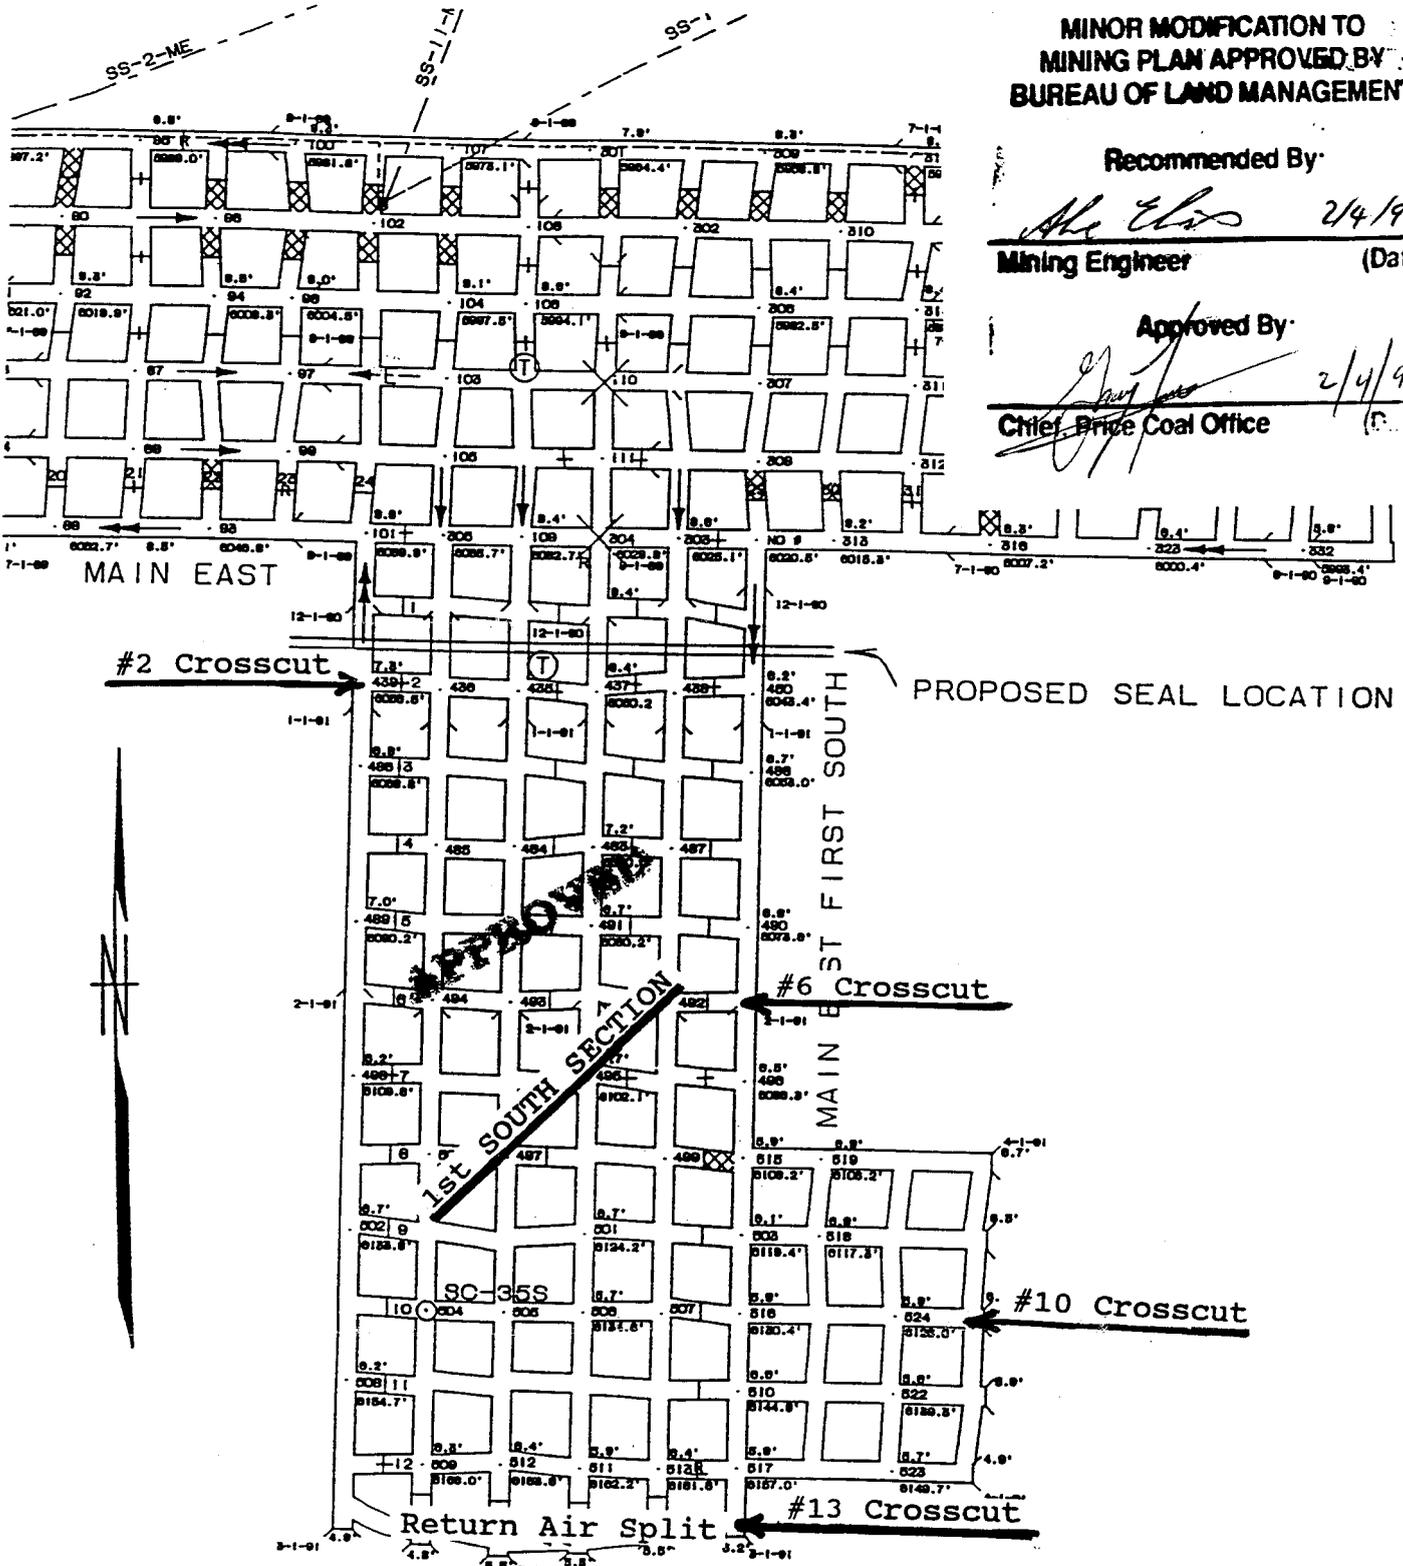
SOLDIER CREEK COAL COMPANY  
SOLDIER CANYON MINE  
SUNNYSIDE SEAM  
APPROVED MINE MAP  
Enclosure 2

The 1st South section of the Sunnyside Seam was also inspected. During the inspection, rib sloughage and floor heave (up to 2 feet) were observed between #13 and #10 crosscuts. The same condition was also noticed between #6 and #2 crosscuts. The remaining four pillar rows between #10 and #6 crosscuts are in good mining condition except about 16 inches of cap siltstone above the coal seam. Company measurements showed that the section's return air split contained 1.7% of methane gas versus the maximum allowable 1% required by MSHA regulations.
