RE: Minor Modification to the Soldier Canyon Mine - Partial Pillars Extraction in the 6th North, the 5th North and the 3rd North 5th East Sections

SOLDIER CREEK COAL COMPANY
SOLDIER CANYON MINE
ROCK CANYON SEAM
APPROVED MINE MAP

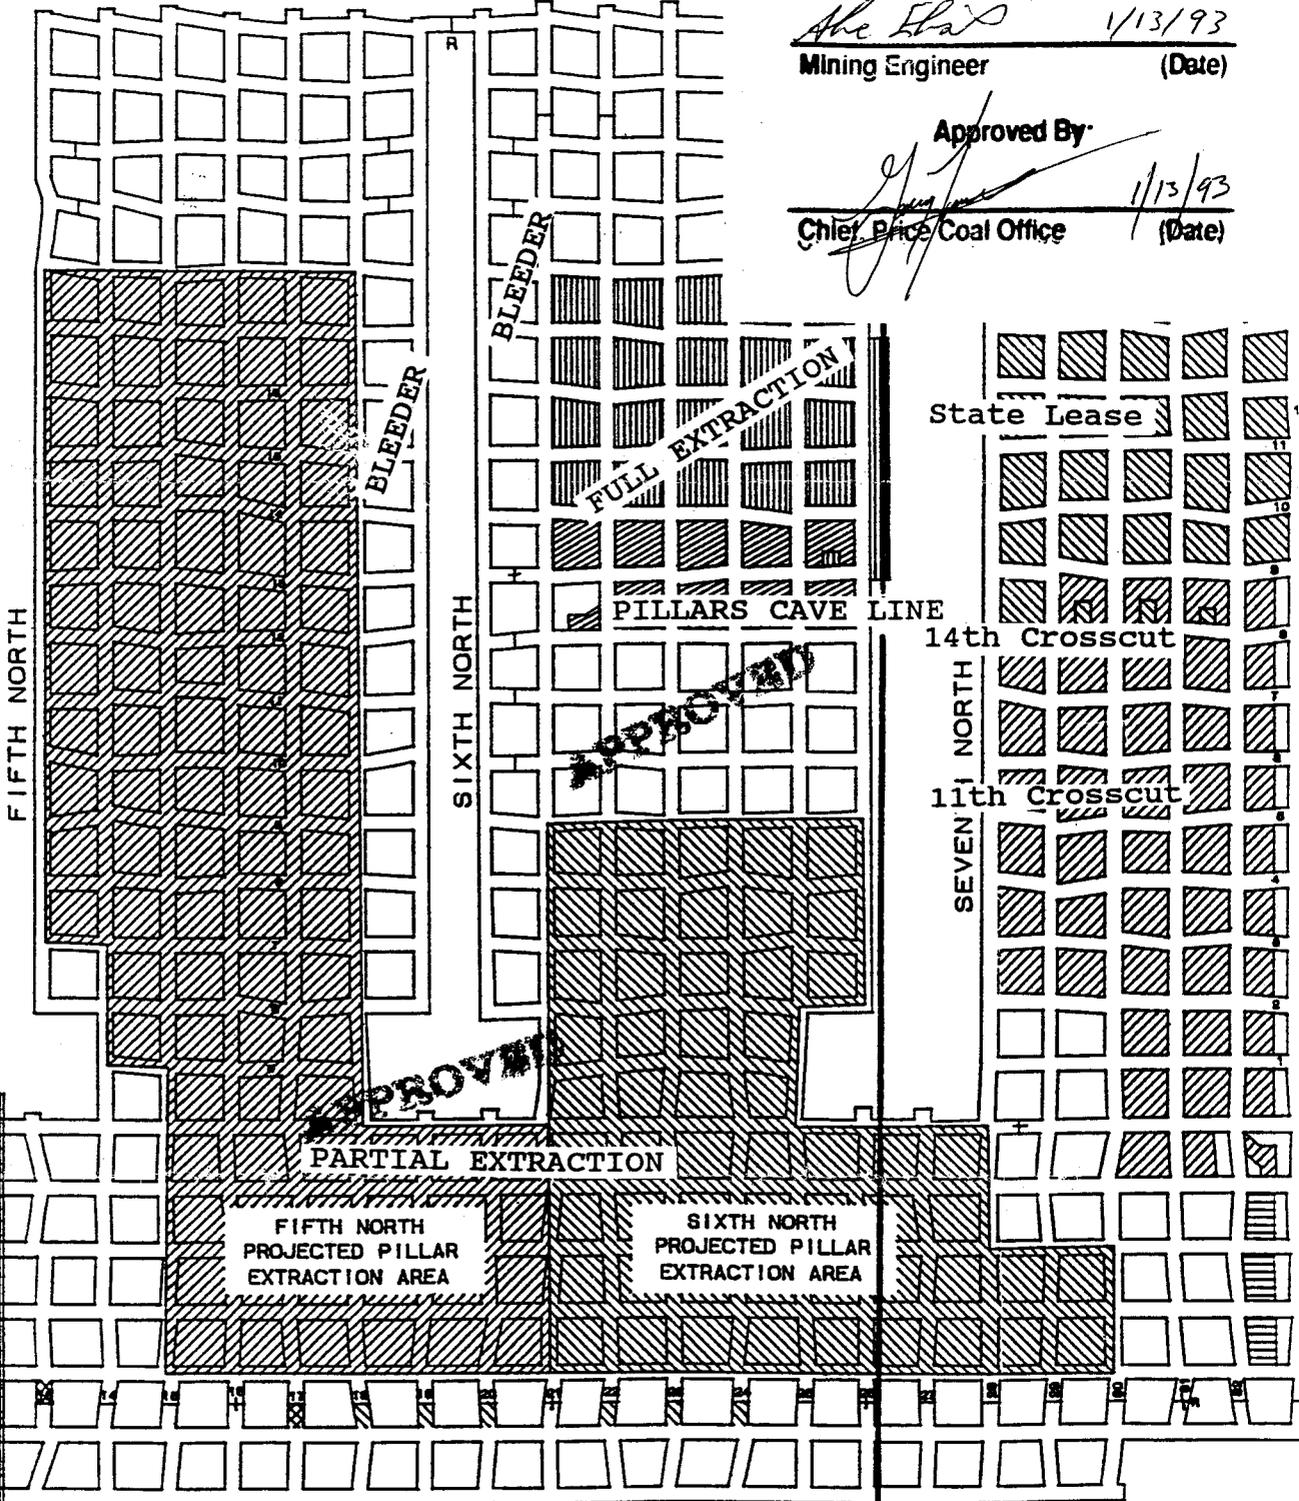
THIRD NORTH FIFTH EAST

On December 9, 1992, the 6th North section was reinspected. Floor heave, roof fractures, severe rib bursts and pillar failure were observed between #12 and #14 crosscuts. The #14 crosscut was experiencing a major roof fall, where plates were pulled out of the roof bolts due to extreme vertical pressures. Bouncing activities were expanding to approximately 200 to 300 feet behind the section's continuous miner.

Large caves were observed at the mouth of the 7th North section. The immediate roof strata in the caved material consisted of the same lamination observed at the 6th North section. Roof coal was also observed in the 6th North, the 5th North and the 3rd North 5th East sections. A discussion with SCCC representatives indicates that the top coal was left to protect crew members from roof falls and minimize ash dilution in the overall production. Independent calculations conducted by a BLM engineer indicate that a pillar size of 80 x 80 foot centers is marginal for 1500 to 1750 feet of cover.

The combination of a shale roof, the sandstone formation above the shale, and marginal pillar sizes have created an unsafe condition. The proposed plan of leaving three complete pillar rows and one partial row (16 pillars) should be an adequate barrier to support the overriding stresses in the 6th North section. Partial pillar extraction will redistribute the vertical and horizontal pressures as a precaution against further bounces. Also, the partial pillar extraction will delay the immediate roof from caving which will protect coal production from added dilution.

Under the present circumstances, Price Coal Office personnel agree with this proposal to abandon these pillars to reduce safety risks to the mining crew. The MSHA approved partial pillar extraction plan for the 6th North section is adequate and can be utilized for the 5th North and the 3rd North 5th East sections, in coordination with the authorized officer of the BLM. Full pillar extraction should be implemented when mining conditions allow.
