Canyon Fuel Company, LLC
Soldier/Dugout Canyon Mines
P.O. Box 1029
Wellington, Utan 84542
Phone: (435) 637-6360
Fax: (435) 636-2897

SUBJECT: Earthen Seals Damaged at Soldier Canyon Mine - July 1, 2000

**LIGHTING INCIDENT
and IGNITION**

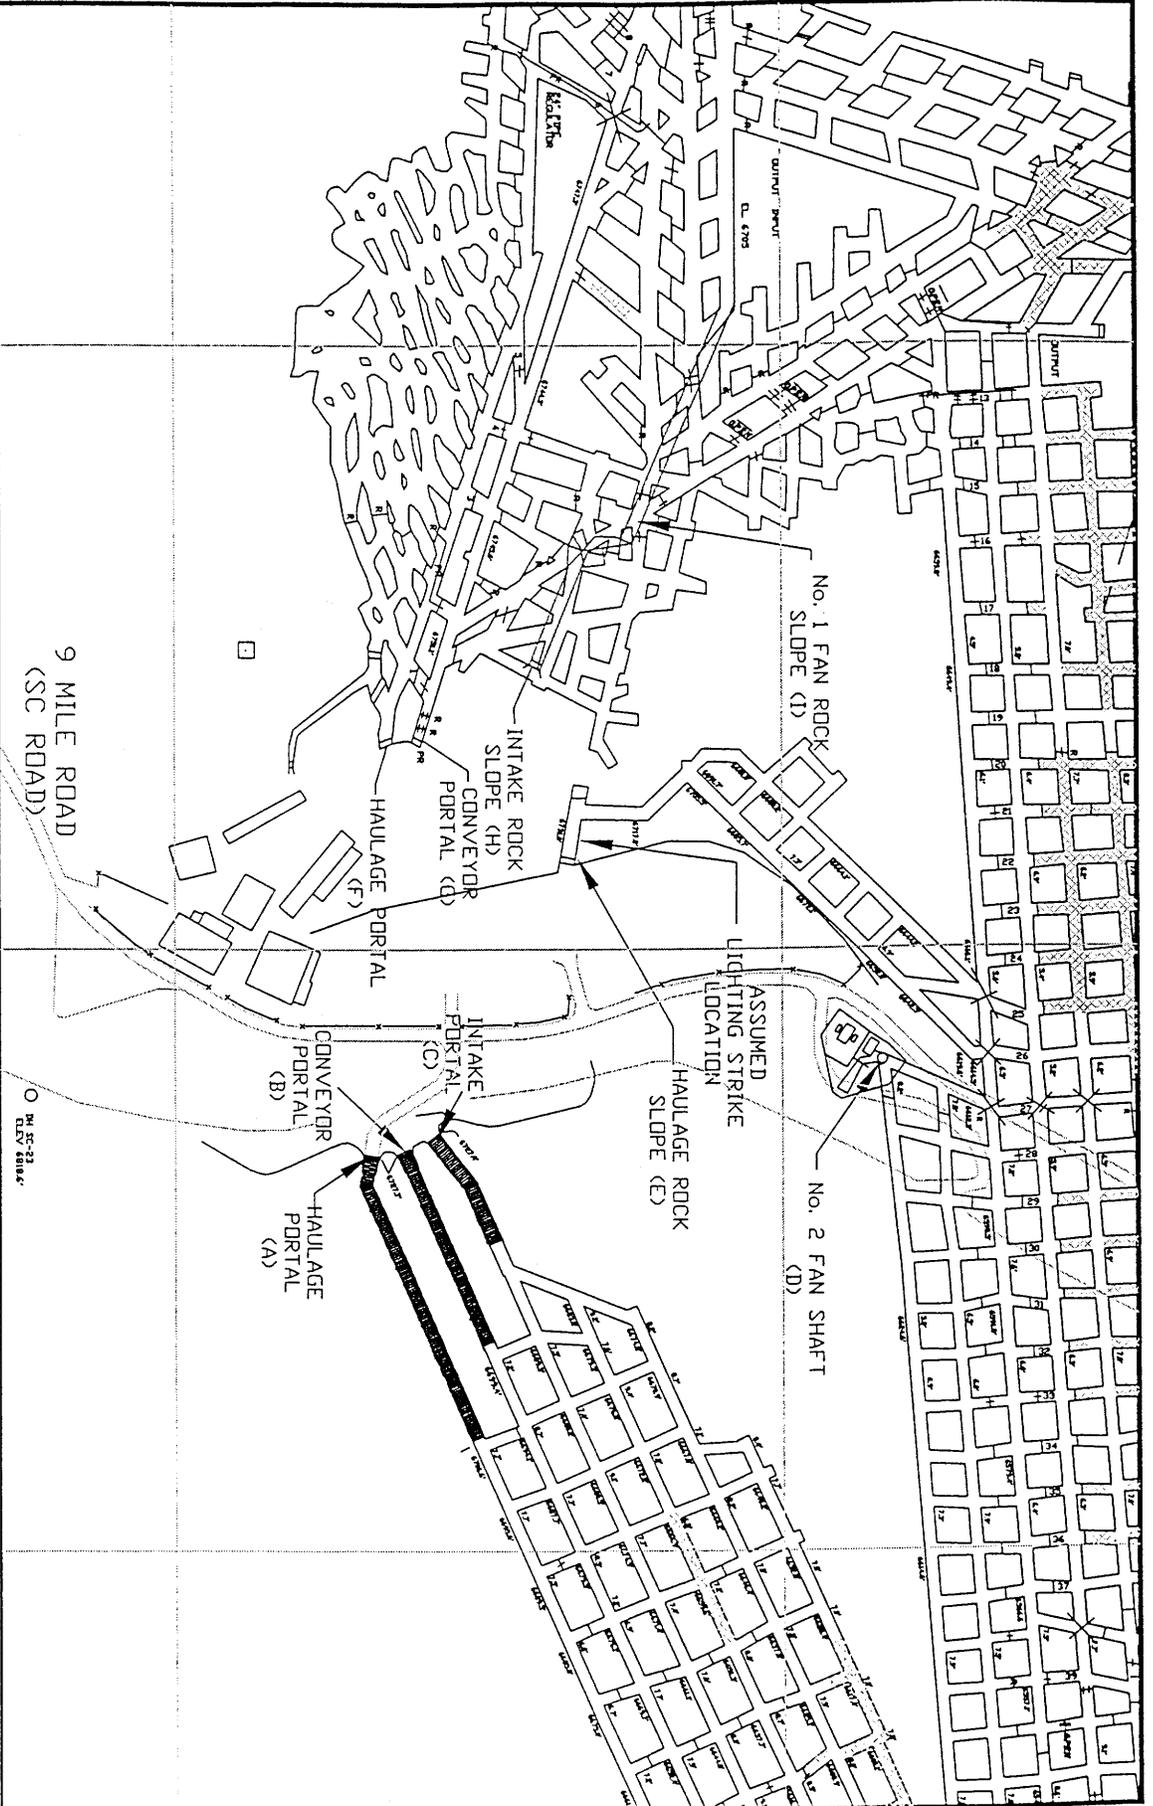
The initial survey of damage (please see attached drawing indicating portal/shaft locations and corresponding letters) indicated the following:

SEALS ORIGINALLY INSTALLED 7-01-99

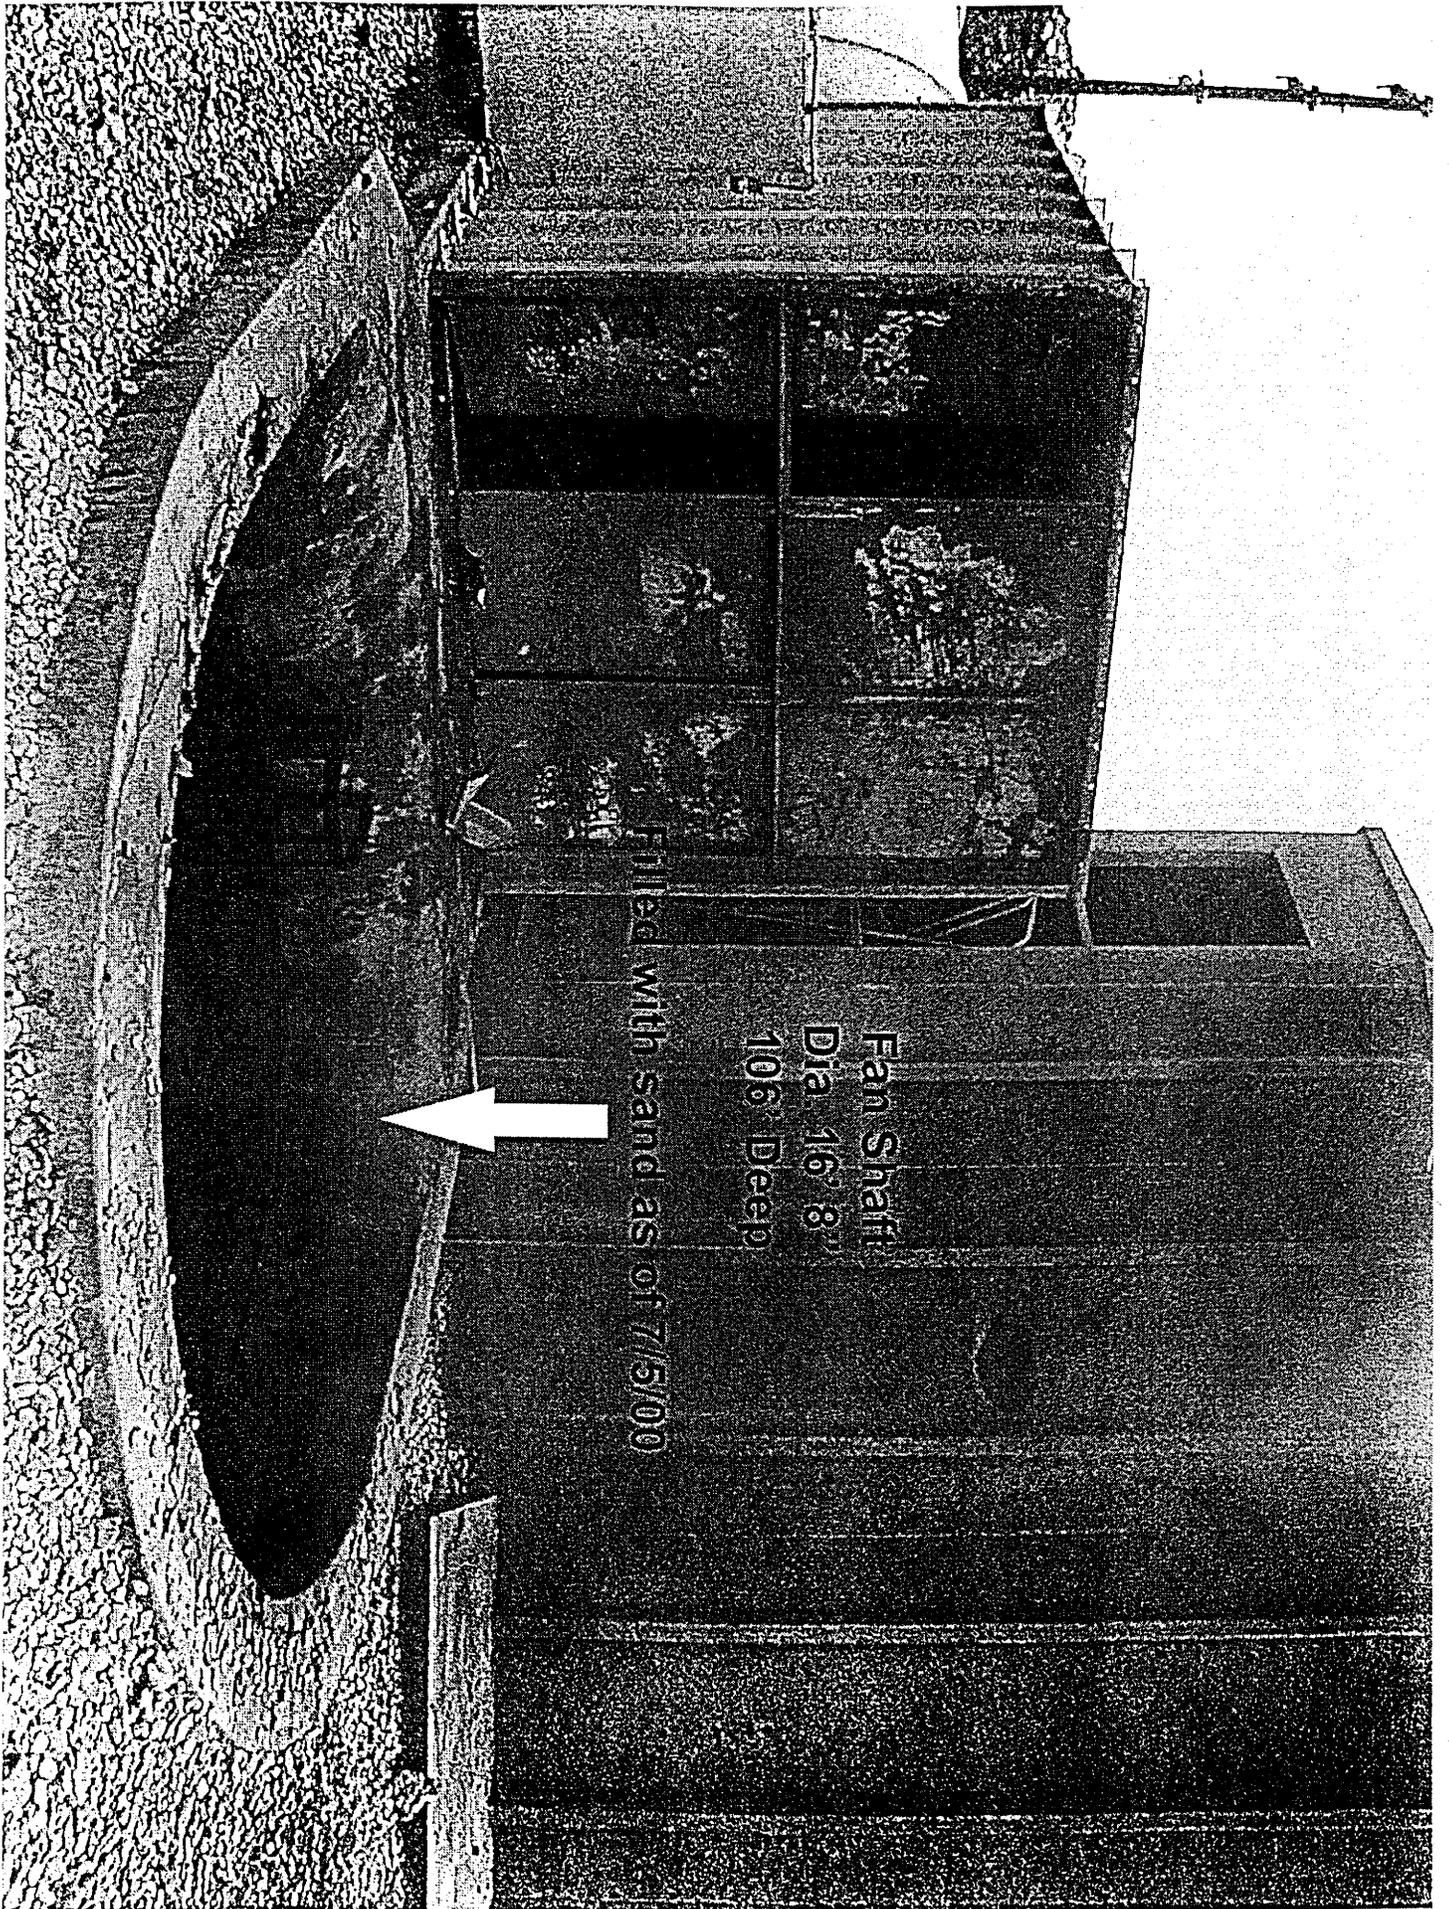
The 10" thick, two section concrete cap measuring 20' x 20' had been blown off the top of the shaft. One piece was lying in the county road approximately 50 yards north of the shaft and the other was on the south side of the fan structure. Note that the fan structure was not damaged. A light amount of smoke was emitting from the shaft with high levels of carbon monoxide and methane. It should be further noted that portions of a Kennedy stopping had been blown up the shaft and twisted Kennedy panels were found approximately 175 yards from the shaft opening.

Fan Shaft
Dia 16' 8"
106' Deep

Filled with sand as of 7/5/00

Looking North on County Road

1/2 of Fan Shaft Seal
Approx 20' x 10' x 10'

On July 3 it was observed that water running down the shaft lining had eroded a portion of the seal at the shaft bottom and mine atmosphere was being liberated from the shaft. MSHA was contacted related to this matter and management elected to fill the shaft with earthen material to prevent the recurrence prior to pouring a new concrete shaft cap.

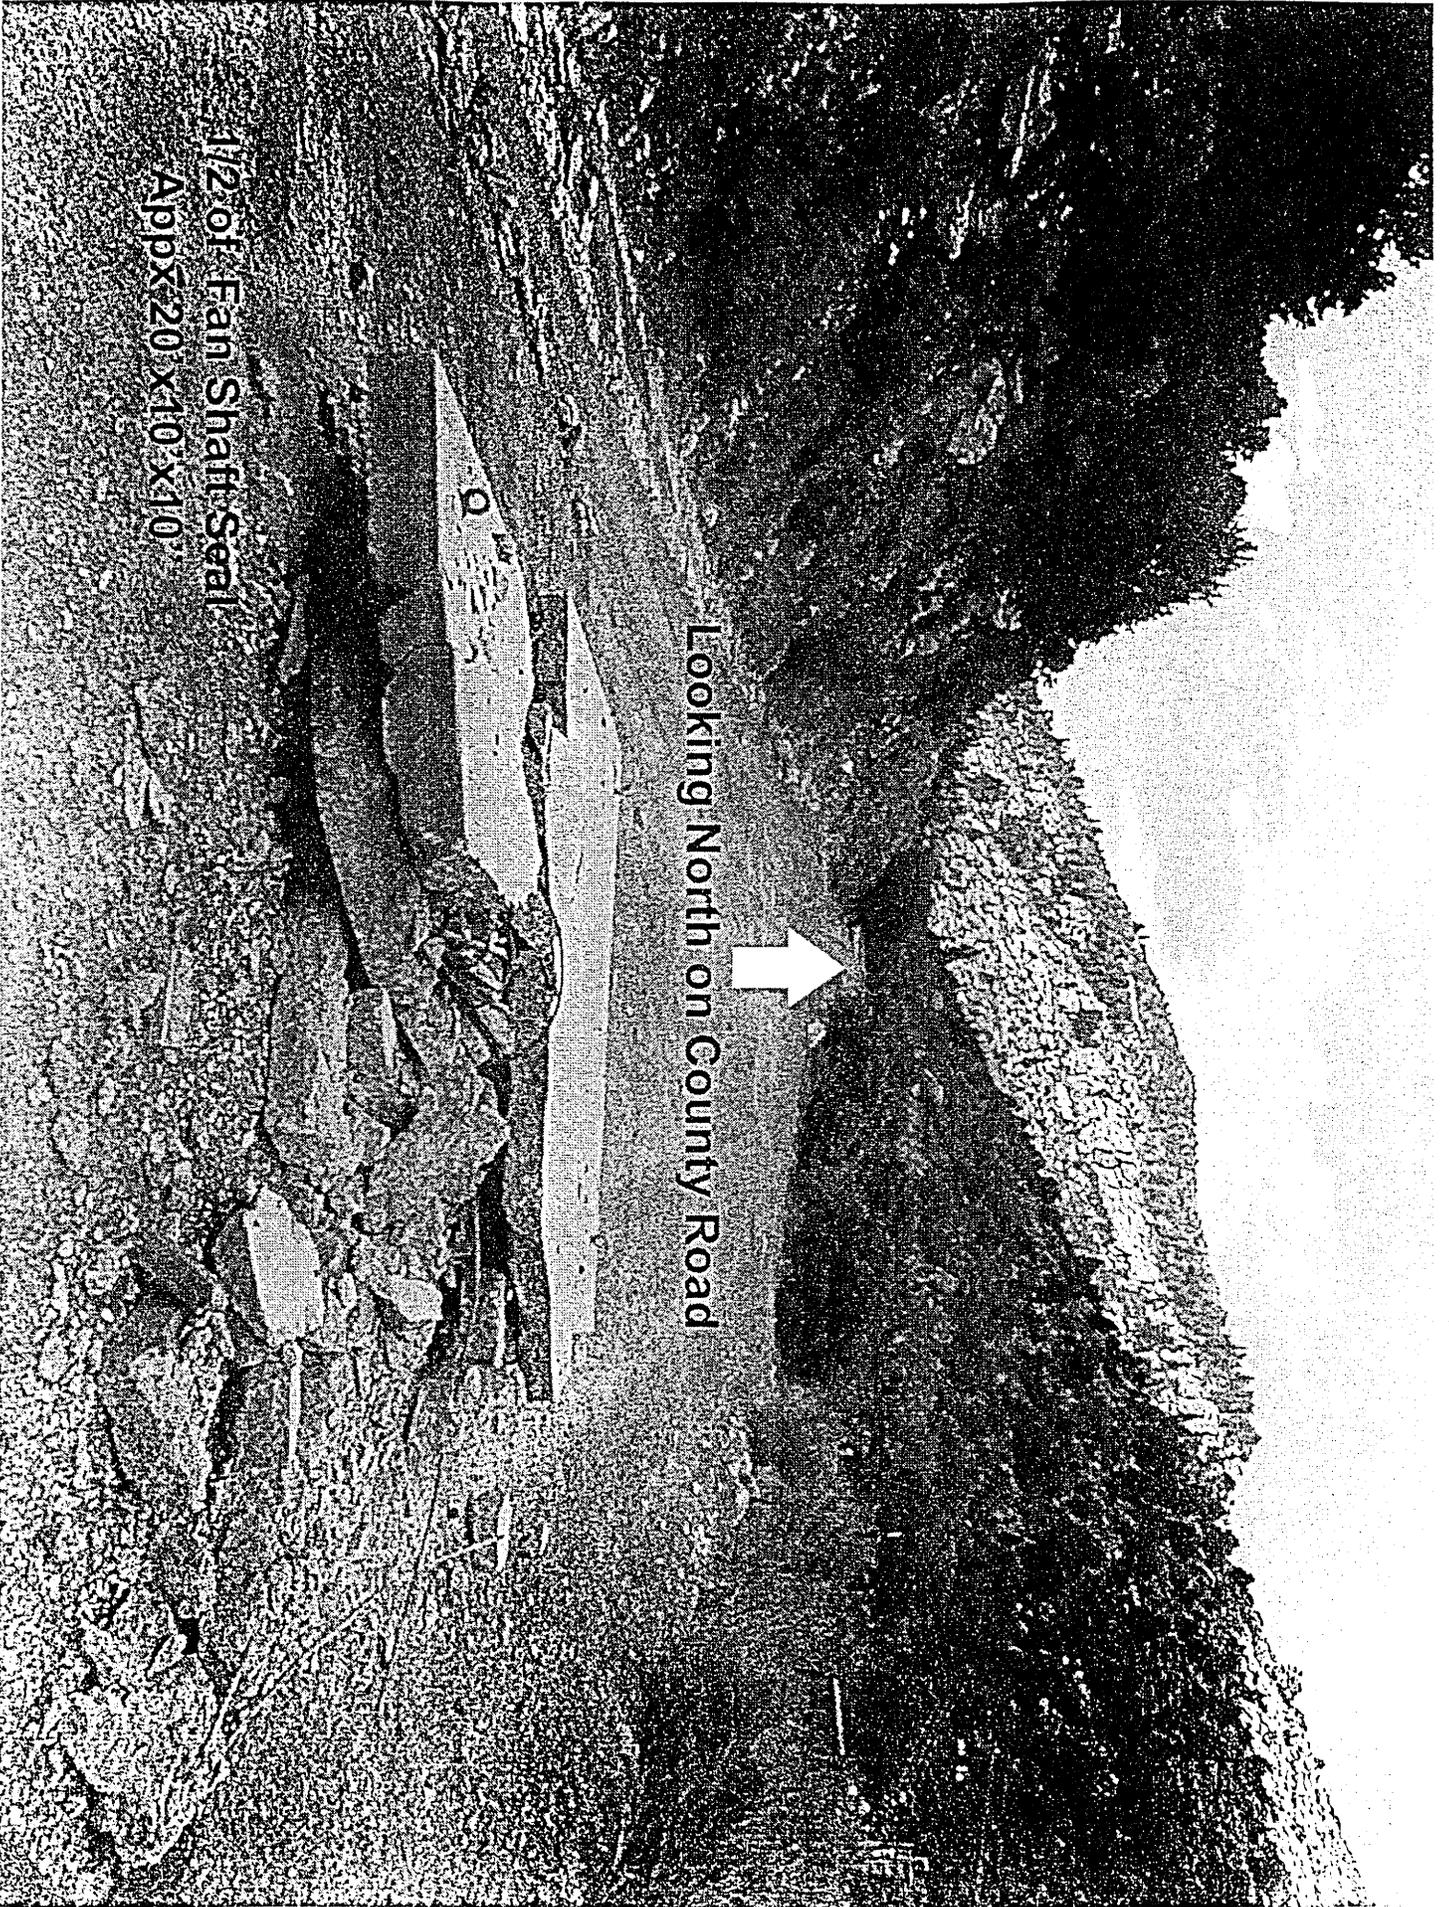
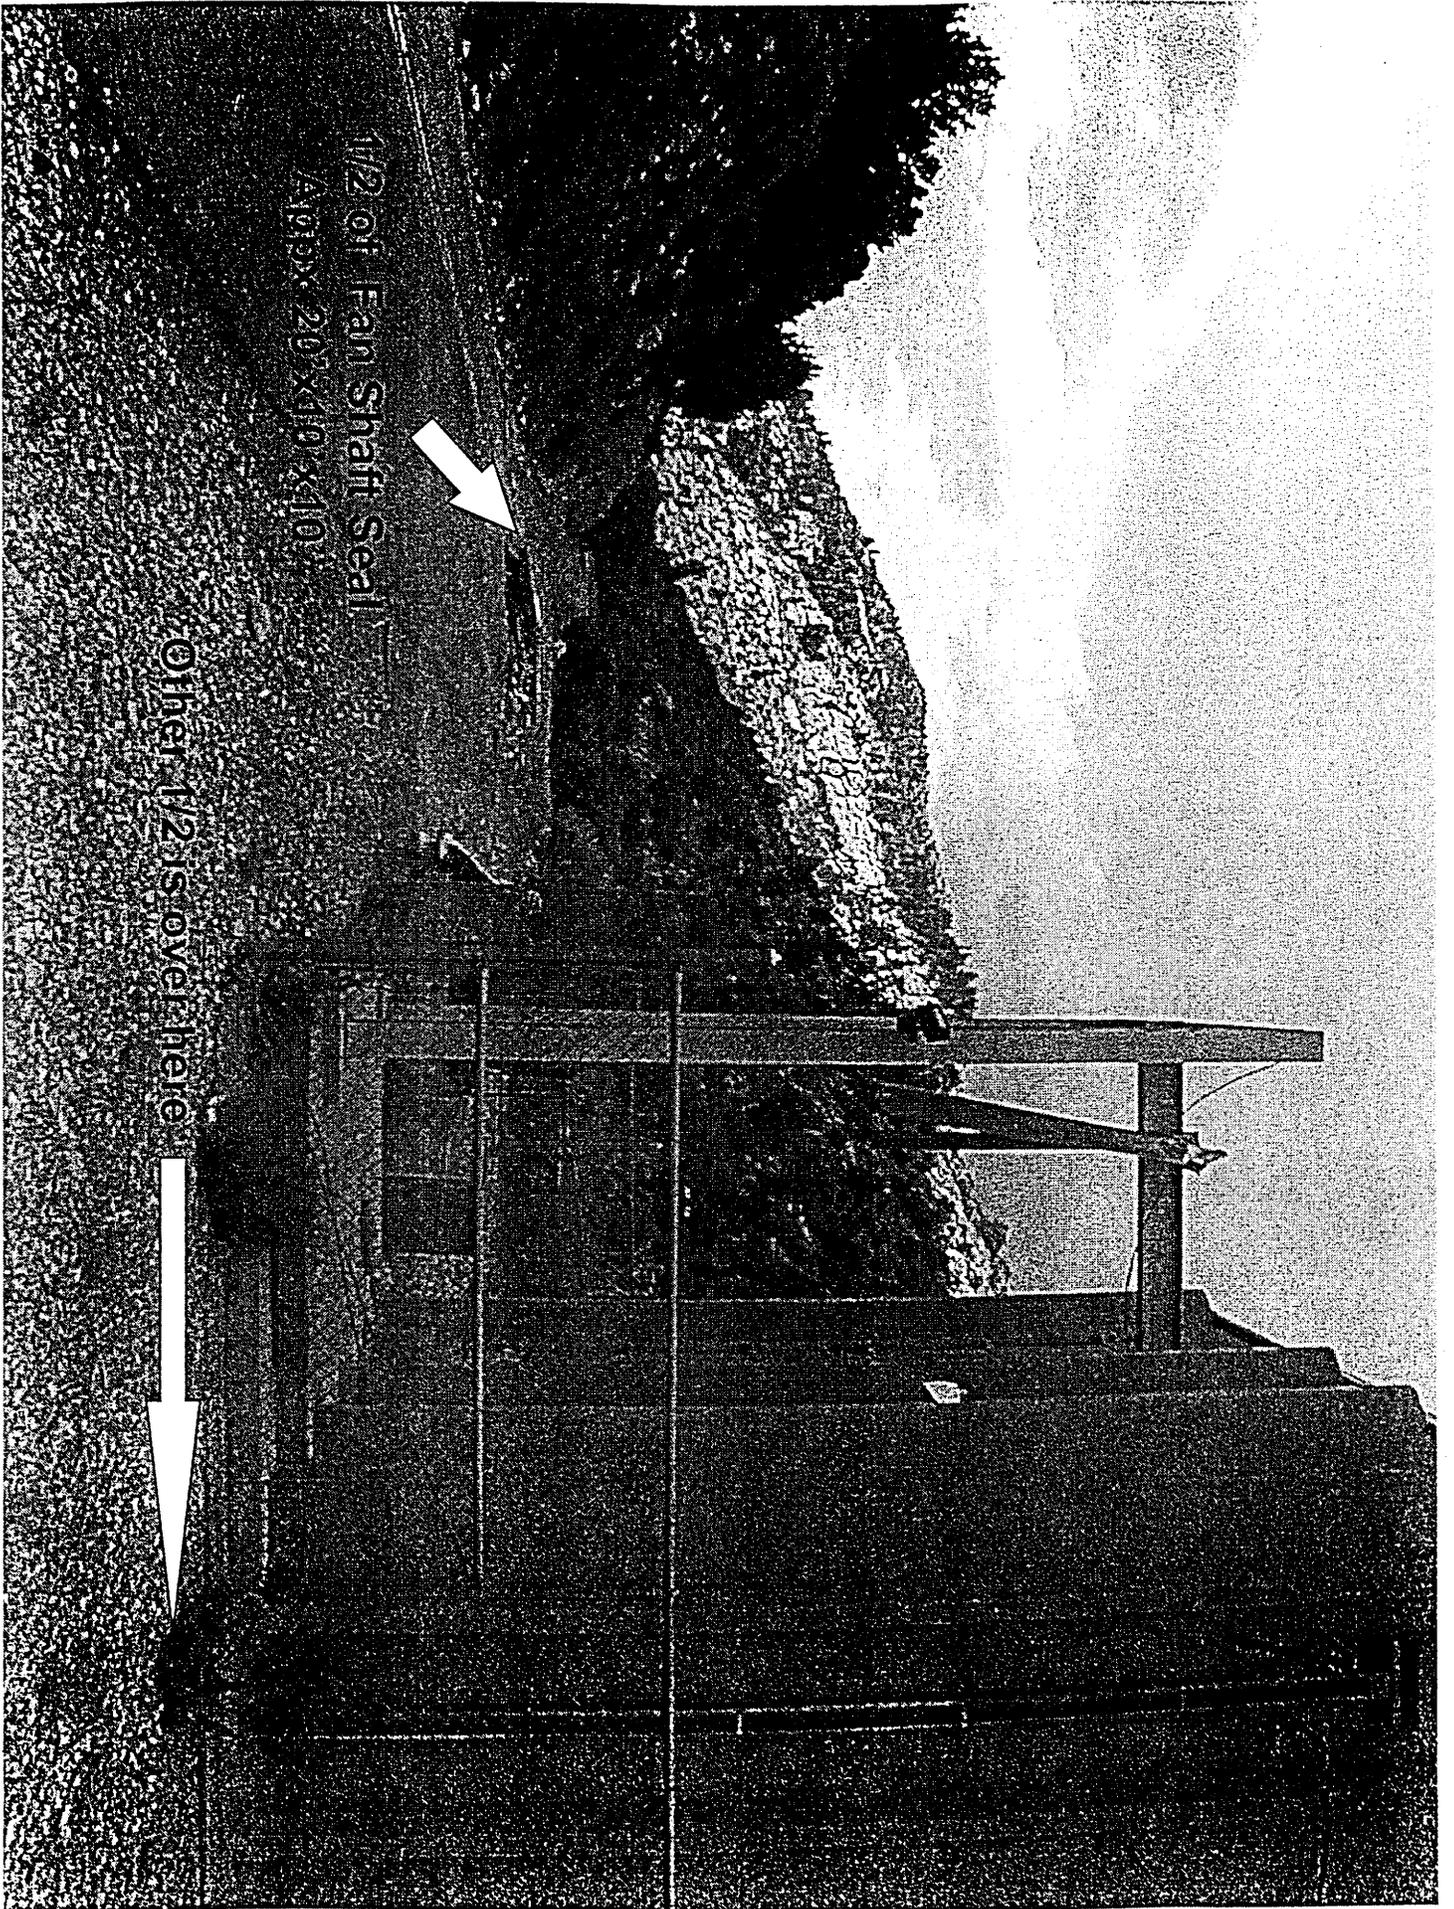
1/2 of Fan Shaft Seal
Approx. 20" x 10" x 10"

Other 1/2 is over here

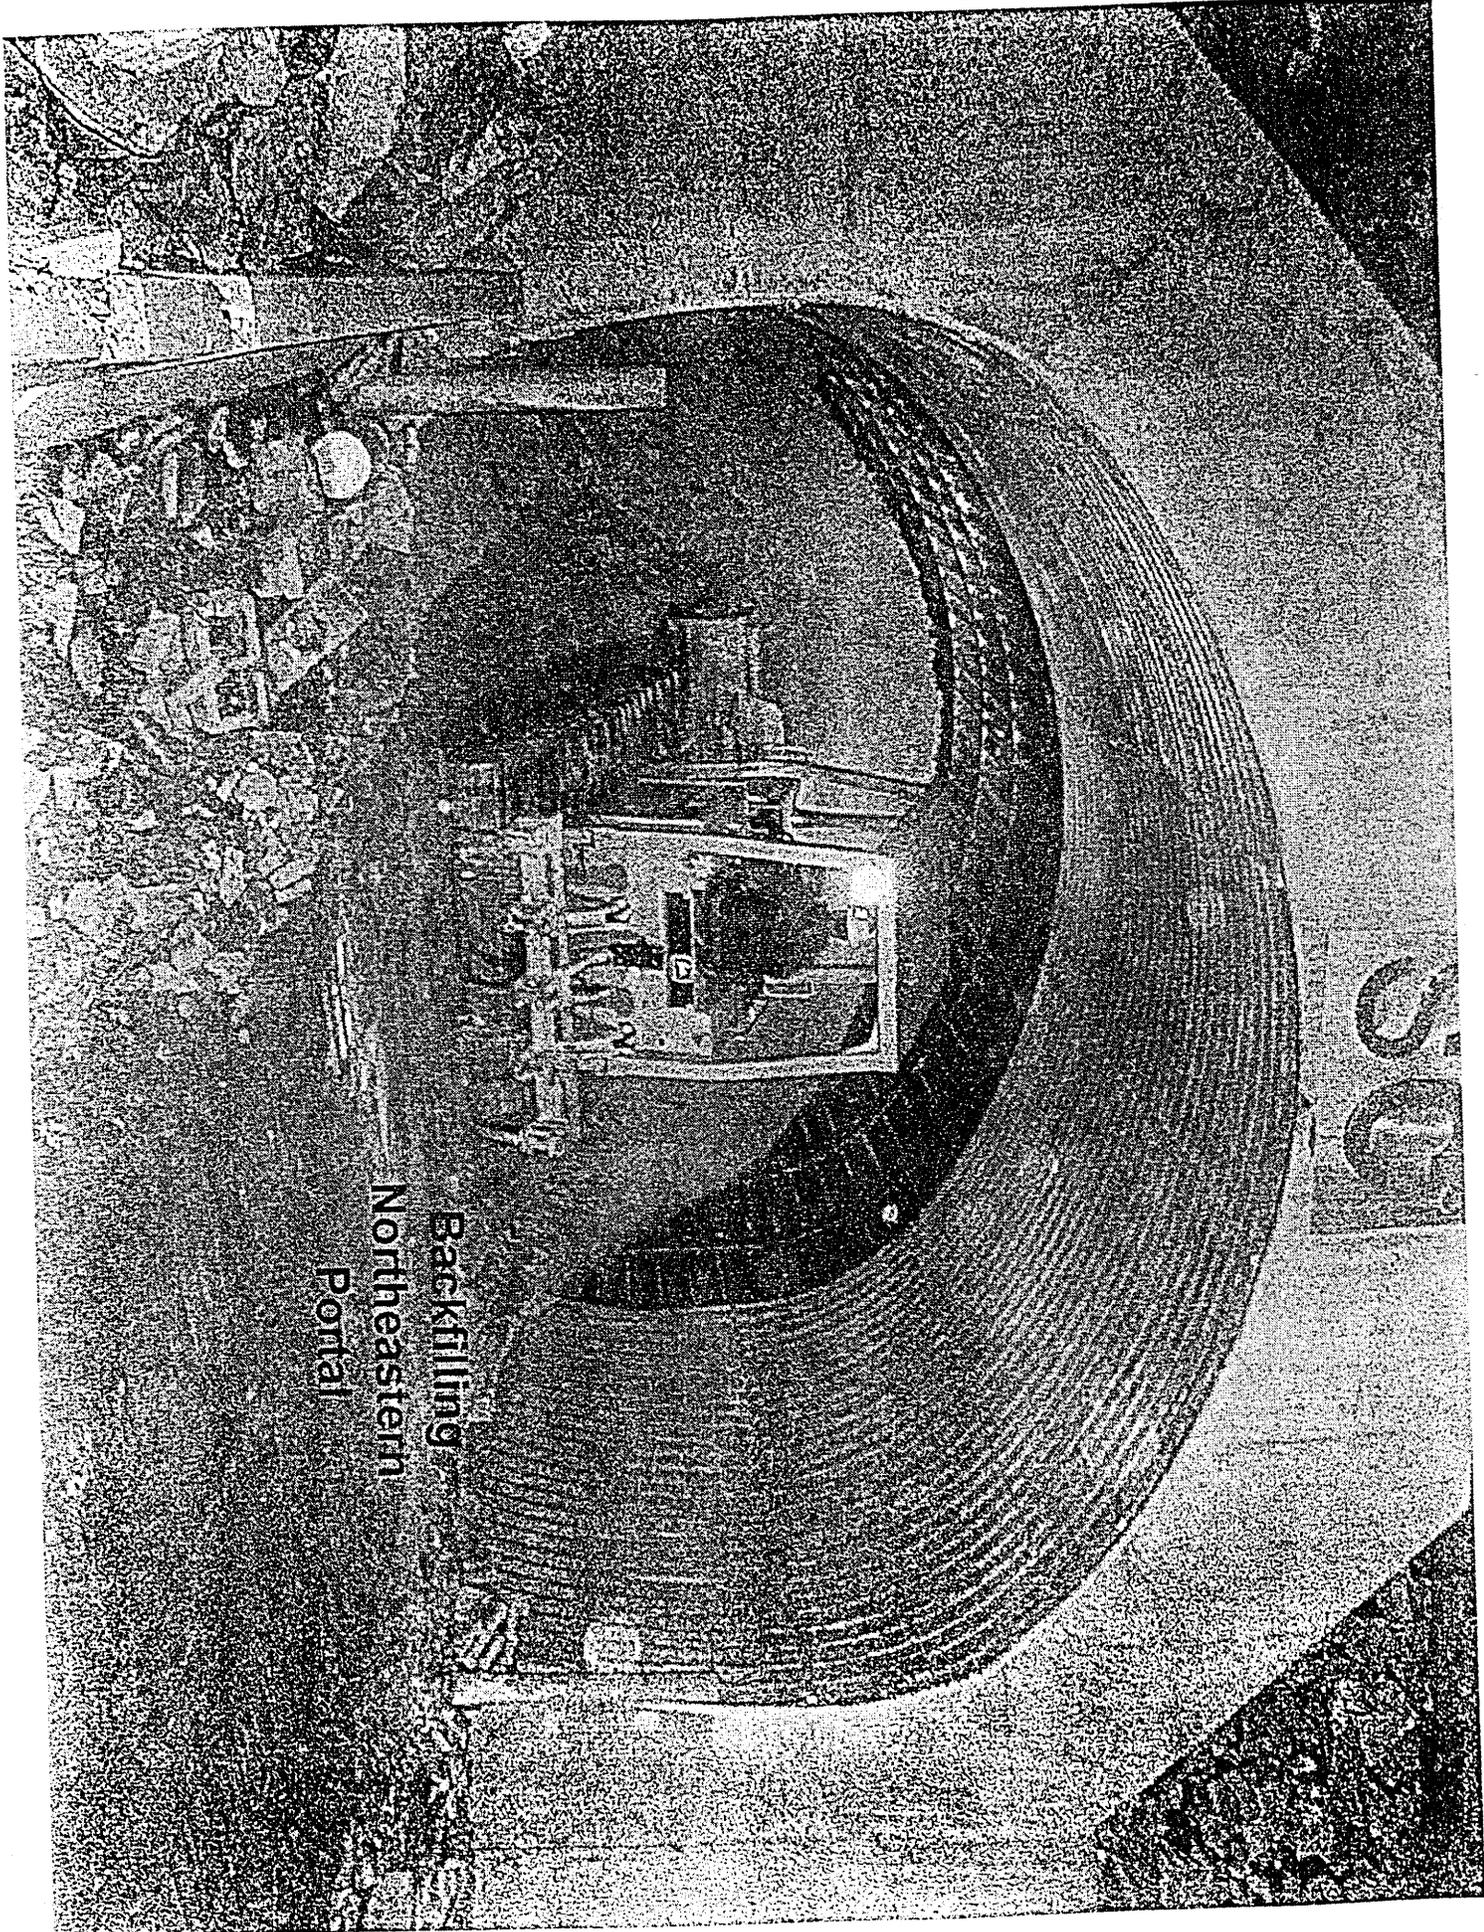
Backfilling
Northeastern
Portal

Discussions between mine management, and local, Denver and Arlington MSHA officials concluded that earthen material remained the best option for permanently resealing the portals. Another plan was submitted to MSHA that reflected completely filling the portal openings with dirt and completely covering, wherever practical, the entire portal. MSHA accepted the plan and activities as to the aforementioned began July 7.
