# WATER QUALITY MEMORANDUM

Utah Coal Regulatory Program

RE: 2006 Fourth Quarter Water Monitoring, Canyon Fuel Company, Soldier Canyon Mine, C/007/0018-WQ-06-4, Task ID #2681

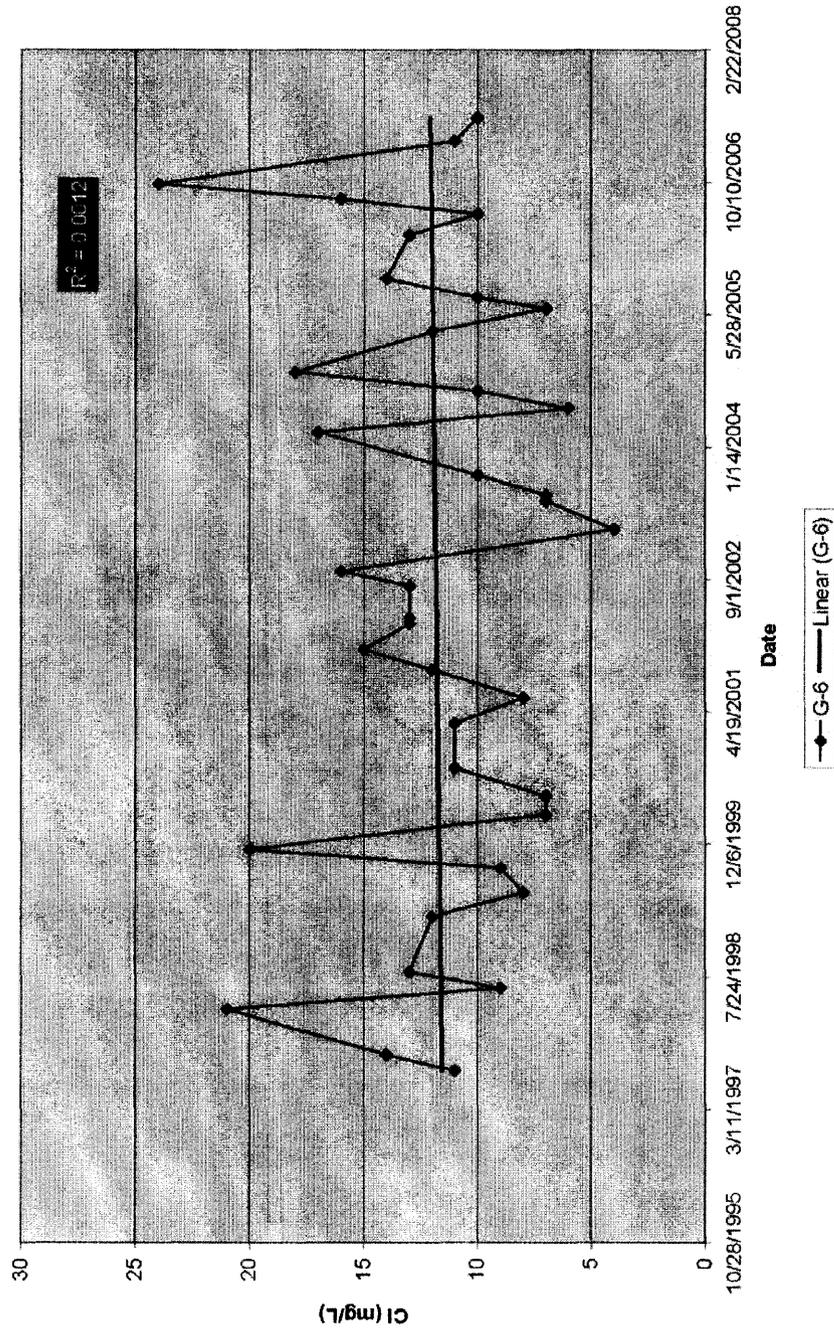
Chloride (24 mg/L) has no real trend at G-6 ( $R^2 = 0.0012$ ) nor correlation to flow ( $R^2 = 0.03$ ). This is the highest concentration of chloride ever recorded at this site, but a level of 24 mg/L is well below any water quality limits.

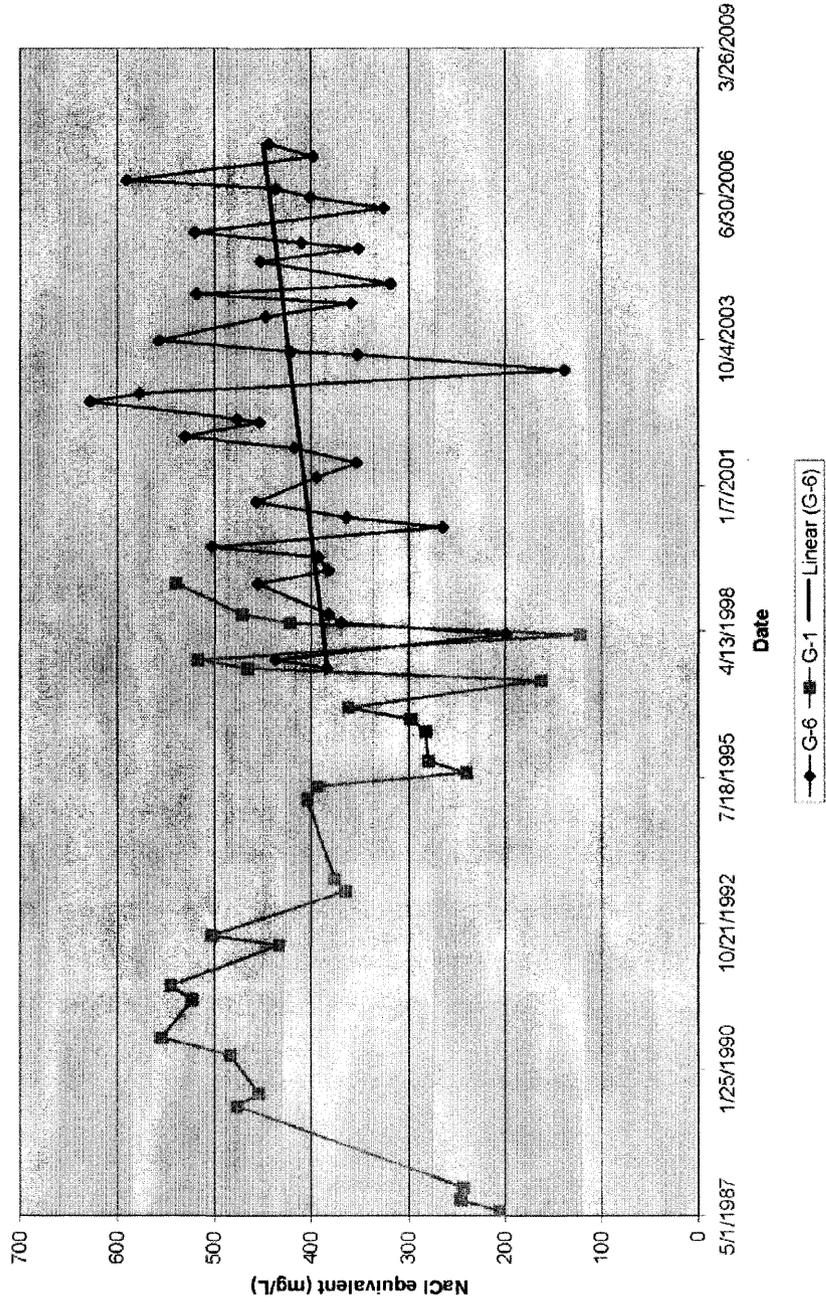
Salinity

The salinity at G-6, which is affected by several parameters (Cl, Na, Mg, SO<sub>4</sub>, Ca, K, HCO<sub>3</sub>, etc.), has always been at the high end of "fresh" (<500 mg/L NaCl equivalent) and at times crosses into the "brackish" category (500-30000 mg/L NaCl equivalent). The average salinity has been approximately 415 mg/L NaCl equivalent with 21% of all samples >500 mg/L, 55% >400 mg/L, and 92% >300 mg/L. There is no real upward trend in salinity ( $R^2 = 0.0482$ ) and a weak negative correlation to flow ( $R^2 = 0.22$ ). Similarly high, fluctuating salinity values were recorded at G-1 (2 miles upstream) from 1987 to 1999. Samples taken at G-7 in the 1970's ranged from 385 to 635 mg/L NaCl equivalent.

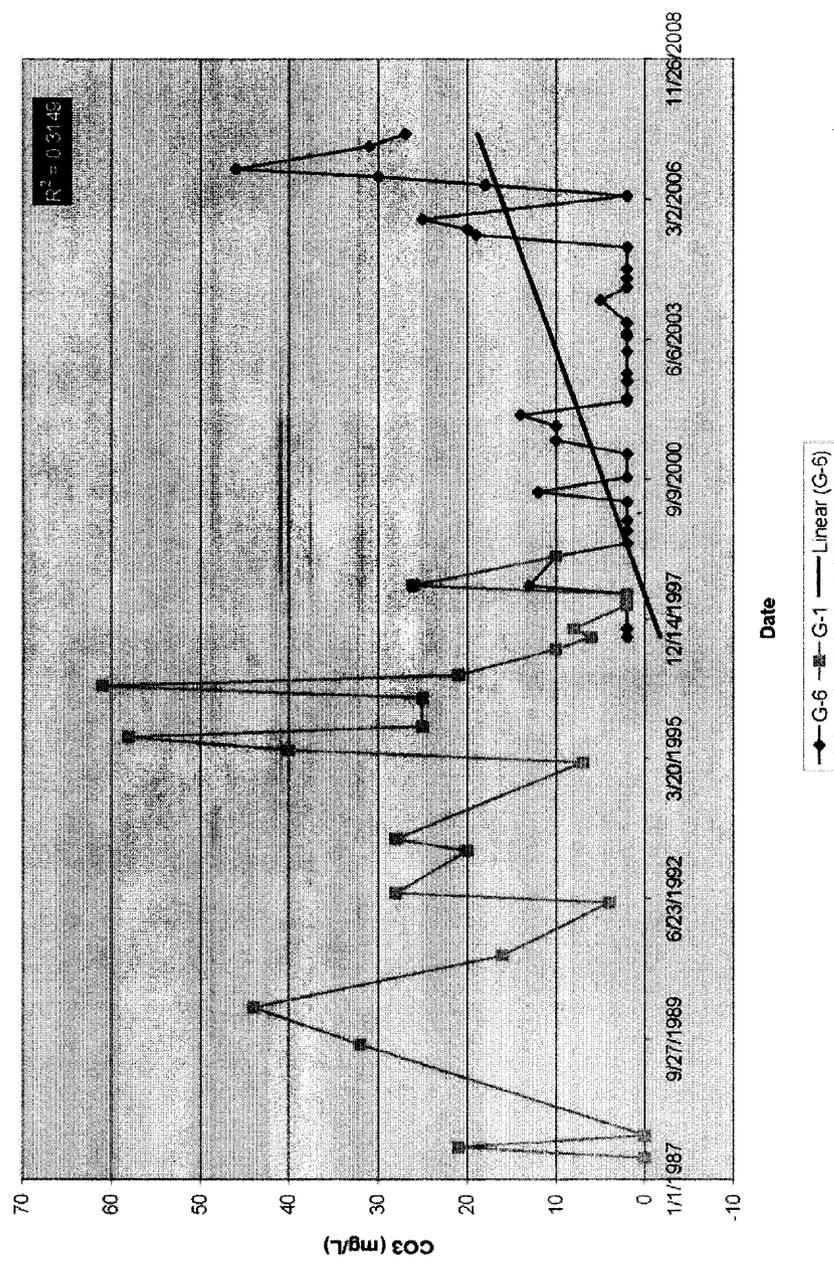
The alkalinity at G-6 has no real trend ( $R^2 = 0.0755$ ), with a weak negative correlation to flow ( $R^2 = 0.29$ ). Carbonate has a weak upward trend ( $R^2 = 0.3149$ ) and no correlation to flow. Alkalinity is a measure of buffering capacity, or the ability of a water-source to absorb acid
