## United States Department of the Interior

May 21, 2015

## **Soldier Canyon Mine Complete Oversight Inspection Report**

Utah Division of Oil, Gas and Mining (DOGGM) Permit ID # C/007/0018

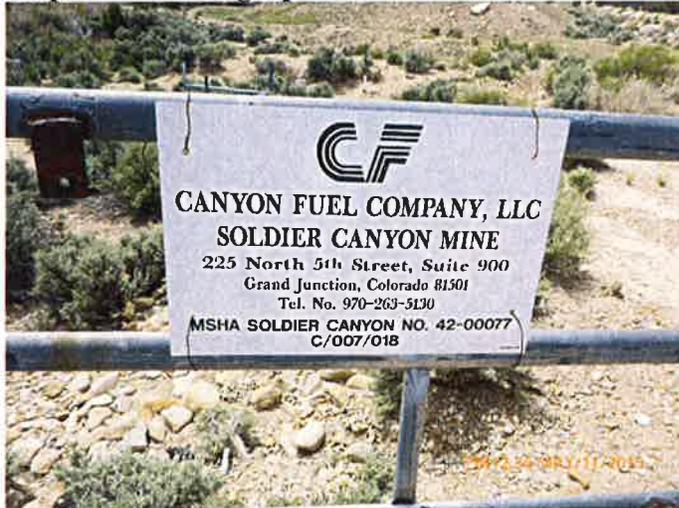
All entrances to the Soldier Canyon permit area, topsoil storage area, and sewage lagoon / greywater evaporative ponds displayed proper mine identification signs. Topsoil piles and disturbed area boundaries were properly marked. **See Figure 1 below.**

Topsoil storage area identification sign

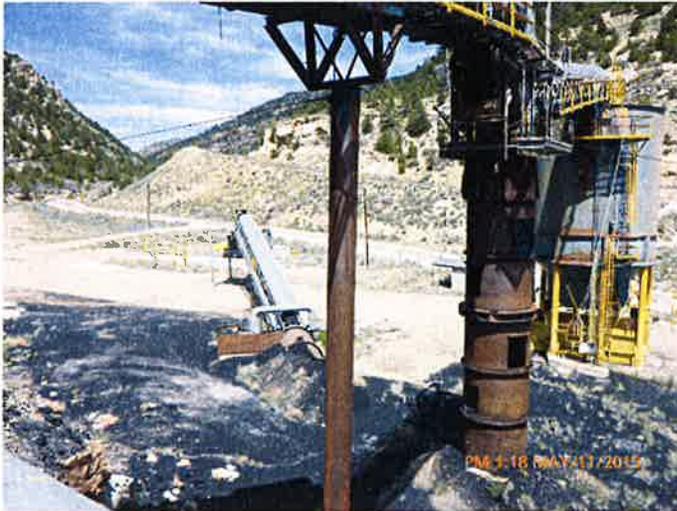
At the time of inspection, all portals had been temporarily sealed with earthen backfill. No fuel or lubricants were stored onsite. Vandals have stripped the facility of almost all its copper wiring. The mine uses some of the buildings to store equipment from the active, adjacent Dugout Canyon Mine. **See Figure 2 and 3 below.**

Surface facilities featuring stacktube and conveyor

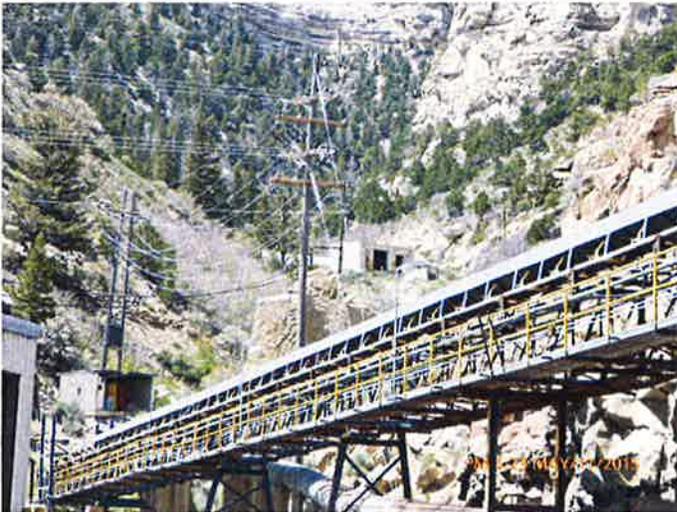
Figure 3

Surface facilities featuring conveyor, bulk fuel storage shed, and fan portal

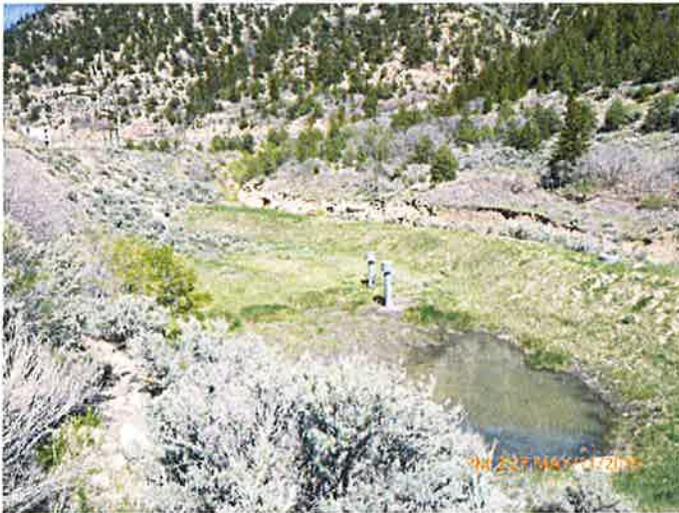
The surface facilities sedimentation pond exhibited stable, well vegetated banks and unobstructed principal and emergency spillways. The pond contained a small amount of water at the time of inspection. The cleanout indicator level was visible. **See Figure 4 below.**

Surface facilities sedimentation pond
