**ANDALEX**  
**RESOURCES, INC.**

TO: Randy Harden, UDOGM  
FROM: Michael W. Glasson *MWG*  
DATE: May 12, 1989  
SUBJECT: Sed Pond Slope Stability

**PALMER  
WILDING**

Re: Sedimentation Pond Slope Stability

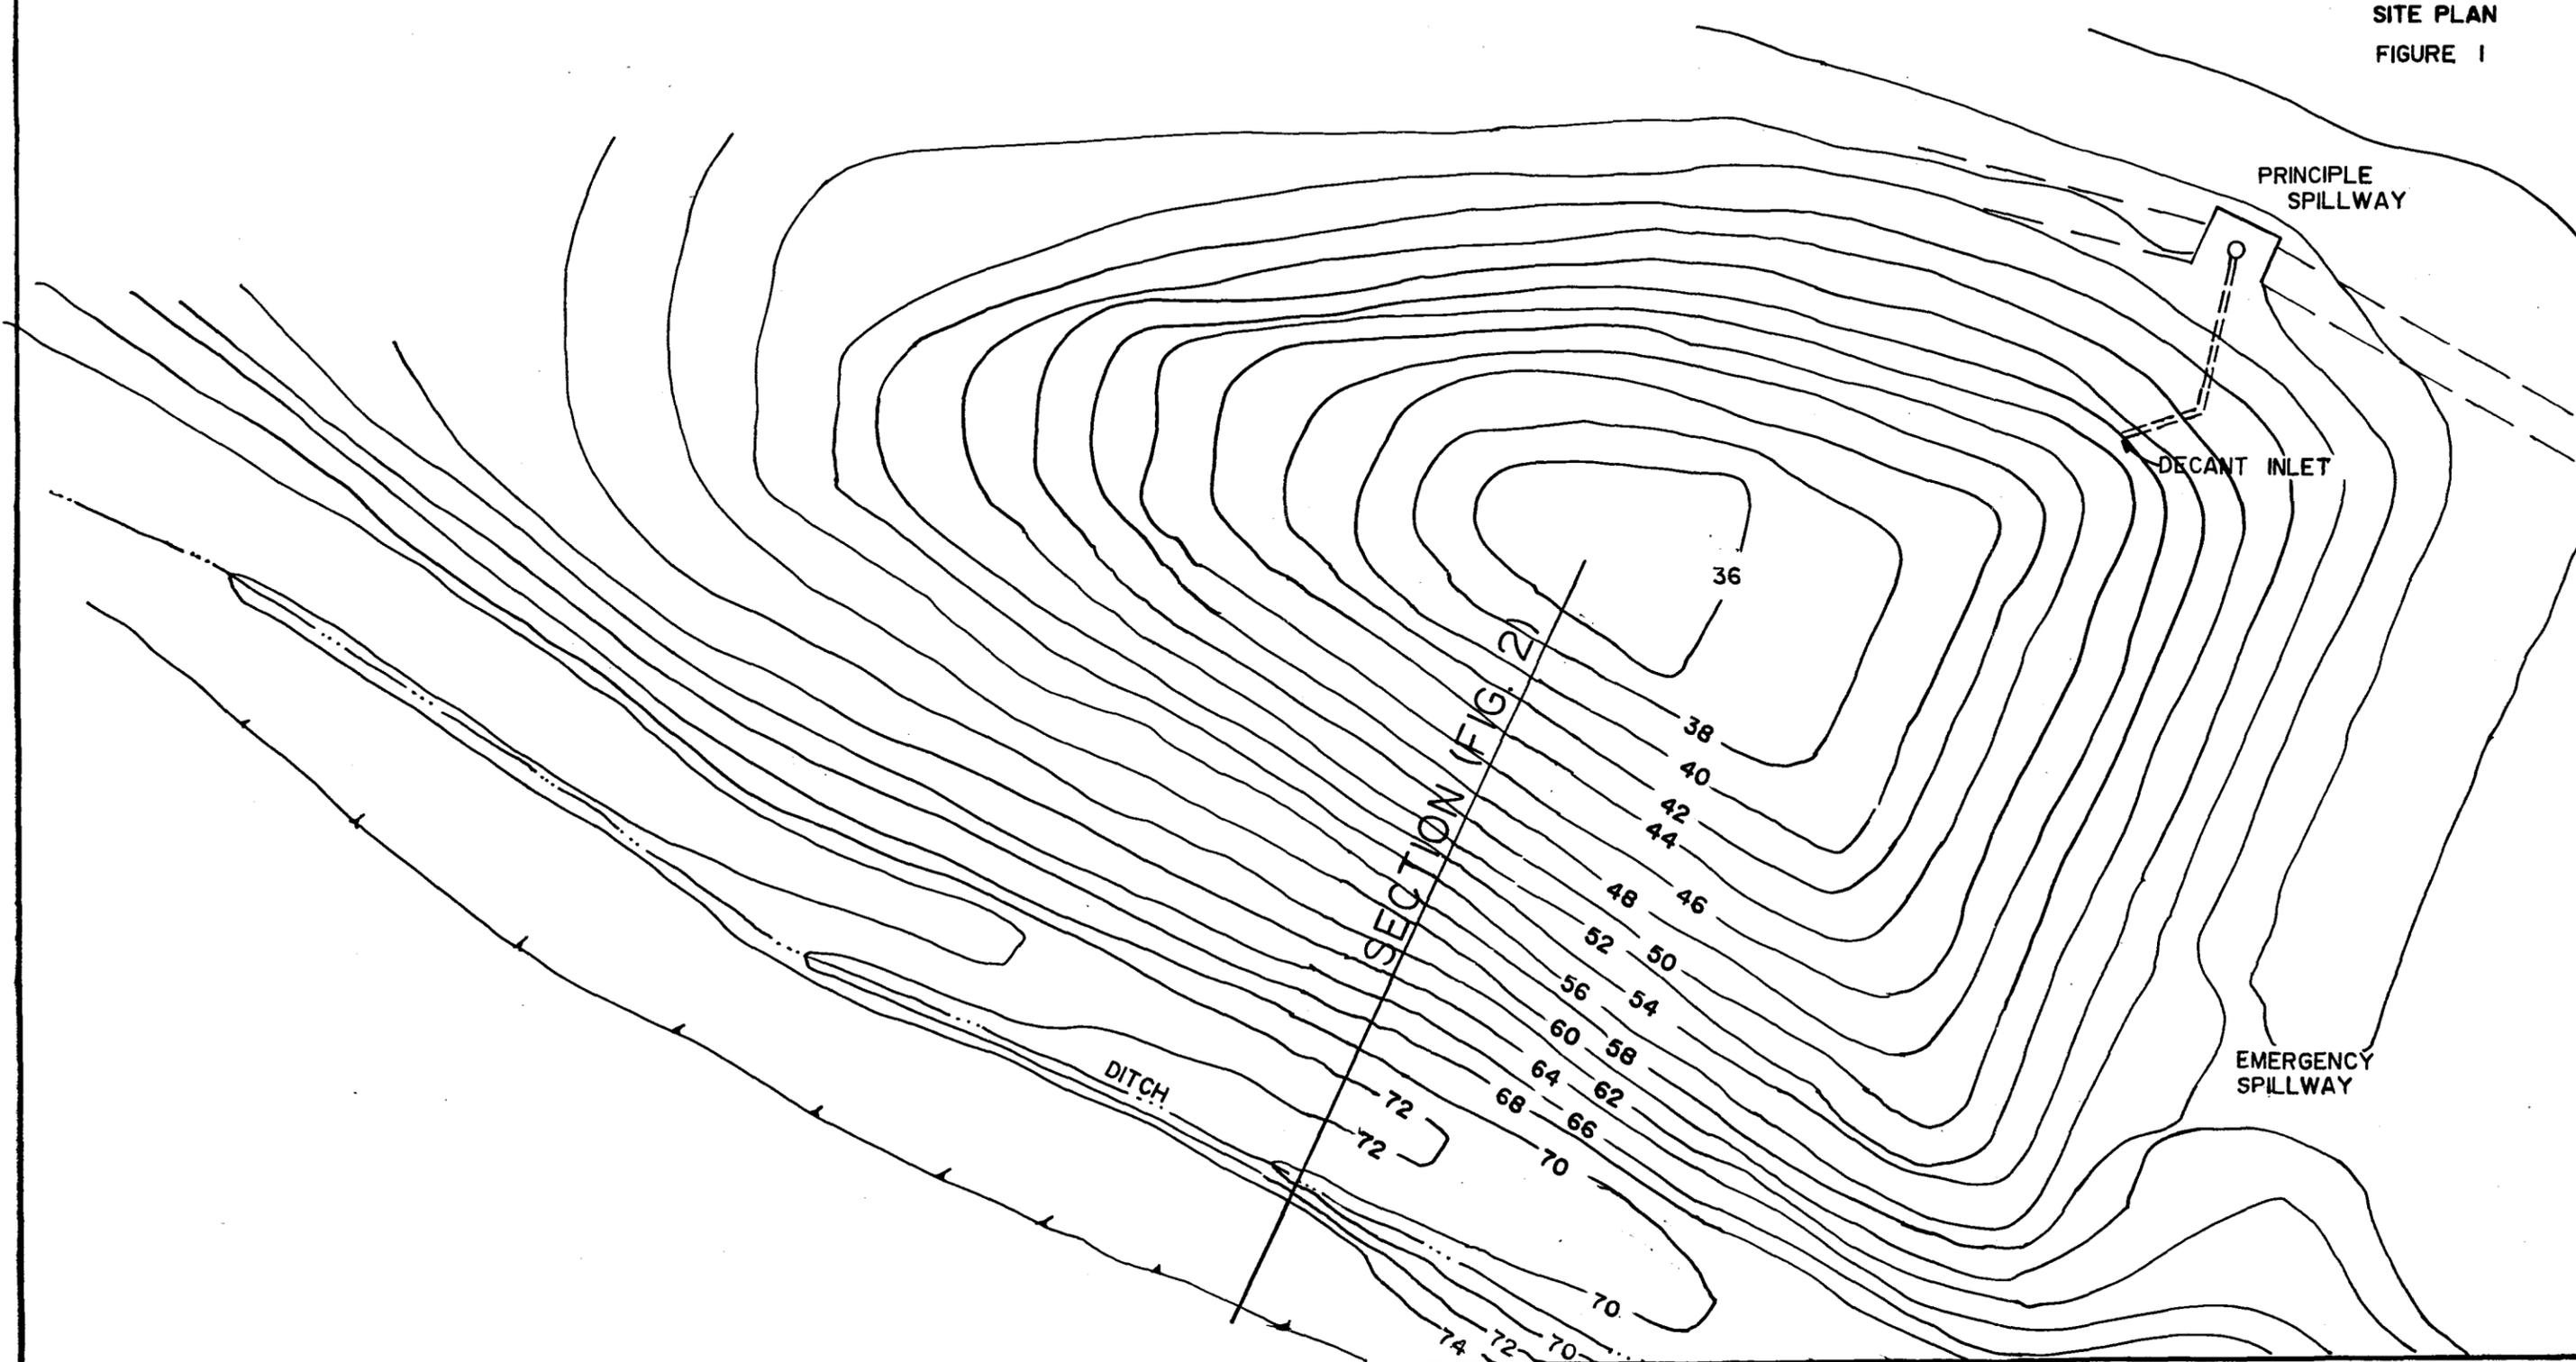
ANDULEX RESOURCES  
SITE PLAN  
FIGURE 1

Based on "As Constructed" drawing of the pond provided by Andalex Resources, the following configuration is presented (see Figure 1). The sediment pond is principally excavated west of the Andalex access road and in part into the west side of the canyon. The pond is approximately 200 feet long, 100 feet wide and 22 feet deep at the deepest location. The excavation of the pond on the west side of the canyon has resulted in a cut slope 44 feet high laid on a 1.4:1 slope (1.4 feet horizontal : 1.0 feet vertical).

The east side and south end (downstream end) of the pond is principally excavated with some fill placed above an imaginary line extending from the decant inlet up to the east end of the emergency spillway (or approximately 14 feet), see Figure 1. The slope of the east cut and embankment is about 2.0:1.

The west slope of the pond was analyzed at the maximum cut height at a slope of 1.4:1. The configuration of the slope is based on the "As Constructed" drawing provided by Andalex Resources, as depicted on Figure 1.

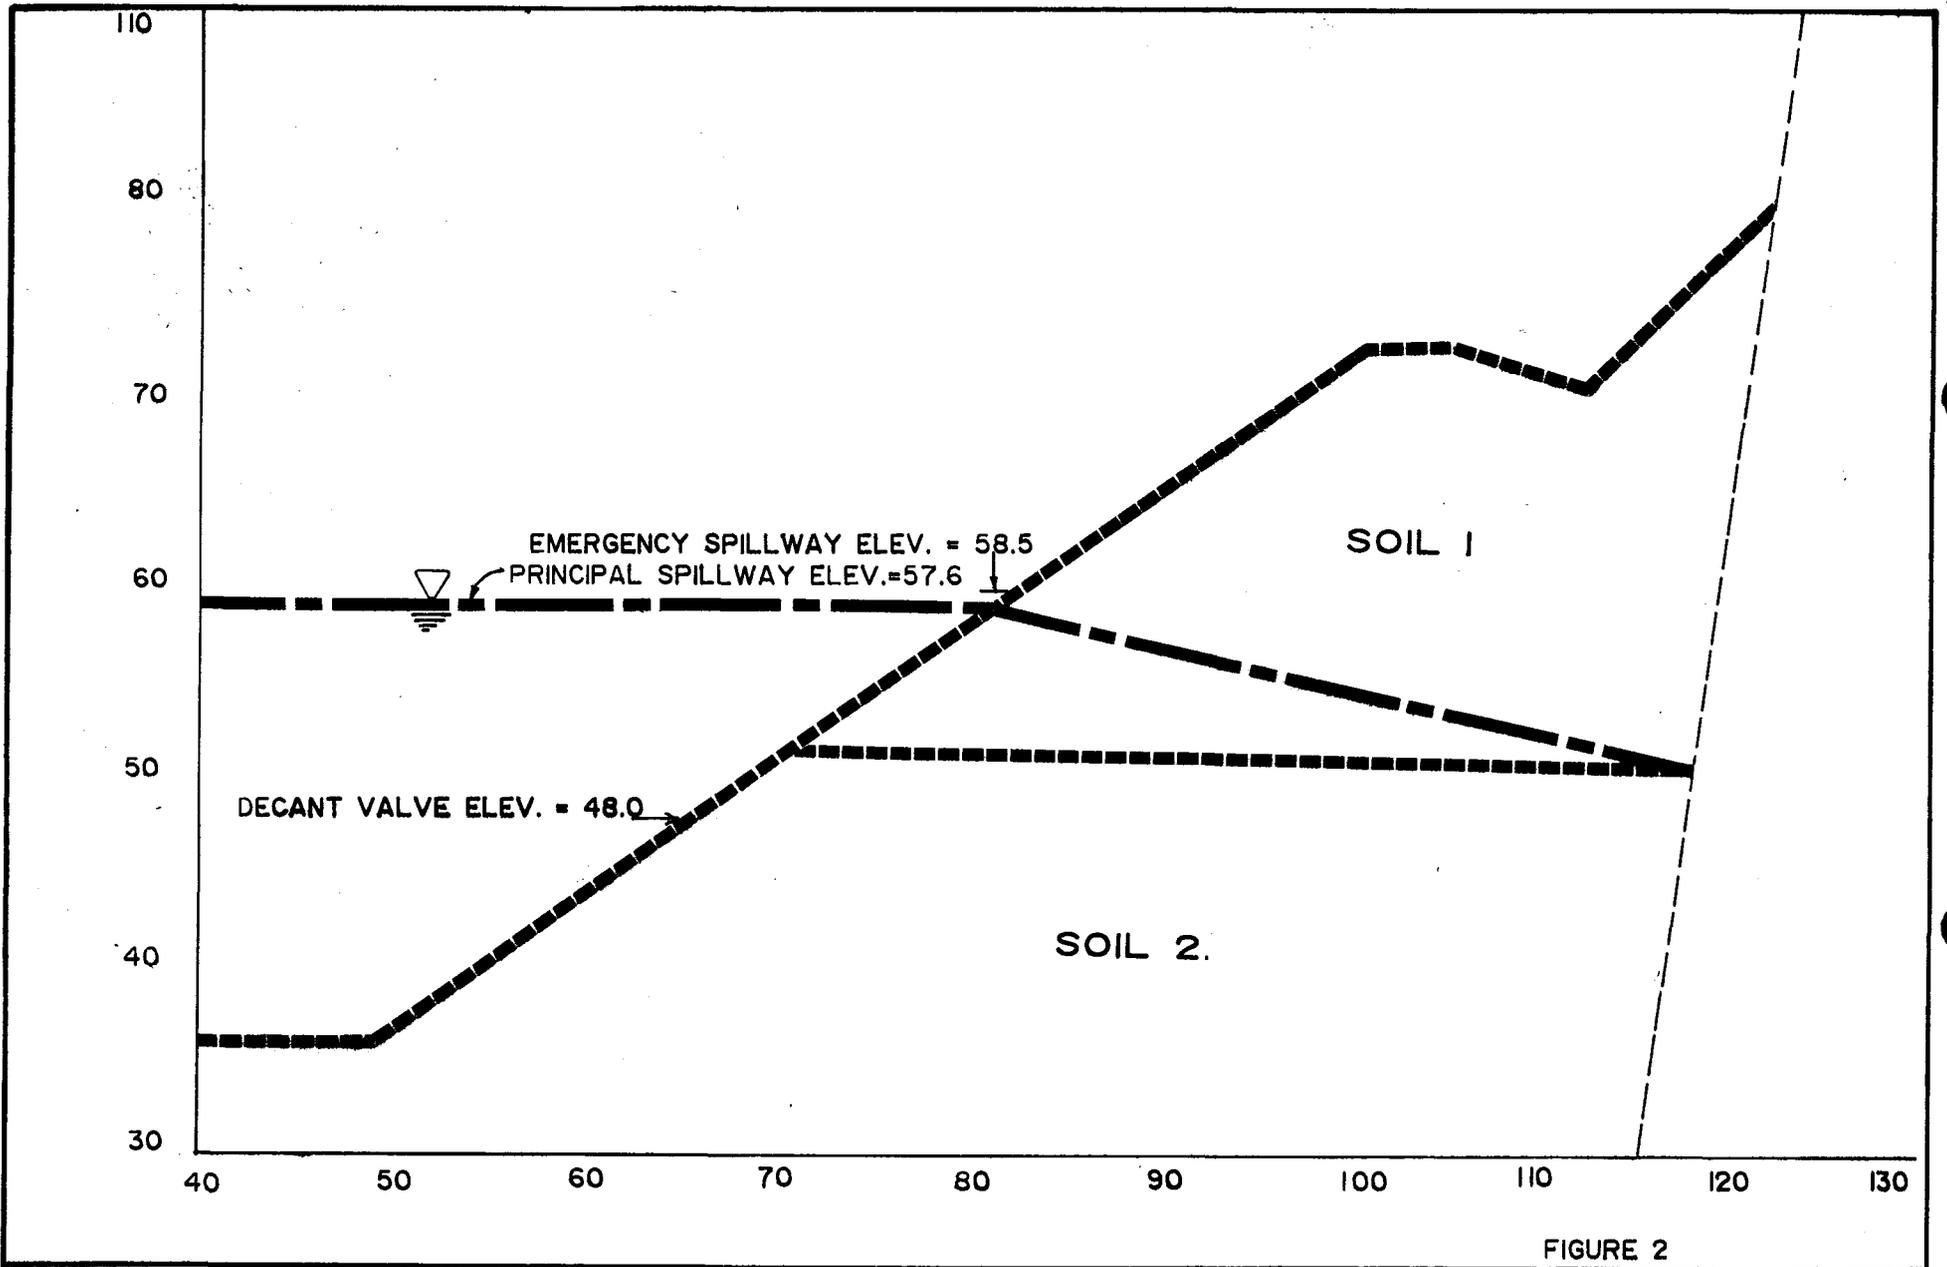
FIGURE 2

The water elevation, assuming steady state seepage, was maintained at the principal spillway elevation. The phreatic surface within the slope, assuming a draining subsurface, falls off to the west at a moderate slope of approximately 4:1, see Figure 2.

The lowest factor of safety obtained in the analysis with the specified configuration and strengths was 1.59. Generally, minimum acceptable factors of safety for long term steady seepage have been recognized as 1.5.

The results of the stability analysis are adequate and indicate a stable section with respect to shear under static loading conditions.
