Mine Site Inspection

Mine Name: Centennial Mine

Permittee: Andalex Resources, Inc.

Inspection Date: December 11, 2012 10:20 – 12:20

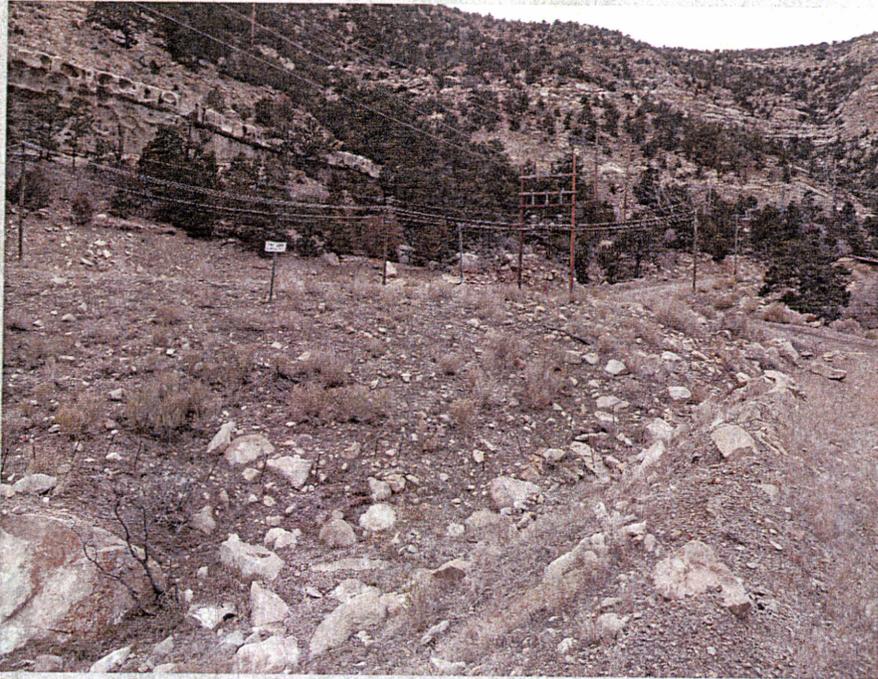
Photo ID: 9375

Topsoil: Salvaged topsoil is stored in several stockpiles on the mine site. Roof bolts have been erected around the base perimeter of the topsoil stockpiles near Pond C. Those bolts appear to have functioned by securing hay bales to the ground for sediment control. Some hay bale remnants remain in place; however, most hay has been removed (see photo 9375). It was unclear whether ARI was permitted to remove the sediment control devices or if the bales need to be replaced. Mr. Leonard indicated he would check whether the bales needed to be replaced and would have them replaced if necessary. There was no evidence of sediment leaving the topsoil stockpiles. Any topsoil to escape the piles would be deposited in Pond C.

Roof bolts used to secure straw bales to ground. Straw has been removed. Please ensure this is in compliance with the approved permit, or replace bales as necessary.

Subject: TOPSOIL STOCKPILE

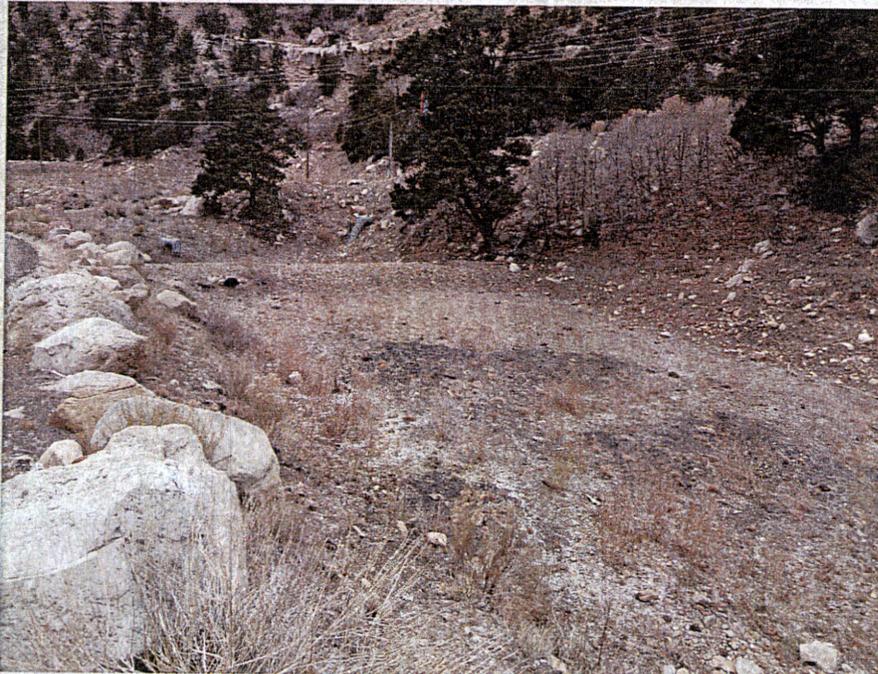
Photo ID: 9376

Hydrology / sediment control: All ponds and diversions were dry at the time of inspection. All diversions were clear and intact. Pond C and Pond B (a 4-celled series) were in good condition. The third cell of Pond B has accumulated sediment to nearly the base of the outlet culvert (see photo 9376). All other cells exhibited greater storage capacity and appear to have been cleaned more recently than the third cell.

All other cells have greater storage capacity.

Subject: SEDIMENT ACCUMULATING IN CELL 3 OF POND B

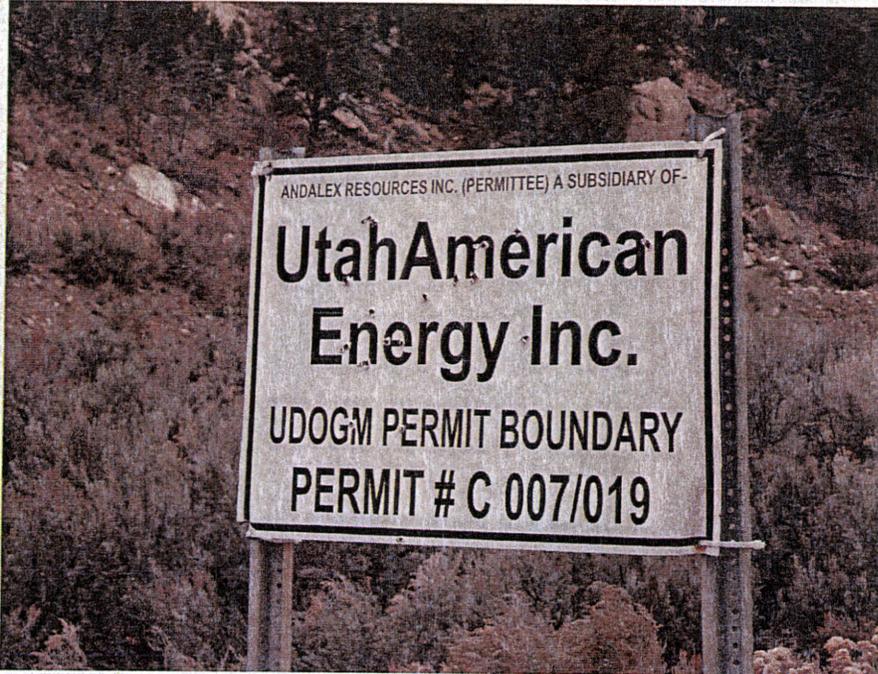
Photo ID: 9377

Signs and markers: All topsoil stockpiles are marked. The mine identification sign posted at the access point from the county road included the permittee name and permit number, but did not include the permittee address and telephone number as required under R645-301-521.243 (see photo 9377). The sign should be updated to comply with regulatory requirements.

Sign includes permittee name and permit number, but does not include permittee address and phone number as required under R645-301-521.243.

Subject: MINE IDENTIFICATION SIGN

No enforcement actions were taken as a result of this inspection. The mine ID sign at the site entrance from the county road should be updated to include the permittee's business address and phone number

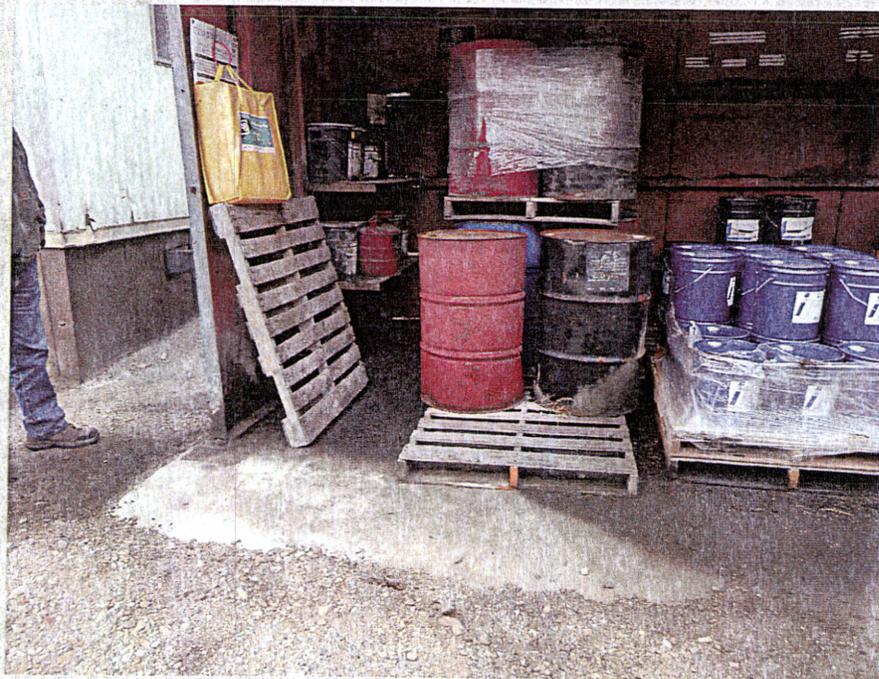
Photo ID: 9378

General compliance: Secondary containment measures around the oil storage shed are in need of improvement. A small berm would impound fluidized waste if spilled, but it may not currently be high enough to contain a 55 gallon spill (see photo 9378). The sides and back of the building are rusting and holes have developed along the bottom of the shed. We discussed building up the berm and extending it around the entire shed. Mr. Leonard indicated he would pursue it. The equipment storage areas are orderly. Large quantities of old machinery, vehicles, and parts have been stored on site for a long time and are deteriorating.

Secondary containment berm in need of maintenance, would benefit from being extended around the entire shed due to rust holes in base of shed.

Subject: OIL STORAGE SHED, SECONDARY CONTAINMENT
