Inspection Report

Permit Number:	C0070019
Inspection Type:	PARTIAL
Inspection Date:	Thursday, June 20, 2013
Start Date/Time:	6/20/2013 9:00:00 AM
End Date/Time:	6/20/2013 2:40:00 PM
Last Inspection:	Wednesday, June 12, 2013

Permittee: **ANDALEX RESOURCES INC**
 Operator: **ANDALEX RESOURCES INC**
 Site: **CENTENNIAL MINE**
 Address: **PO BOX 910, EAST CARBON UT 84520-0910**
 County: **CARBON**
 Permit Type: **PERMANENT COAL PROGRAM**
 Permit Status: **ACTIVE**

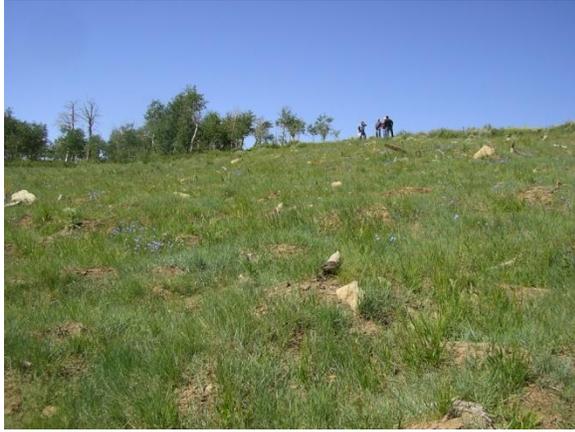
GVH 1 looking W

Seventeen sites were disturbed to enhance the Aberdeen Mines ventilation system; only 14 wells were drilled. GVH 1 in longwall panel #6 and GVH 5 in panel 7 have been plugged and reclaimed. These two sites were observed this day and the Division recommended that the Permittee submit a Phase 1 / Phase 2 bond release application for the associated 1.03 acres.

GVH sites #1 and #5 have been revegetated and the grasses look very good. Herbicide has been utilized to control musk thistle. A few plants were observed at GVH-1.

The Permittee should apply for Phase 1,2,and 3 bond release for well sites GVH's #1 and #5. All well sites are bonded, however the bond amount for some should be re-evaluated. The amount presently posted for wells 1, 3 ,4, 5 ,5A, 6, 7 ,8 and 9 appears quite low.

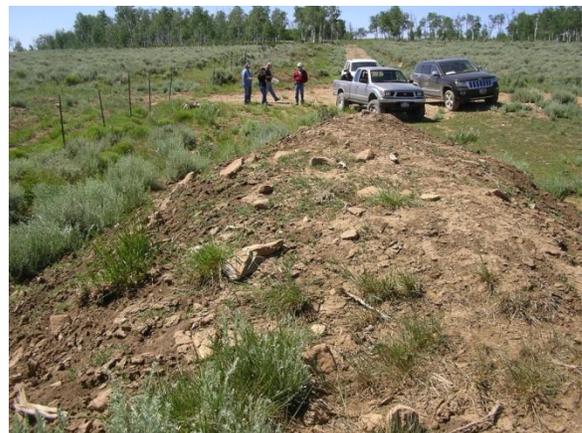
The topsoil pile adjacent to the access for GVH-5 needs to have a topsoil storage sign replaced. It probably was removed by high winds in the area. Mr. Leonard agreed to replace the sign.

Access road topsoil pile needs signage

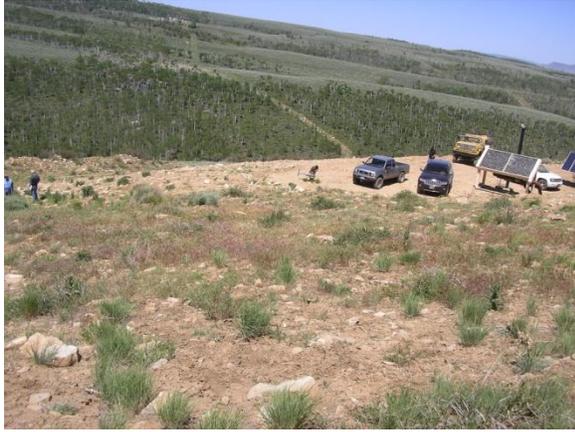
GVH 6 looking N

Well site GVH 6 has been re-graded to reduce the size of the footprint, although some solar panels and CH4 plumbing remain. Spraying of thistle in the area is next, followed by topsoiling of the 0.46 acres. Other well sites which have had the disturbance footprint reduced in size are GVH-9 (Panel 7) , GVH-11 (Panel 10), GVH-6 and GVH-8 (Panel 7), and GVH-12. Wells 12, 13, and 14 (located in Panel 10) have yet to be undermined by the longwall secondary extraction process.

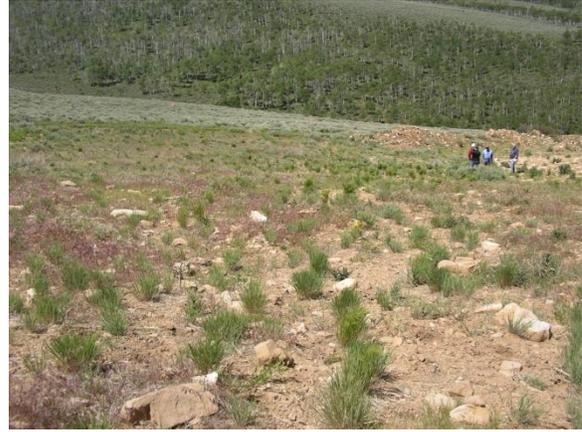
Side slope of GVH 6 needs cheat grass control

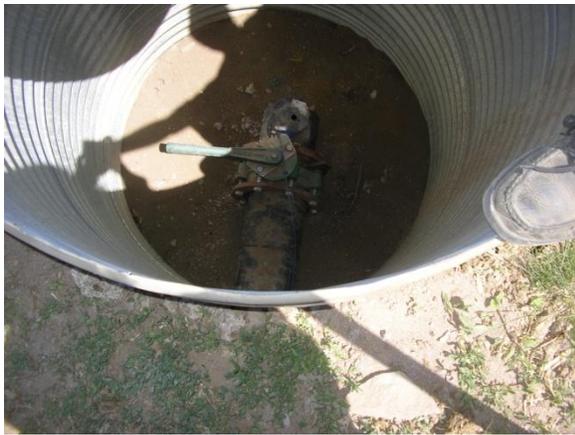
Site 17 valve protective culvert

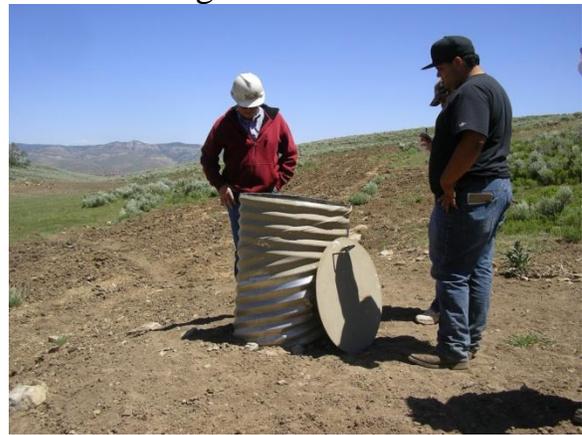
GVH 17 landowner or Blue Tip well?

2012 and spring 2013 contemporaneous reclamation has focused on Mathis lands. Summer and fall work will move to Critelow/Cave owned surface lands. UEI will contact Blue Tip about the stand papas and either retain the pipes with a post-mining landuse change or Blue Tip will remove the valves and stand pipes so that full reclamation can occur.

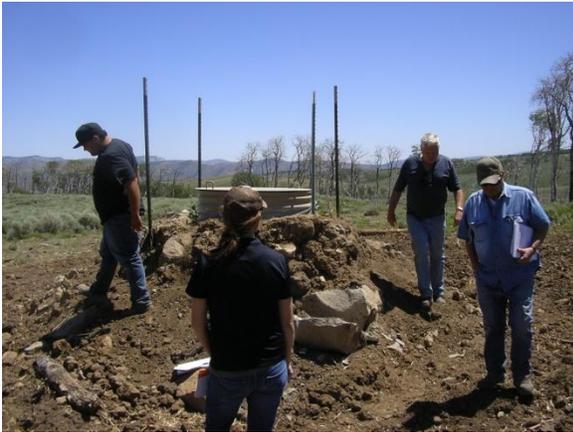
GVH 16 valve and protective culvert

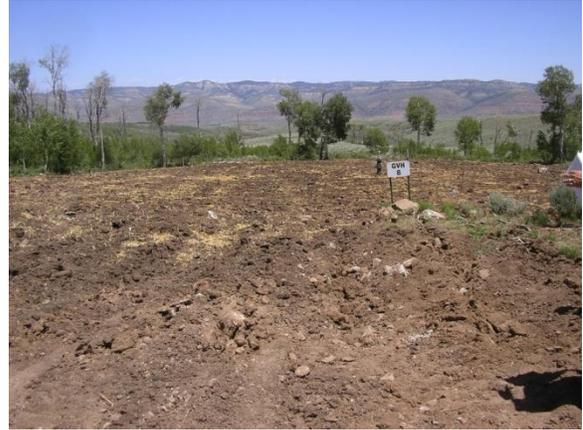
GVH site 8 looking N

GVH sites #7, #8, #9 and #14 are still venting methane to Bluetip Energy.

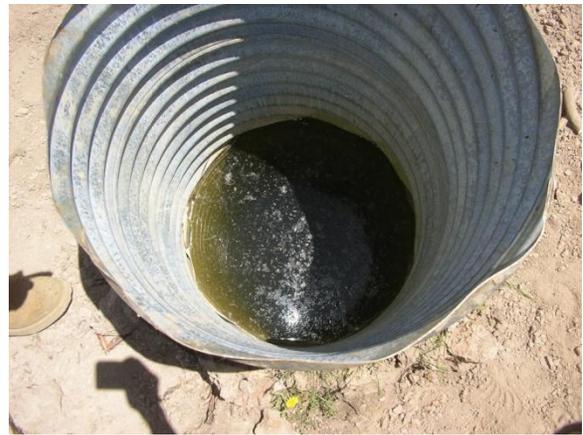
Landowner well near GVH 8?

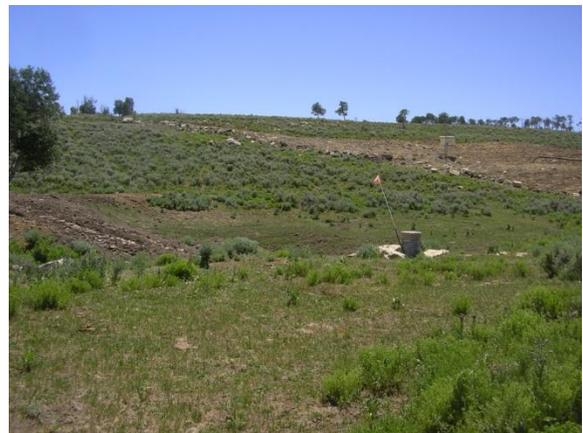
Landowner well near GVH 8A?
