DEPARTMENT OF NATURAL RESOURCES

Division of Oil, Gas and Mining

Inspection Report

Permittee: **ANDALEX RESOURCES INC**
 Operator: **ANDALEX RESOURCES INC**
 Site: **CENTENNIAL MINE**
 Address: **PO BOX 910, EAST CARBON UT 84520-0910**
 County: **CARBON**
 Permit Type: **PERMANENT COAL PROGRAM**
 Permit Status: **INACTIVE**

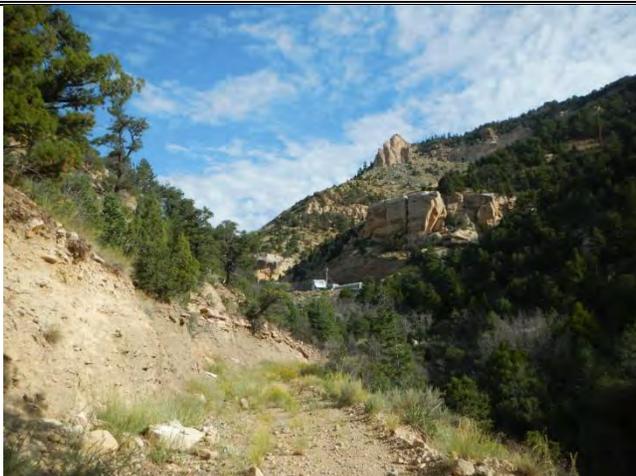
PHOTO 1 Left Fork fan

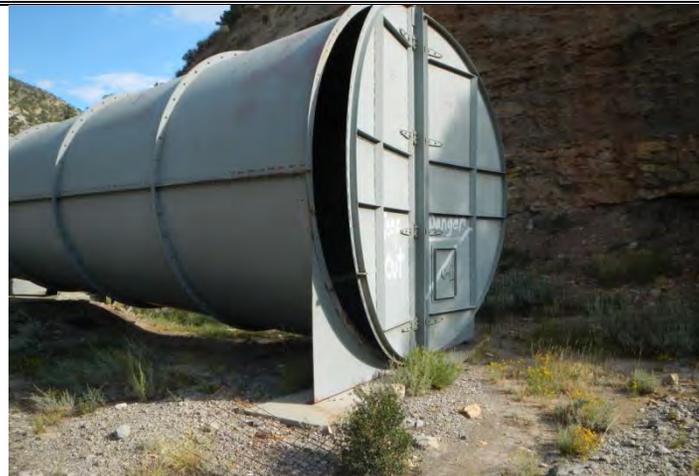
The Left Fork fan installation is inactive. The fan portal is sealed and power is disabled. Water is puddled in front of the stoppings. The site berm is stable.

PHOTO 2 Left Fork fan sealed

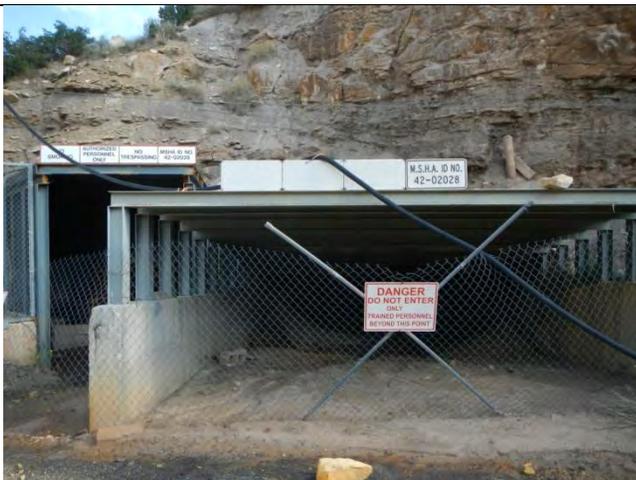
PHOTO 3 two sealed portals

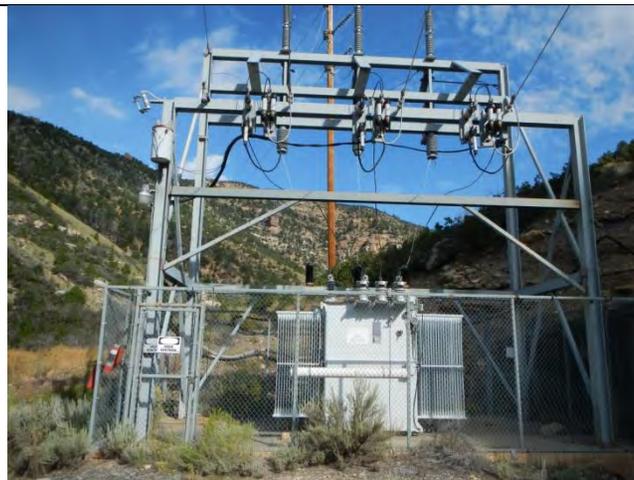
PHOTO 4 Left Fork substation

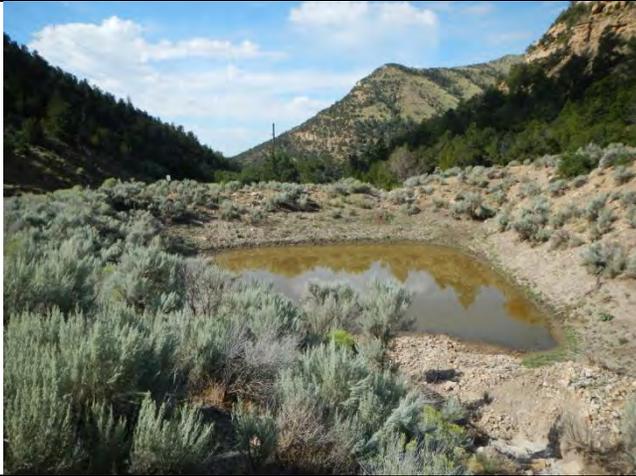
PHOTO 5 Sediment pond E

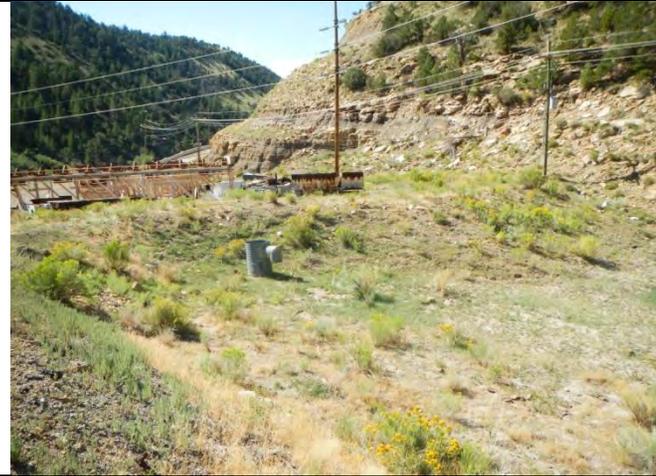
PHOTO 6 Sediment pond C

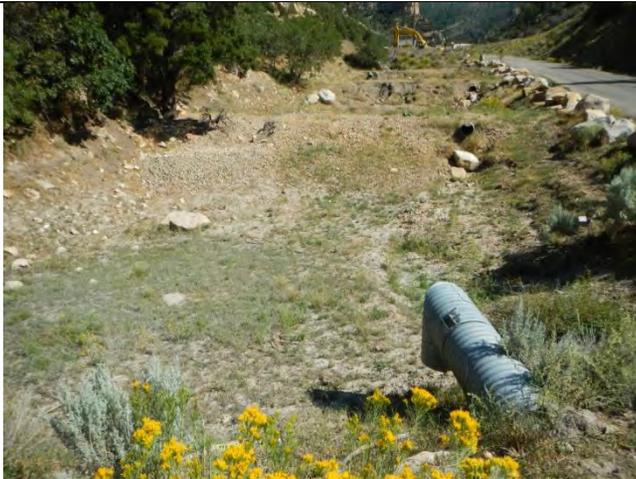
PHOTO 7
Catch basin B cell 4

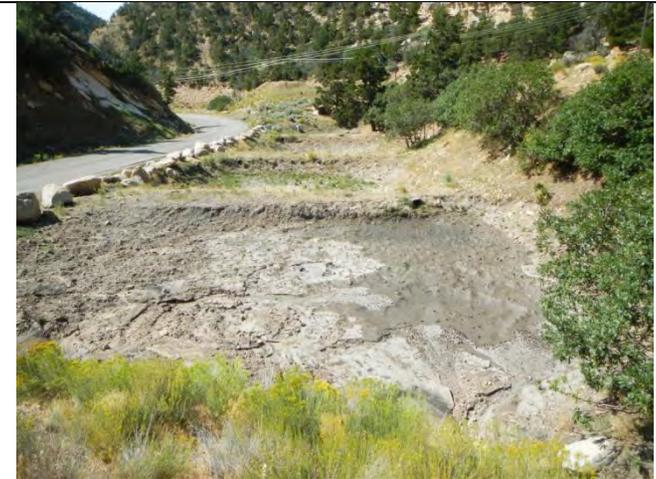
PHOTO 8
Catch basin B cell 1

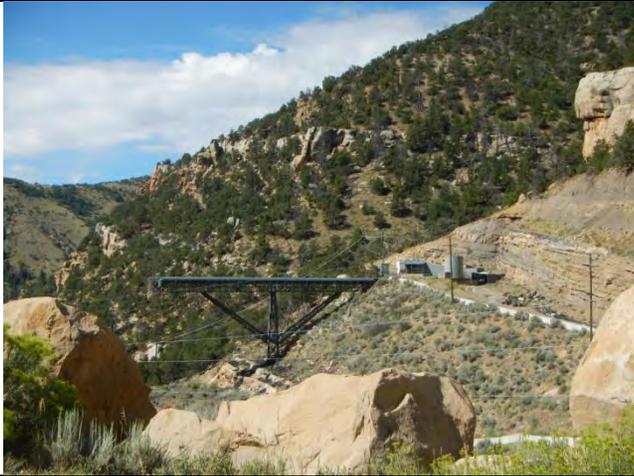
PHOTO 9
Aberdeen Mine from Admin. Bldg

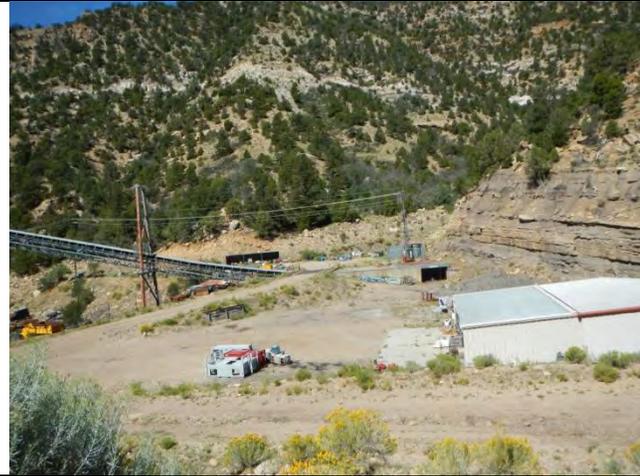
PHOTO 10
Apex fan portals, PR 9 and loadout

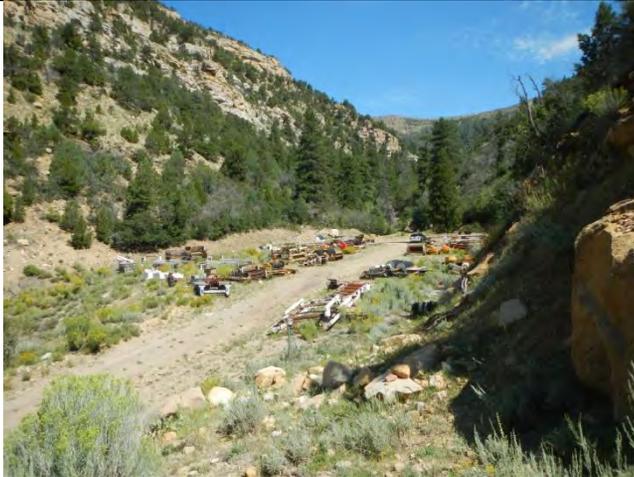
PHOTO 11
Material storage N of PR 2 road

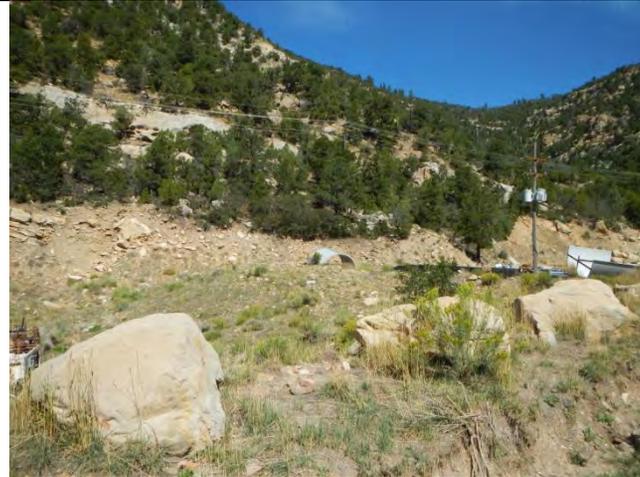
PHOTO 12
Substitute topsoil slope below Apex loadout

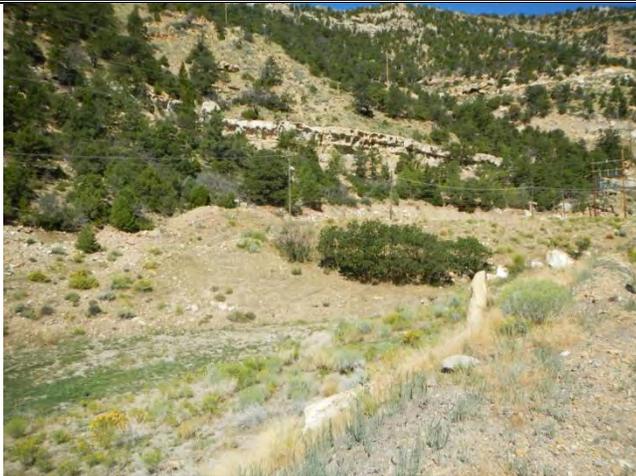
PHOTO 13
Topsoil pile G at N end of Sediment pond C

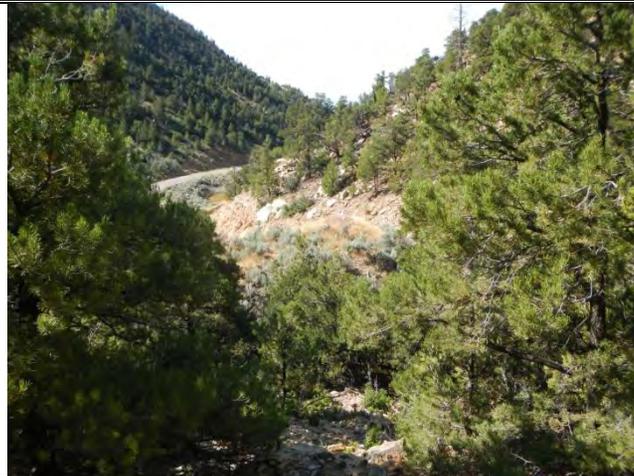
PHOTO 14
Topsoil pile J

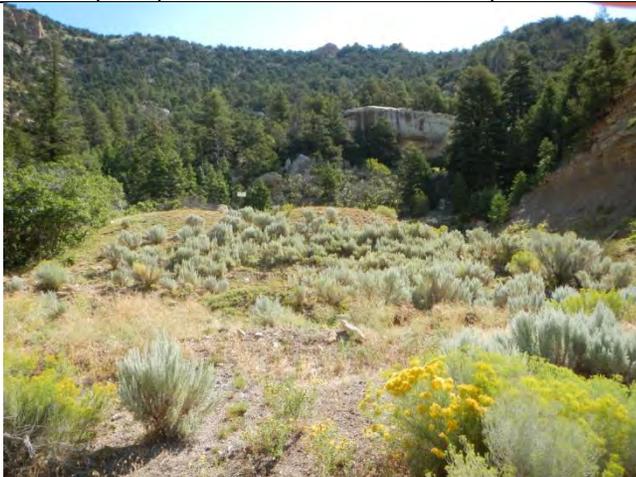
PHOTO 15
Topsoil pile A

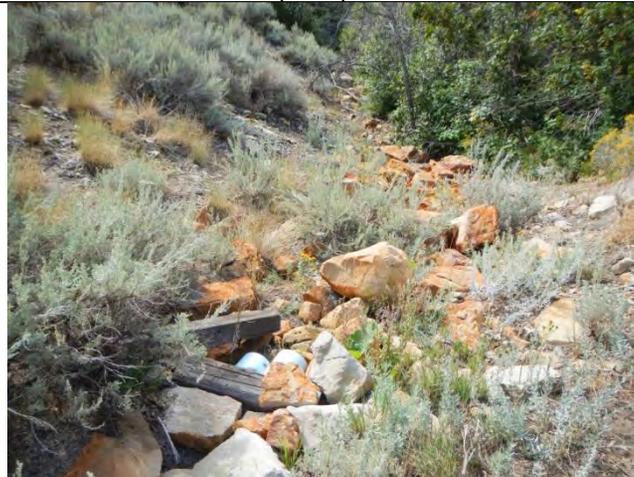
Ephemeral stream sampling location Site 18-3 is just below the Left Fork facilities. Site 18-3 was photographed; the stream was dry. Well #1 is in the mine yard near the fuel storage. Fourth quarter 2016 water monitoring was reviewed by the Division hydrologist. (Internal 7/29/2017).

PHOTO 16
Monitoring site 18-3 Left Fork

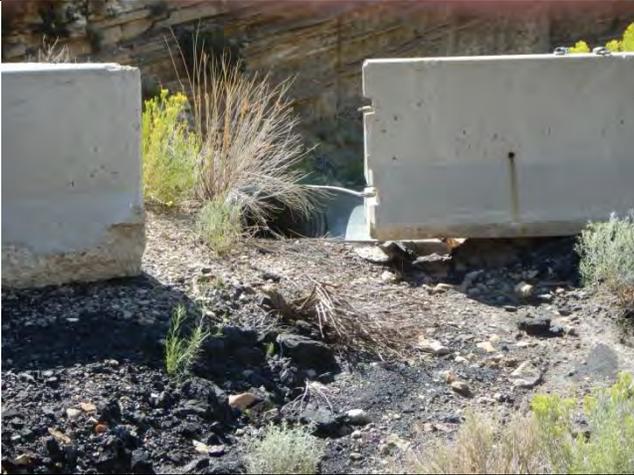
PHOTO 17

Culverts were clear except for an accumulation of sediment in the culvert at the Aberdeen Mine loadout entrance and at the Administrative Office entrance. Flow to culvert at the SE end of the Aberdeen storage yard was being undercut and requires re-setting the culvert. At the North end of the Aberdeen material storage yard, the berm has been undercut and requires repair. A similar hole was noted in the berm at the NE end of the Pinnacle mine storage yard. These maintenance issues must be completed before November 30, 2017.

Flow circumventing culvert in SE corner Aberdeen coal storage yard

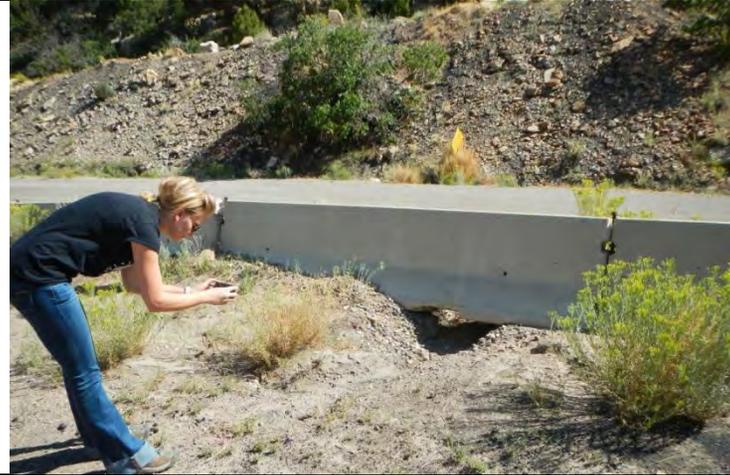
PHOTO 18

Erosion beneath cement berm to PR1 ditch below Aberdeen material storage yard

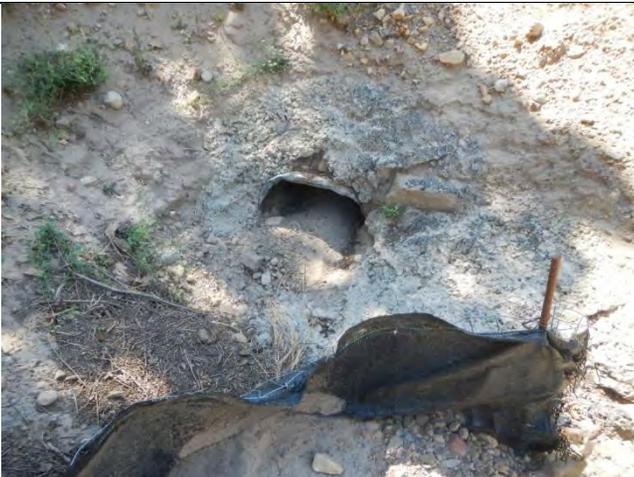
PHOTO 19

Blocked culvert on PR 1 at PR6 intersection

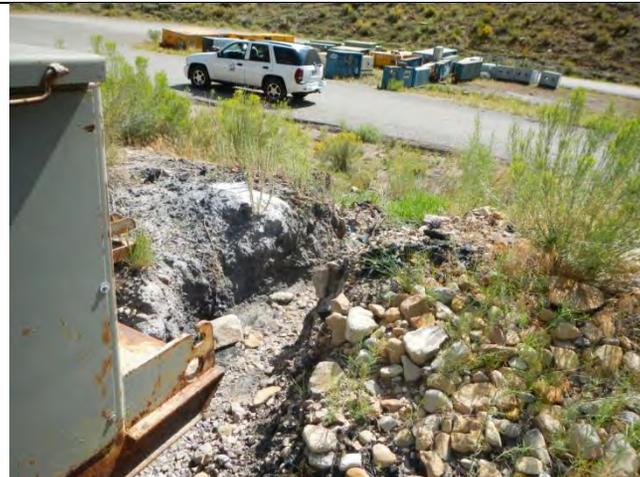
PHOTO 20

Erosion in berm Pinnacle Mine storage yard above PR 4.

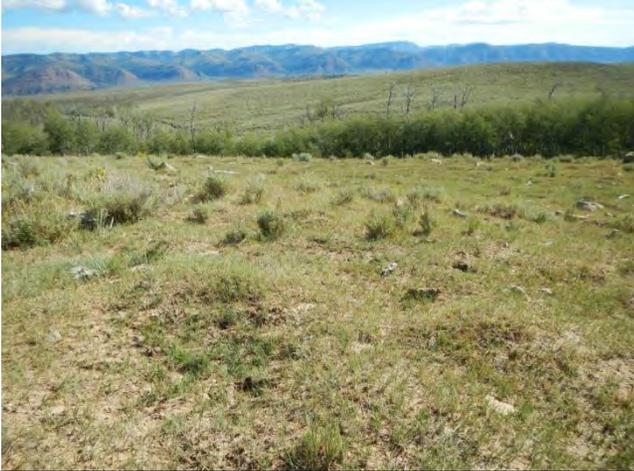
PHOTO 1 GVH 1 (fenced 5 years, now down)

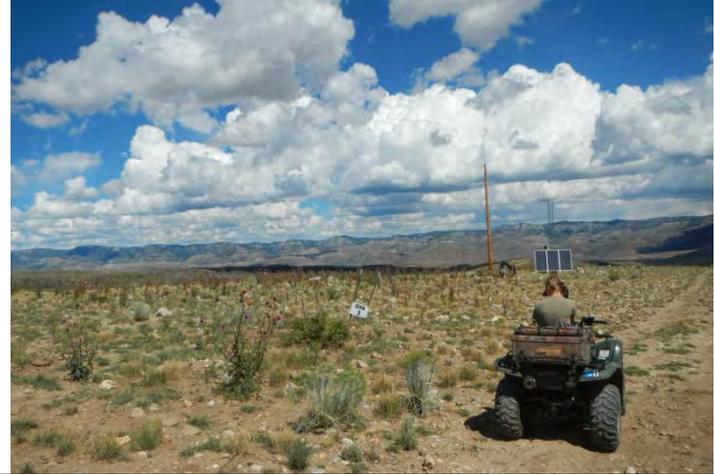
PHOTO 2 GVH 3 (no fence, active status?)

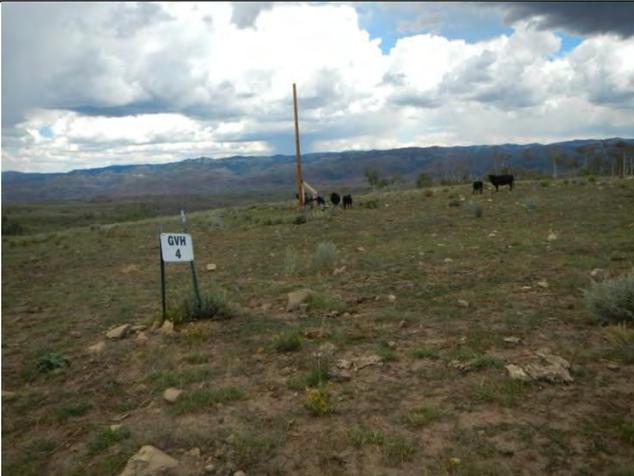
PHOTO 3 GVH4(not fenced, active status?)

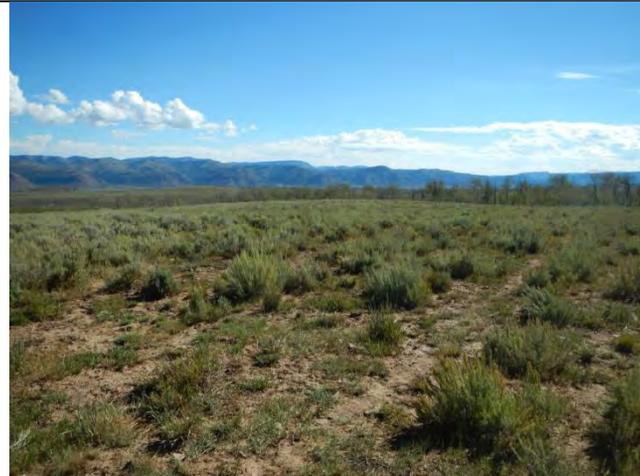
PHOTO 4 GVH 5 (fenced 5 yrs , now down)

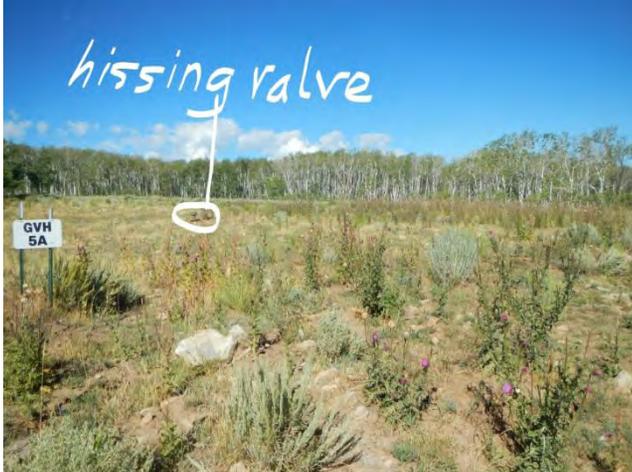
PHOTO 5 GVH 5A (not fenced, active status?)

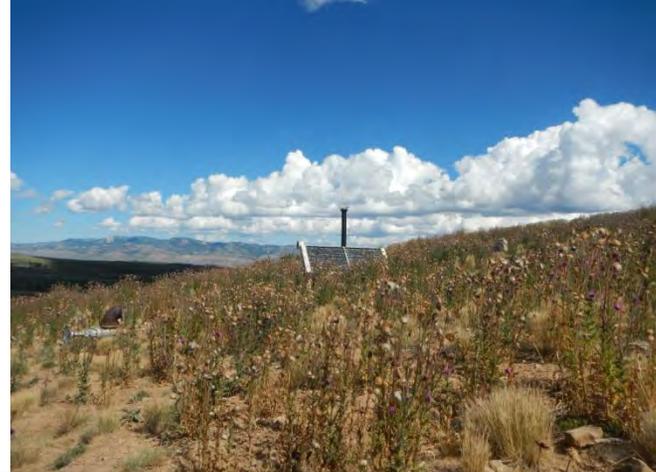
Topsoil piles photographed. Remaining topsoil pile at GVH #6 is covered with thistle.

PHOTO 6 GVH 6 (not fenced, active status?)

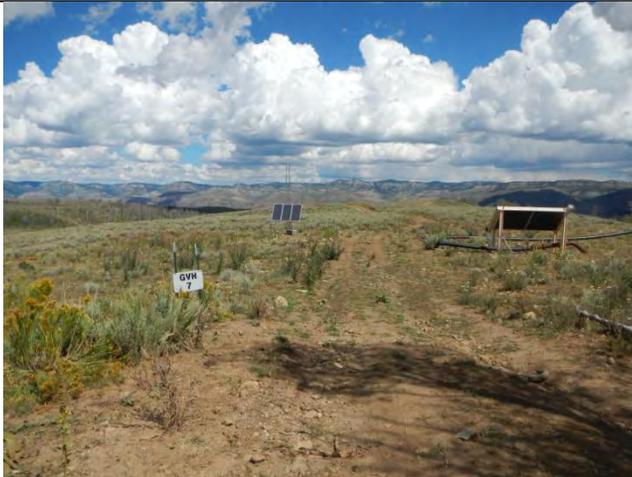
PHOTO 7
GVH 7 (not fenced, active status?)

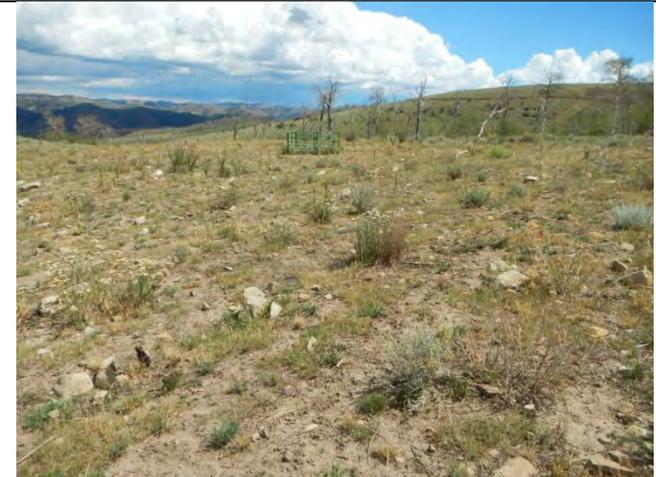
PHOTO 8
GVH 7A (not fenced, active status)

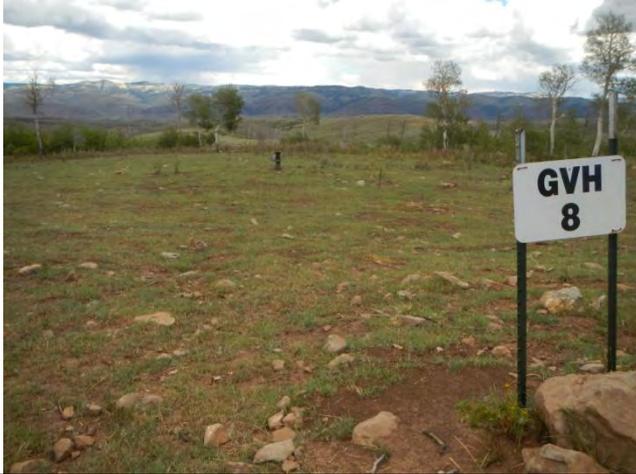
PHOTO 9
GVH 8 (not fenced, active status?)

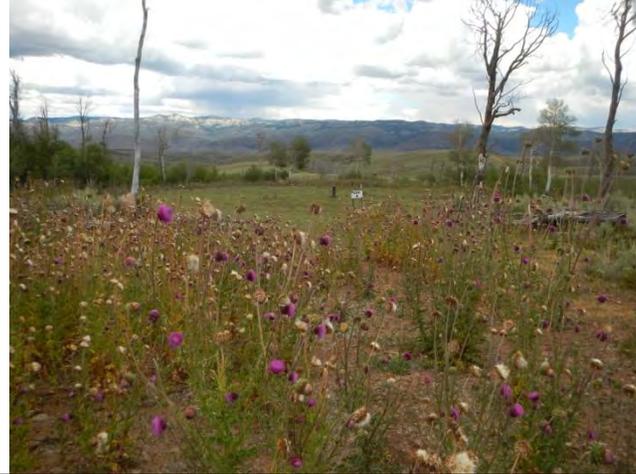
PHOTO 10
Road between GVH 8 & GVH 8A

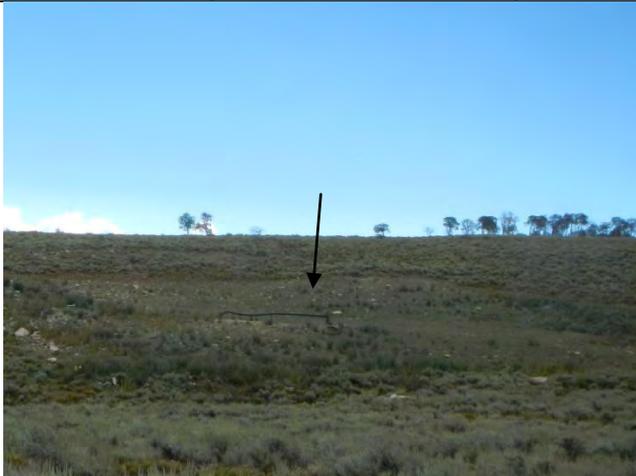
PHOTO 11
GVH 8A (not fenced, active status?)

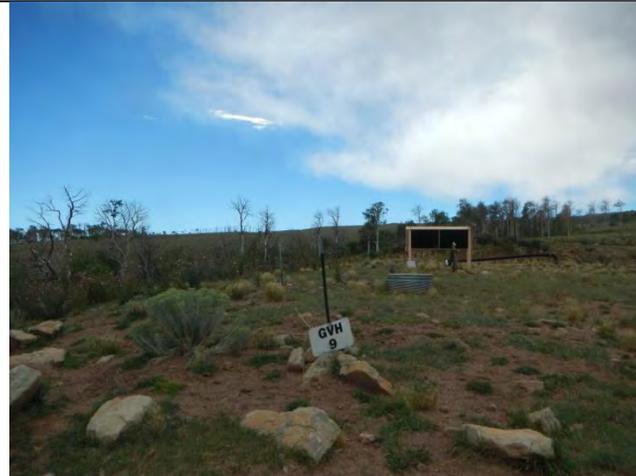
PHOTO 12
GVH 9 (not fenced, active status?)

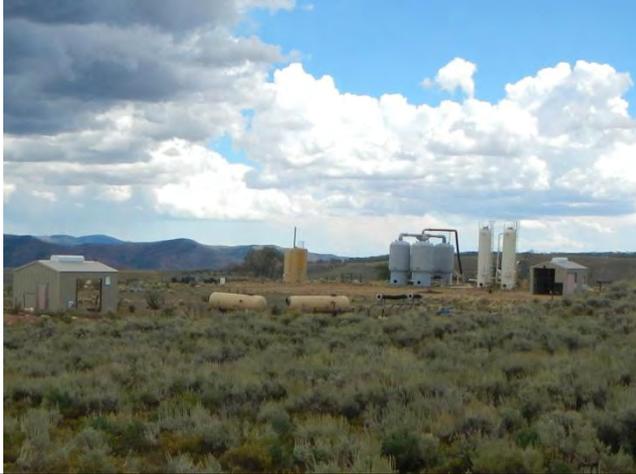
PHOTO 13

Compressor station adjacent to GVH 9, active status?

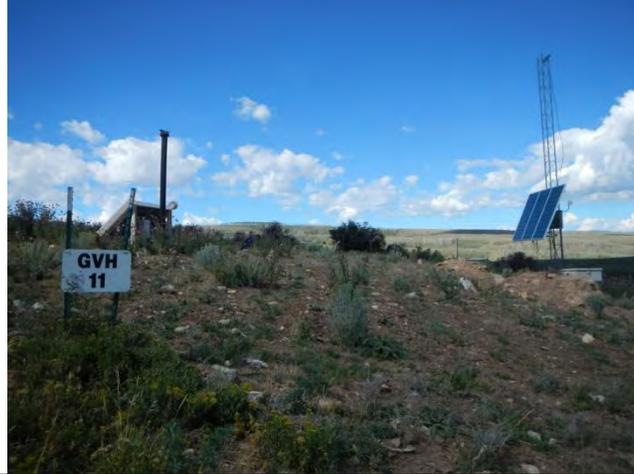
PHOTO 14

GVH 11 (not fenced, active status?)

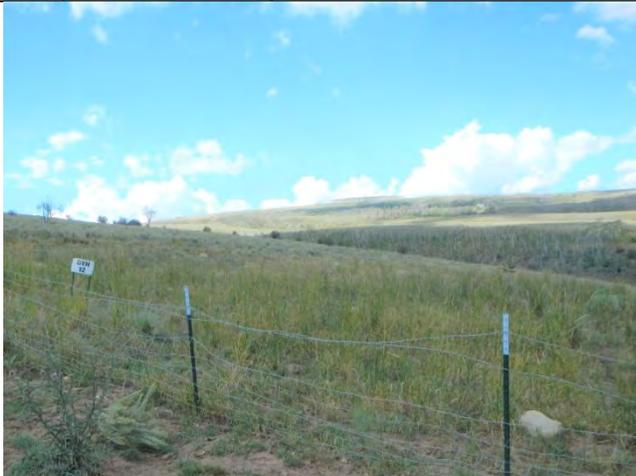
PHOTO 15

GVH 12 (fenced)

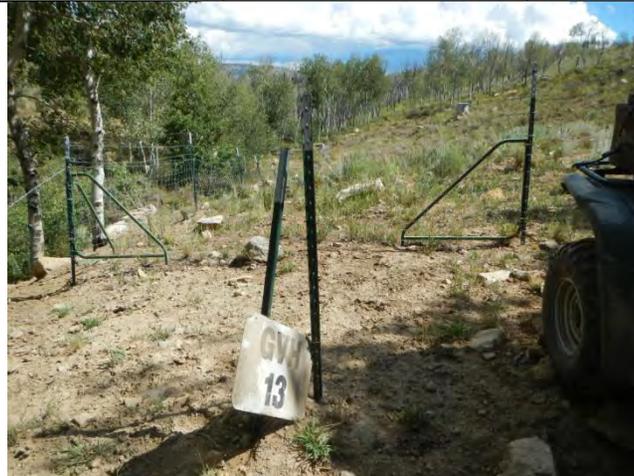
PHOTO 16

GVH 13 (fenced, gate open)

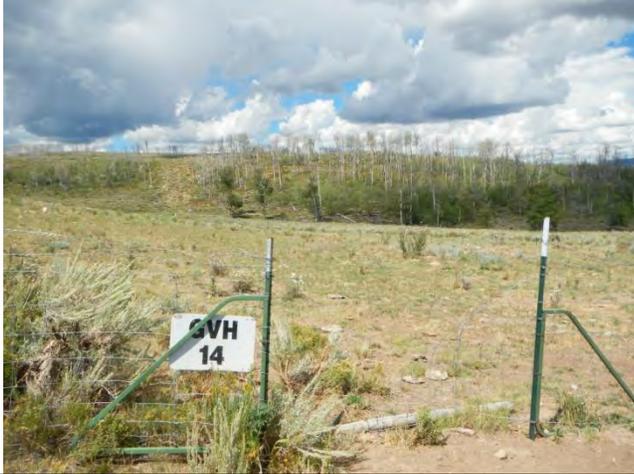
PHOTO 17
GVH 14 (fenced, gate open)

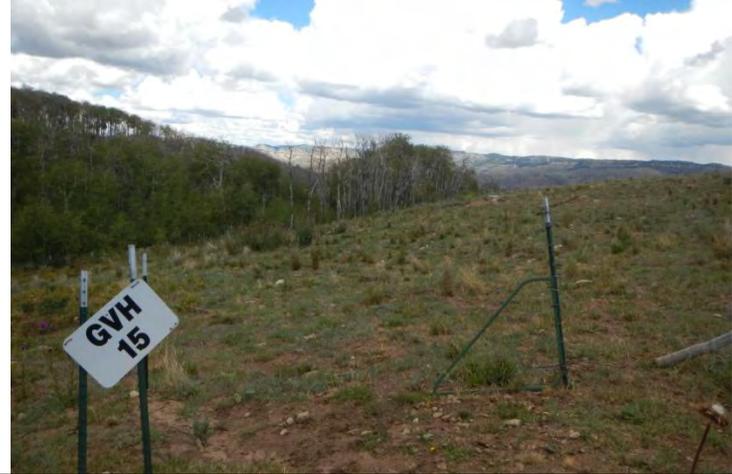
PHOTO 18
GVH 15 (fenced, gate open)

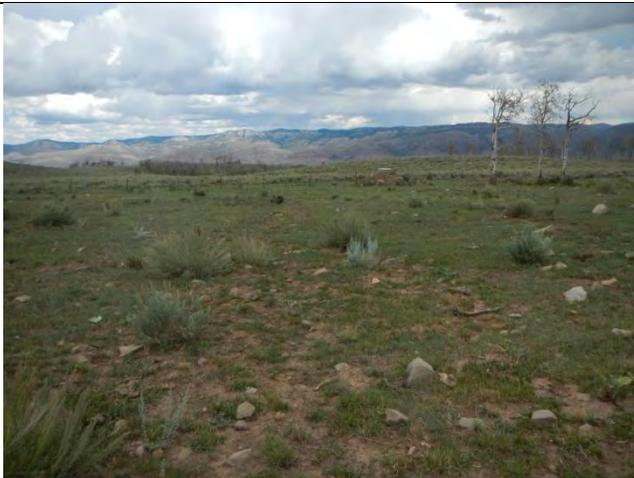
PHOTO 19
GVH 16 (fenced, gate open)

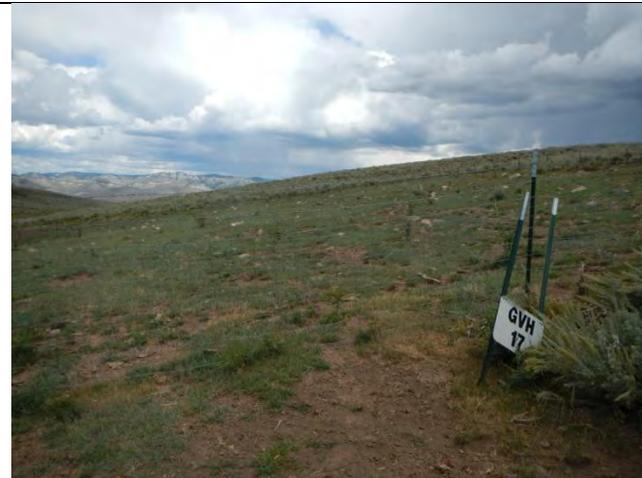
PHOTO 20
GVH 17 (fenced, far NW corner down)

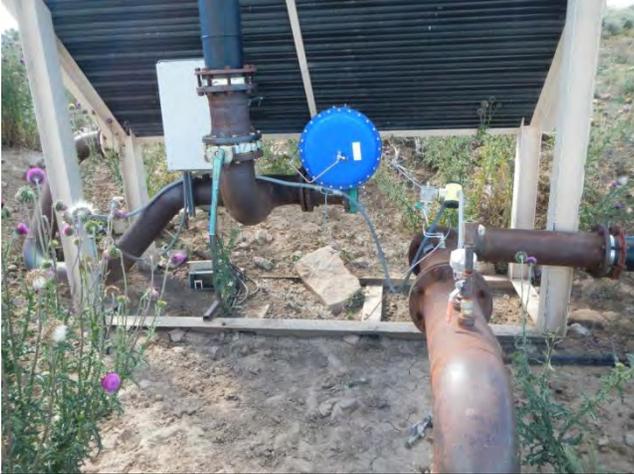
PHOTO 13

Example of pipes and valves remaining on sites with questionable status

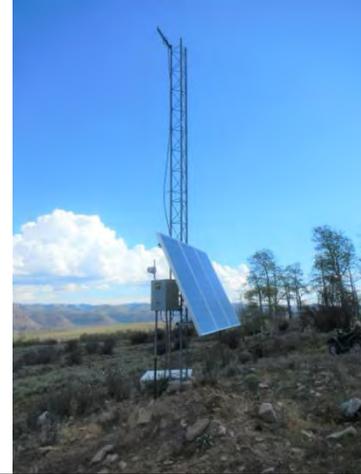
PHOTO 14

Example of solar panel remaining on sites with questionable status

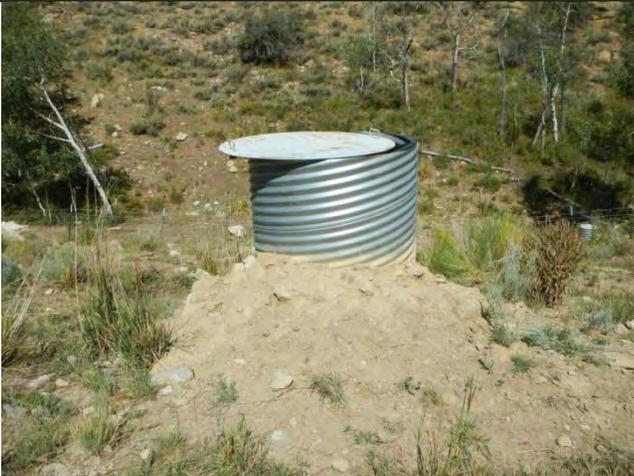
PHOTO 15

Example collection culvert remaining on all sites

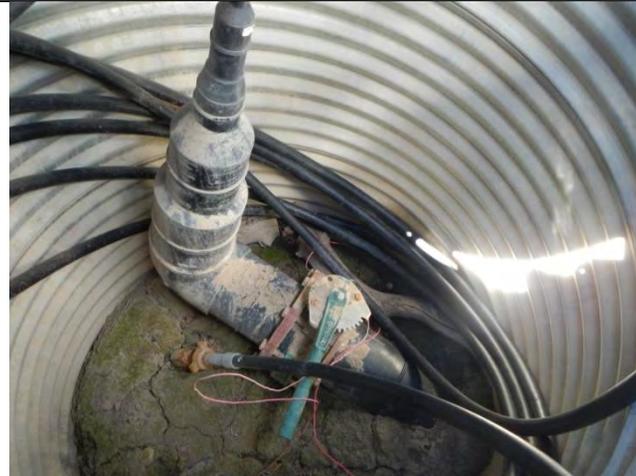
PHOTO 16

Inside collection culvert

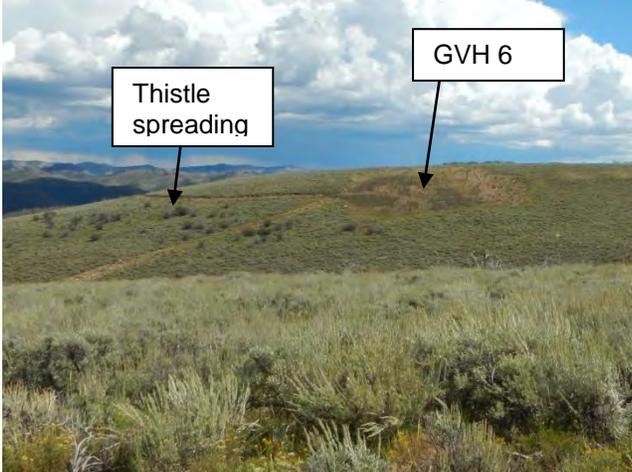
PHOTO 13

Grazing of reclaimed GVH sites has been detrimental to the reclamation of the sites. Musk thistle is spreading from the GVH sites to adjacent undisturbed lands and to access roads.

Thistle on GVH sites is spreading across the plateau.

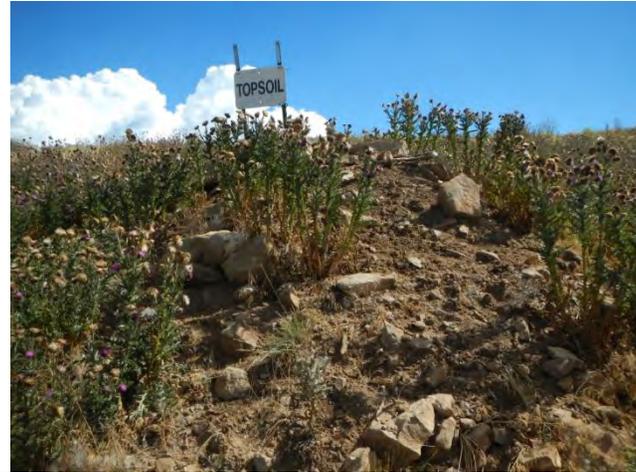
PHOTO 14

Must thistle control

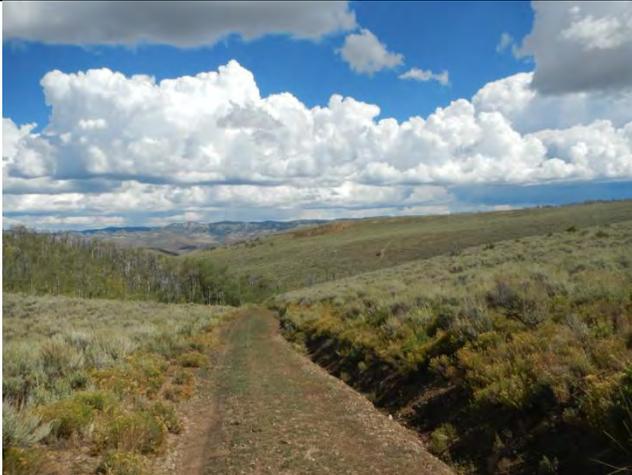
PHOTO 15

Degas well access road sediment logs are filled to capacity. Road wash has cut a large gully at the entrance to the bypass culvert at the North end of the facilities yard. Spur roads to GVH sites do not have sediment control. The roadside ditch on the access road to GVH 13 was incised due to erosion. The access road to GVH 12 was eroded.

No sediment control on access roads to GVH sites

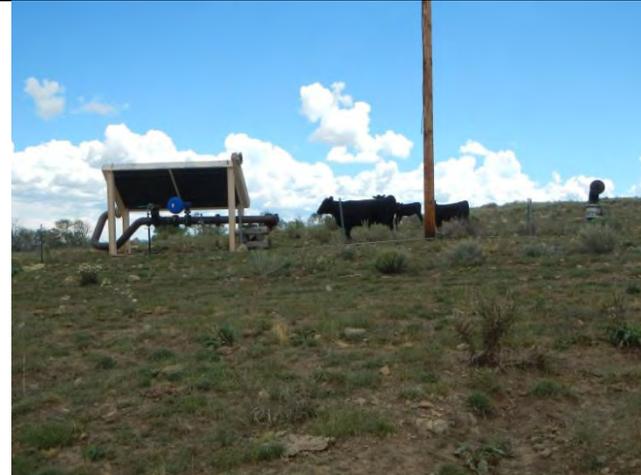
PHOTO 16

Uncontrolled grazing at unfenced and fenced sites.
