# State of Utah

Division of Oil, Gas and Mining

## Inspection Report

Permittee: **ANDALEX RESOURCES INC**  
Operator: **ANDALEX RESOURCES INC**  
Site: **CENTENNIAL MINE**  
Address: **PO BOX 910, EAST CARBON UT 84520-0910**  
County: **CARBON**  
Permit Type: **PERMANENT COAL PROGRAM**  
Permit Status: **INACTIVE**

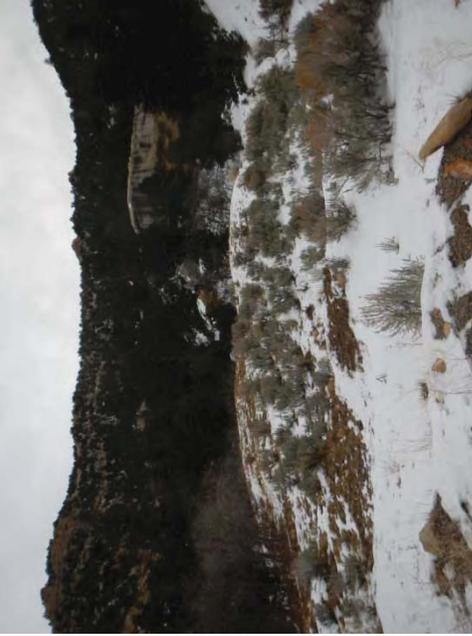
**PHOTO 1** Topsoil Pile A

Stockpiles A, C, G, & F were photographed, as was the topsoil substitute slope below the Apex loadout. (Topsoil stockpile J was not photographed.)

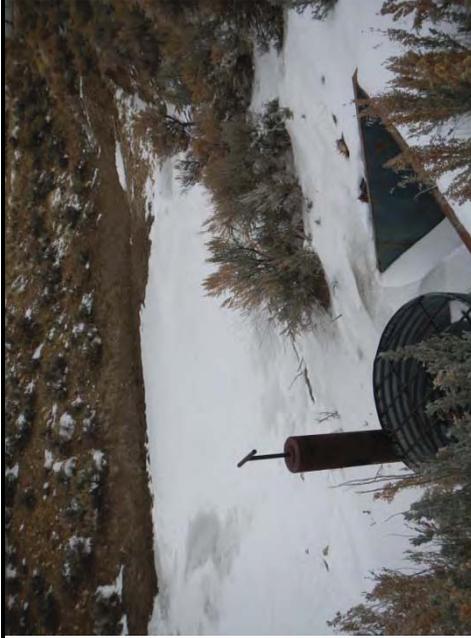
**PHOTO 5** Sediment pond E

All ponds were dry. Ponds E, C and catchment basin B were photographed. Maintenance is required on Catchment B cells #2 and #4, because their upstream embankments have eroded. This erosion is likely due from melting snow pack and rains. Clearly, it is not due to overflow from the cells above, which rarely hold water high enough to reach the primary spillway, let alone overflow the cell.

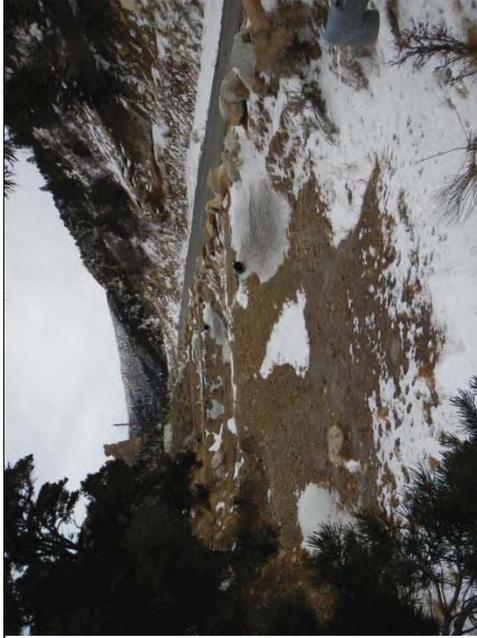
**PHOTO 7**

Looking upstream at Catch Basin B cell 4

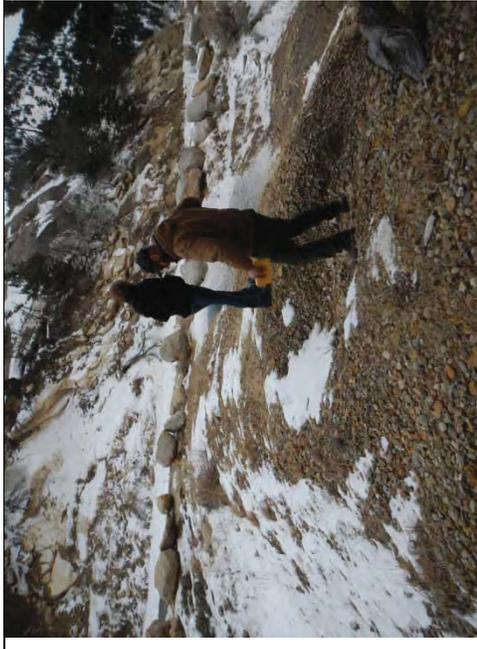
**PHOTO 8**

Erosion inside embankment Cell 4 of Catch basin B

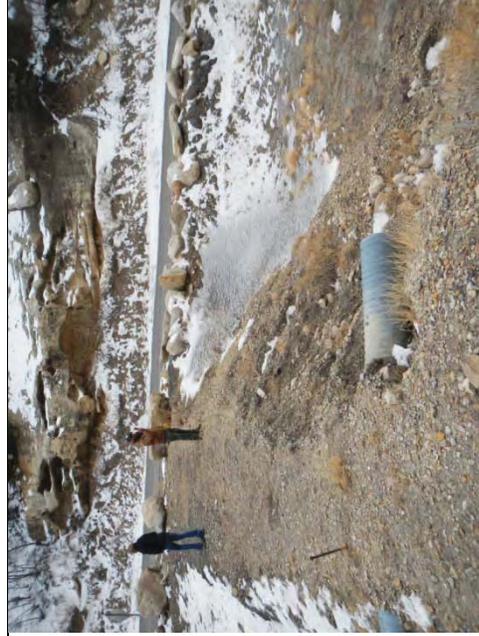
PHOTO 9 Erosion inside embankment Cell 2 of Catchbasin B

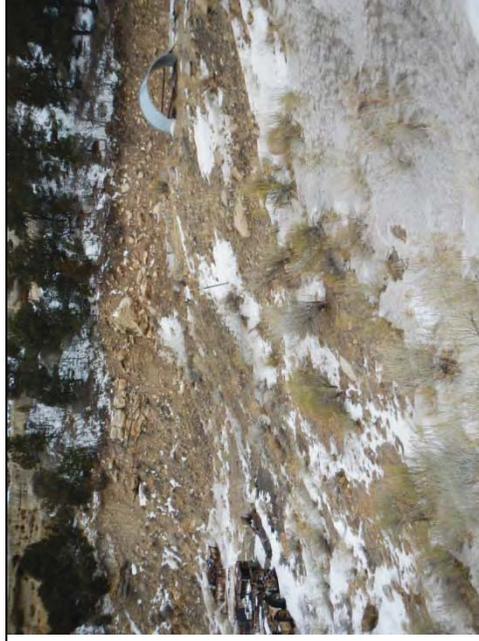
PHOTO 12 substitute topsoil outslope below Apex Mine
