Inspection Report

Permit Number:	C0070019
Inspection Type:	COMPLETE
Inspection Date:	Wednesday, March 20, 2019
Start Date/Time:	3/20/2019 11:00:00 AM
End Date/Time:	3/20/2019 1:00:00 PM
Last Inspection:	Monday, December 17, 2018

Permitee: **ANDALEX RESOURCES INC**
 Operator: **ANDALEX RESOURCES INC**
 Site: **CENTENNIAL MINE**
 Address: **PO BOX 910, EAST CARBON UT 84520-0910**
 County: **CARBON**
 Permit Type: **PERMANENT COAL PROGRAM**
 Permit Status: **INACTIVE**

ATTACHMENT A – Centennial Mine Complete inspection, March 20, 2019

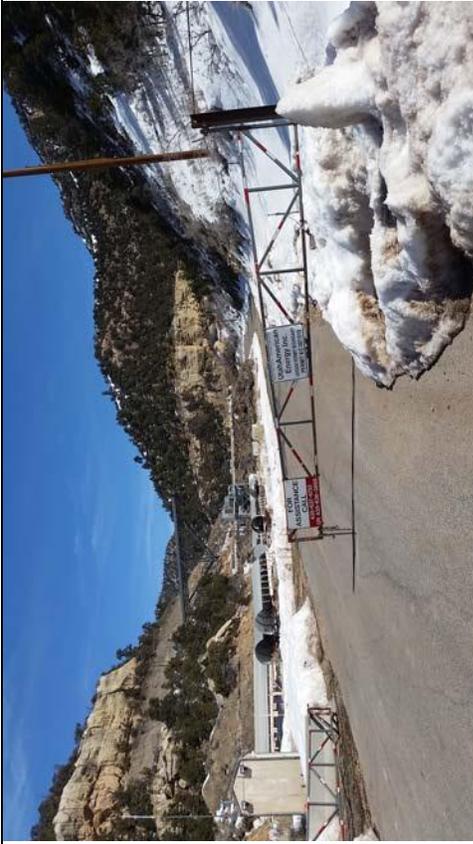
PHOTO 1 – GATED ENTRANCE

This gate is located on the primary road into the site.

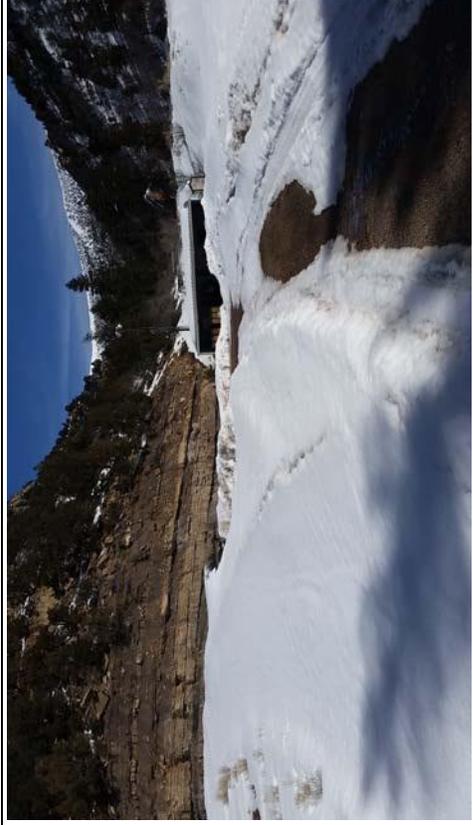
PHOTO 2 – APEX MINE OFFICES

The roads have been plowed and are accessible all of the way up to the Apex Mine, but no further. Permittee plans to perform maintenance on the primary roads in the Spring once the snow clears and roads aren't so muddy.

The snow had been cleared from the roads as far as the old Apex Offices.

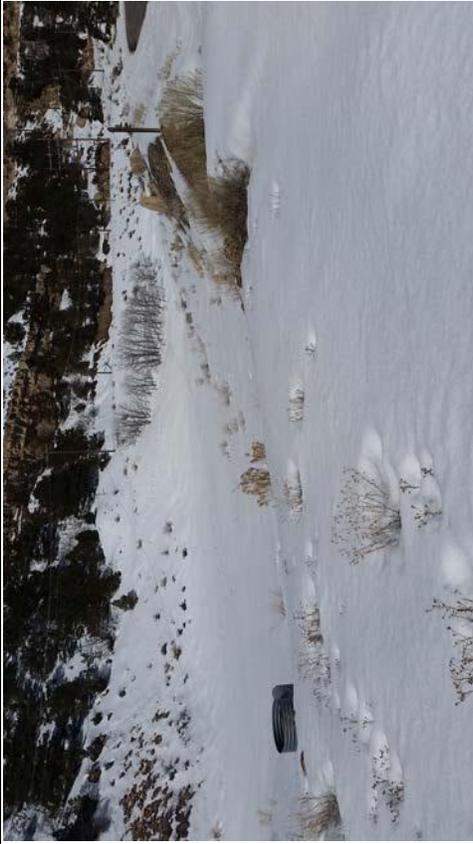
PHOTO 3 – SEDIMENT POND C

The most recent pond inspection was conducted on 10/25/2018, and was reviewed and signed by Tom Paluso, P.E. Most of the ponds on site were either frozen or dry throughout the first quarter. The culverts and sediment markers are still currently buried by snow.

Most drainages and ponds were still covered with a thick blanket of snow.

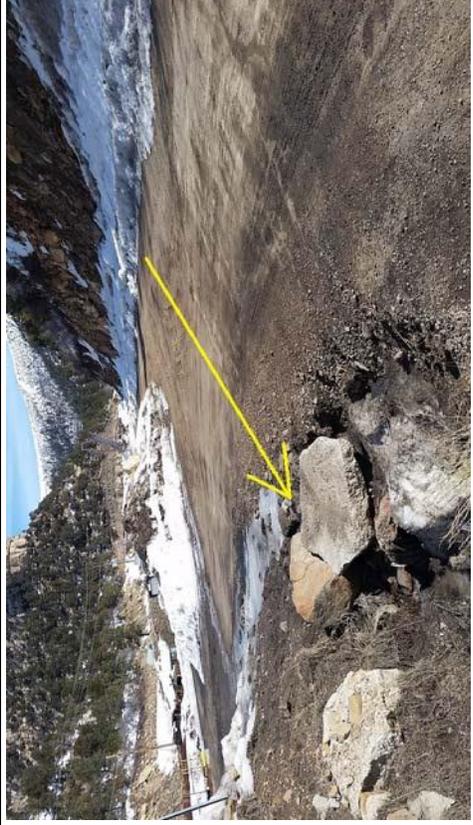
PHOTO 4 – ORPHANED CULVERT

Most diversions are still covered by snow and ice, although a few south-facing diversions are beginning to emerge. One such diversion is where primary road PR-2 passes in front of the shop/warehouse for the Pinnacle Mine. There is an orphaned culvert that emerges where culvert CD-8 crosses beneath the road and continues south on the west side of PR-2. The orphaned culvert is only slightly visible as it is mostly covered by mud at this time. Plate 8 within the MRP does not account for this culvert, and Permittee had plans for Scamp Construction to remove it in late January. Unfortunately, Scamp was unable to remove the culvert at that time due to unforeseen difficulty, and plans to return are pending.

The yellow arrow indicates the location of the orphaned culvert described in the inspection report.
