# Inspection Report

Permit Number:	<b>C0070019</b>
Inspection Type:	PARTIAL
Inspection Date:	Thursday, July 16, 2020
Start Date/Time:	7/16/2020 8:30:00 AM
End Date/Time:	7/16/2020 3:00:00 PM
Last Inspection:	Tuesday, June 9, 2020

Permittee: **ANDALEX RESOURCES INC**  
 Operator: **ANDALEX RESOURCES INC**  
 Site: **CENTENNIAL MINE**  
 Address: **PO BOX 910, EAST CARBON UT 84520-0910**  
 County: **CARBON**  
 Permit Type: **PERMANENT COAL PROGRAM**  
 Permit Status: **INACTIVE**

Centennial Mine Degas Well Inspection 7/16/2020

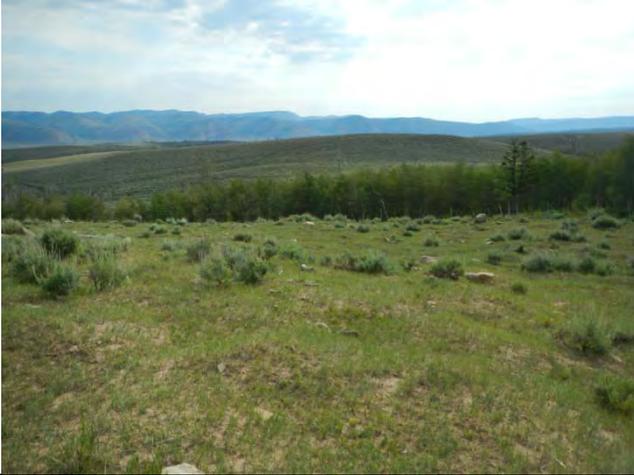
GVH1

A weed control program is in place. Musk thistle is the dominant noxious weed under control. The weed contractor (SCAMP Excavation) is using GlyStar Plus (glyphosate) and Agri Star 2,4-D Amine 4 in combination. During the inspection a crew was spraying at site 8A. We observed that sites 1, 5, 5A, road to 6, site 6, road to site 11, site 11, road to site 12, site 8A, site 9, and site 17 require weed control. The road to site 8A had been sprayed recently.

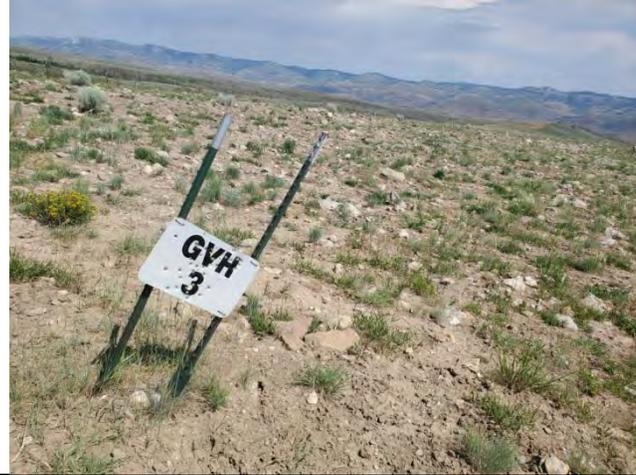
GVH 3

Grazing is causing considerable damage to the revegetation of sites 3, 4, 7, 7A, 8, 8A, 9, 15, 16, and 17 (see attached photos). These sites are fenced, but the fences have been breached. Cows have grazed the grasses down to the crown, limiting their ability to develop into robust, reproducing plants in the short growing season. Cows also carry the thistle and stickseed from site to site. Heavy grazing of desirable plants is selecting for less desirable species, such as squirrel tail grass. Ms. Madsen has contacted the landowner to no avail.

Final grading at sites sites 3, 4, 5A, 6, 7, 7A, & 11 and access roads to sites 6, 11 and 12 was finished in the fall of 2019. Final seeding at sites 3, 4, 5A, 6, 7, 7A, & 11 and access roads to sites 6, 11 and 12 was completed in May 2020.

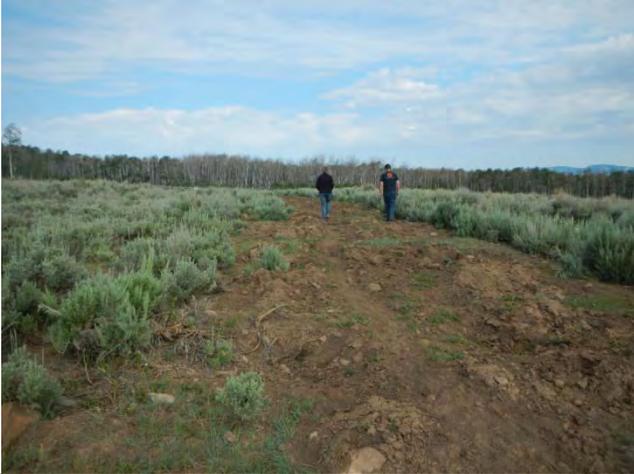
GVH 5A access road

Access roads to sites 1, 5A, 6, 11, 12, 15, and 17 have been reclaimed. The access road through site 4 to sites 8 and 8A will be reclaimed when the wells at GVH pads 8 and 8A are reclaimed.

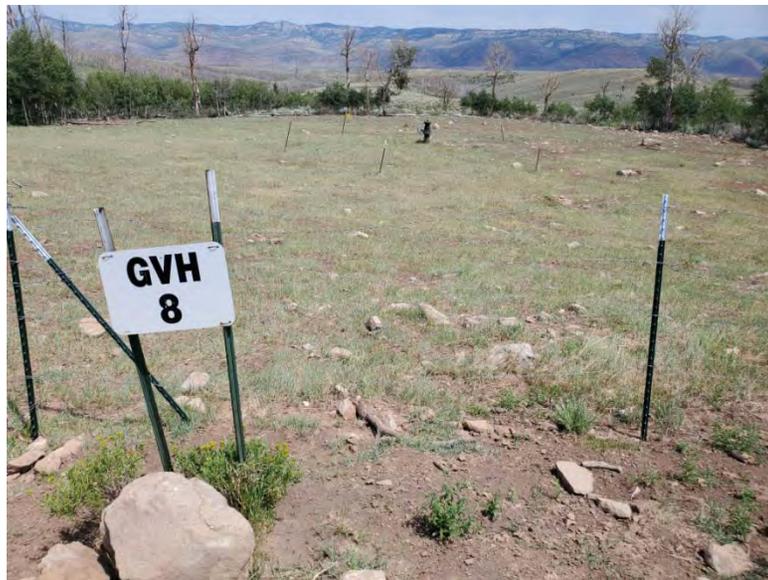
GVH 8

Well valves remain at GVH 8, GVH8A, GVH 9. The wells are temporarily capped. No wells are currently in production. The compressor station was idle.

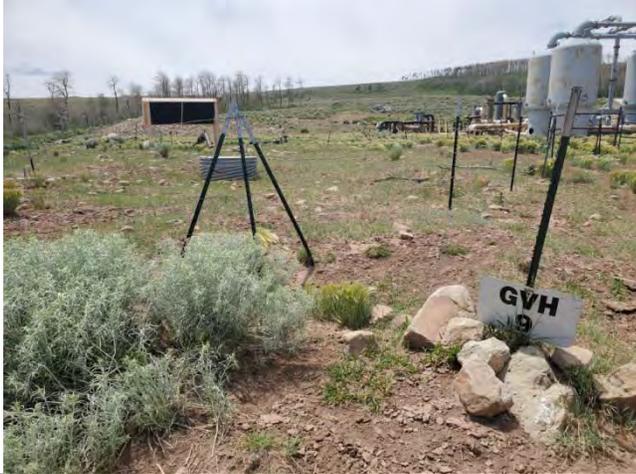
GVH 9

There is a topsoil pile at degas well pad #9. This stockpile needs weed control.

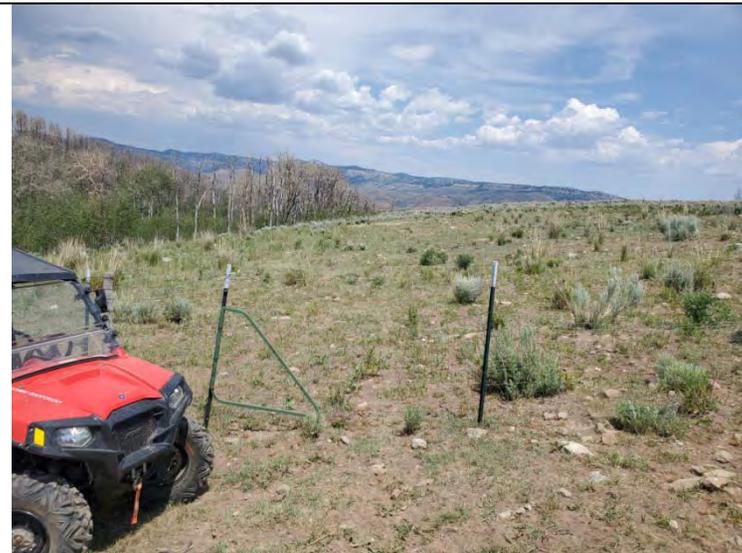
GVH 15

All sites, except Site 15, are signed.

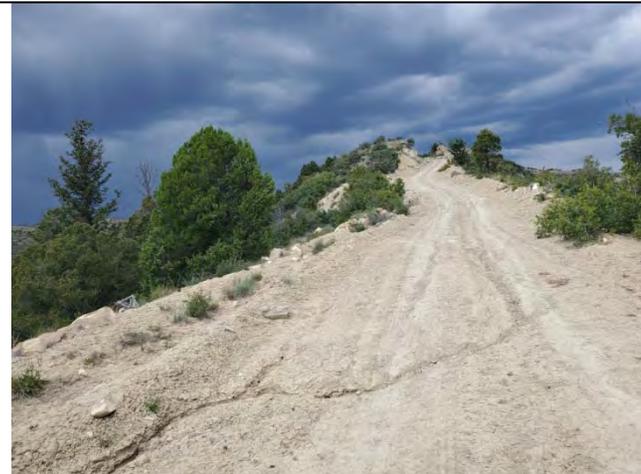
The water bars along several sections of the Deadman Canyon access road are in need of maintenance and repair, particularly in the switchbacks and upper reaches of the road. Anywhere that water bars exist or where runoff has otherwise been diverted has completely washed out the Excelsior logs and silt fences that were previously installed, causing sediment to deposit on the slopes beneath the road. Since this road will be retained through reclamation, erosion and siltation must be maintained as per R645-301-534.150.

The access up the Right Fork of Deadman Canyon is a primary road, because it is to be retained for post mining land use (R645-301-527.123). R645-301-742.423.1 requires that sediment control be maintained on this road. There are many drainage structures on this road that require maintenance.

Sediment control maintenance required on the R. Fk. Deadman Cyn access road
