State of Utah
 DEPARTMENT OF NATURAL RESOURCES
 DIVISION OF OIL, GAS AND MINING

November 7, 1997

RE: NOV N97-45-1-1 Amendment, Horizon Coal Corporation, Horizon Mine,
 ACT/007/020-97F, Folder #2, Carbon County, Utah

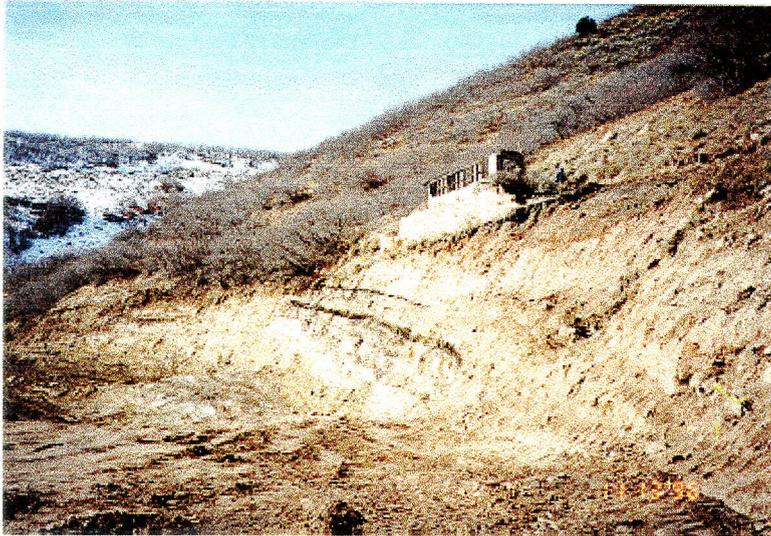
- If soil was left, why is this soil part of the recovery and placement calculations?
 - Photographs from last fall (Figure 1 of this TA) show that all north, northwest hills located adjacent, immediately above the Portal Canyon pad and below the soil stockpile were disturbed during the 1996 fall construction

period. Figure 8-2 clearly shows that no soil was salvaged from these slopes, yet the photograph (TA Figure 1) clearly shows that these hillsides were affected during construction. Therefore, if these slopes were affected during construction, why wasn't soil salvaged?

- Since the amendment states that the hill will remain undisturbed, how can this statement be rectified since these north, northwest hills were disturbed?

Figure 1. 11/13/96, Horizon Mine. ACT/007/020 on-site inspection . DOGM personnel - Robert Davidson and Paul Baker. North, northwest cut slopes created during fall, 1996 construction. Photo taken from the base of the soil stockpile, looking down Portal Canyon. The entire slope from the base of the stockpile to the mouth of Portal Canyon has been affected.
