Inspection Report

Permit Number:	C0070020
Inspection Type:	PARTIAL
Inspection Date:	Wednesday, July 15, 2015
Start Date/Time:	7/15/2015 11:00:00 AM
End Date/Time:	7/15/2015 11:45:00 AM
Last Inspection:	Thursday, June 11, 2015

Permitee: **HIDDEN SPLENDOR RESOURCES**

Site: **HORIZON MINE**

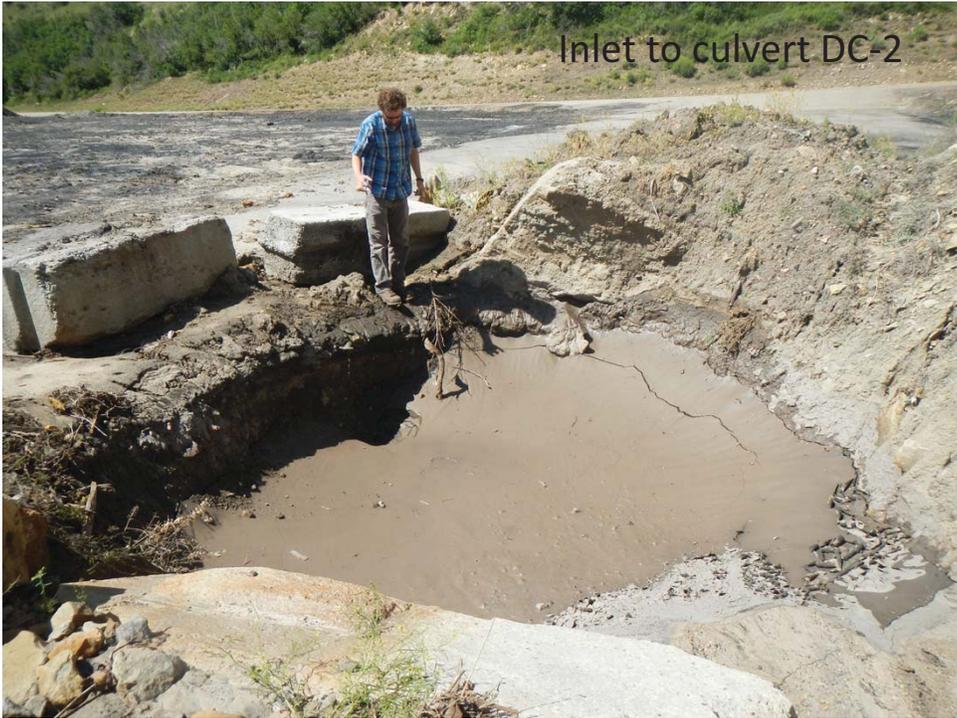
The inlet to DC-2 was completely buried by mud. The culvert was blocked completely and there was evidence that stormwater had exceeded the capacity of the inlet structure, and then flowed down over the lower disturbed area. NOV 21151 was issued for failing to maintain this inlet as well as the outlet of UC-1, which was partially filled with sediment. The inlet to DC-2 should be corrected as soon as possible, and the outlet of UC-1 should be cleared.

Inlet to culvert DC-2

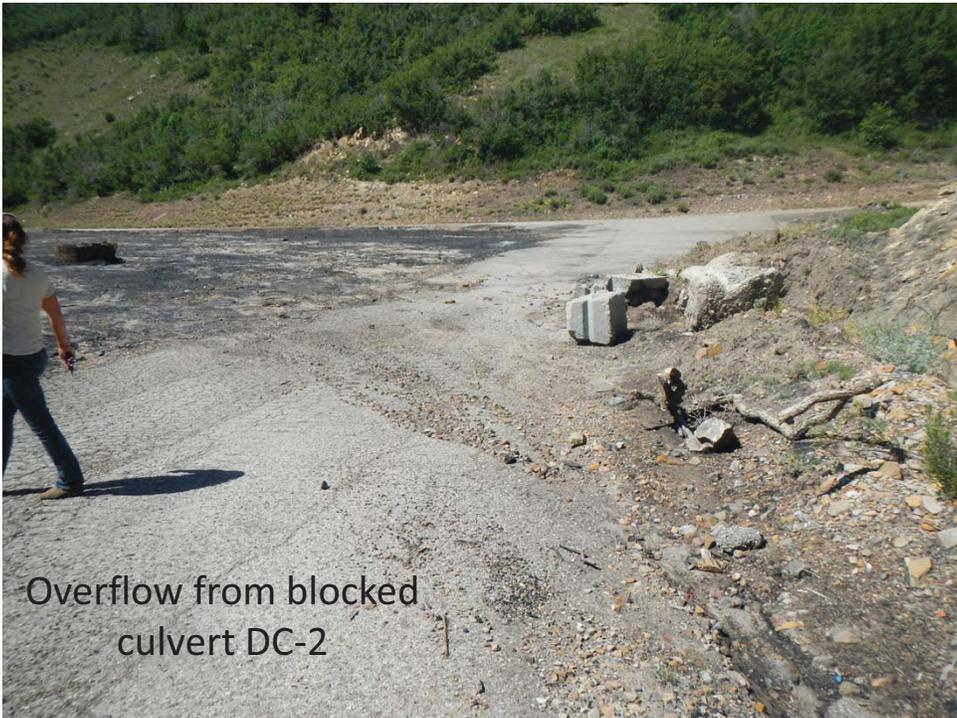
Overflow from blocked
culvert DC-2

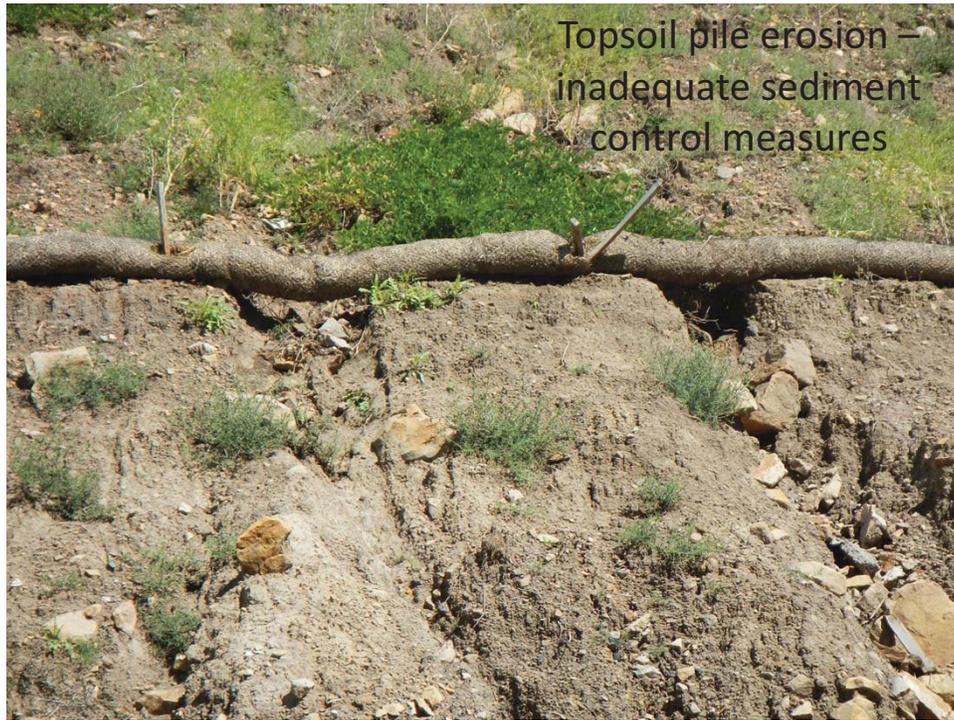
Topsoil piles "Area D" and "Area E" have waddles placed at the toe of the slope to prevent eroding topsoil from washing into disturbed ditches and into the sediment pond. These waddles need constant maintenance, and even though they were recently re-placed at the Division's request, they are already failing to protect topsoil from eroding off the piles. These waddles are clearly not maintained well enough and are not effectively protecting topsoil. See NOV 21153.

Topsoil pile erosion –
inadequate sediment
control measures

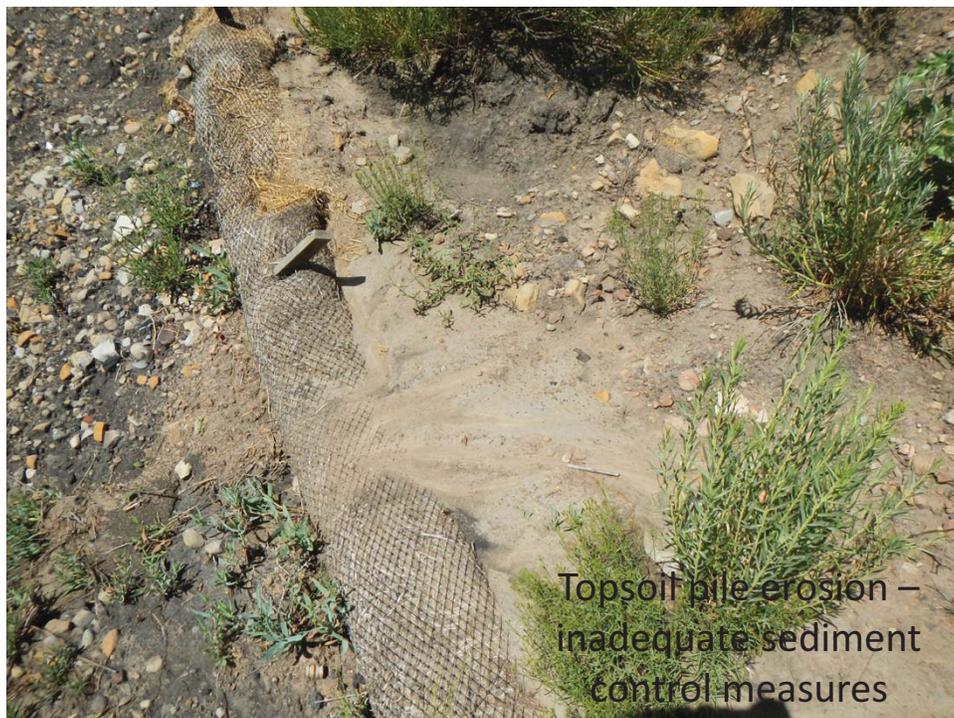
Topsoil pile erosion –
inadequate sediment
control measures

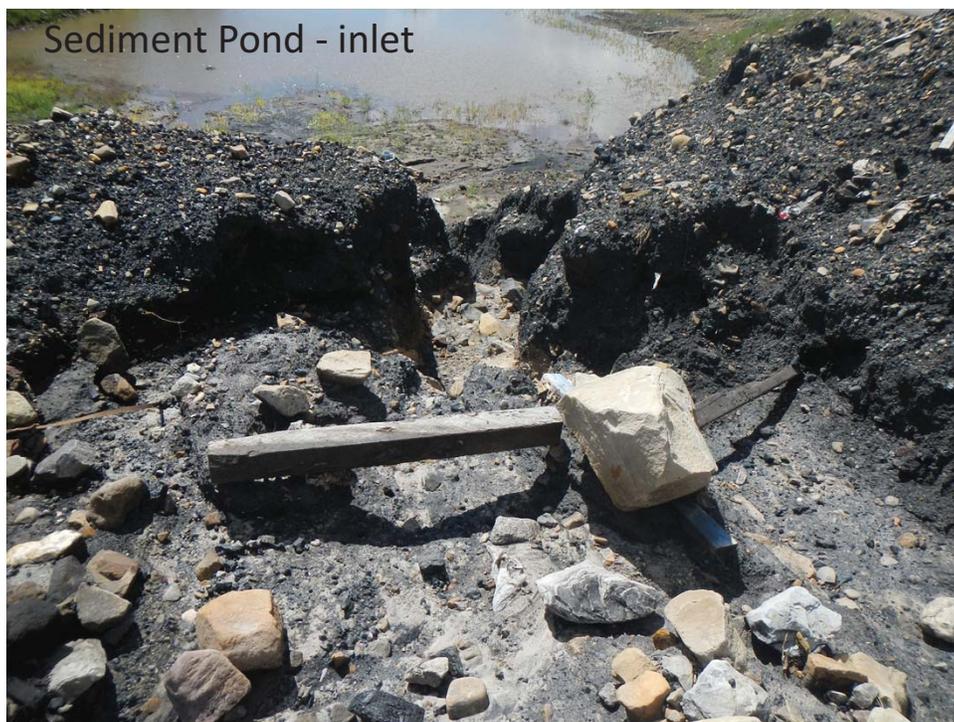
The pond continues to fall into more and more disrepair. The inlets continue to erode and become more unstable. The banks have larger and larger erosion rills, and there is evidence of animal burrowing in the banks of the pond, that should be repaired. FTACO 12147, issued August 5, 2014, is still outstanding.

Sediment Pond - inlet

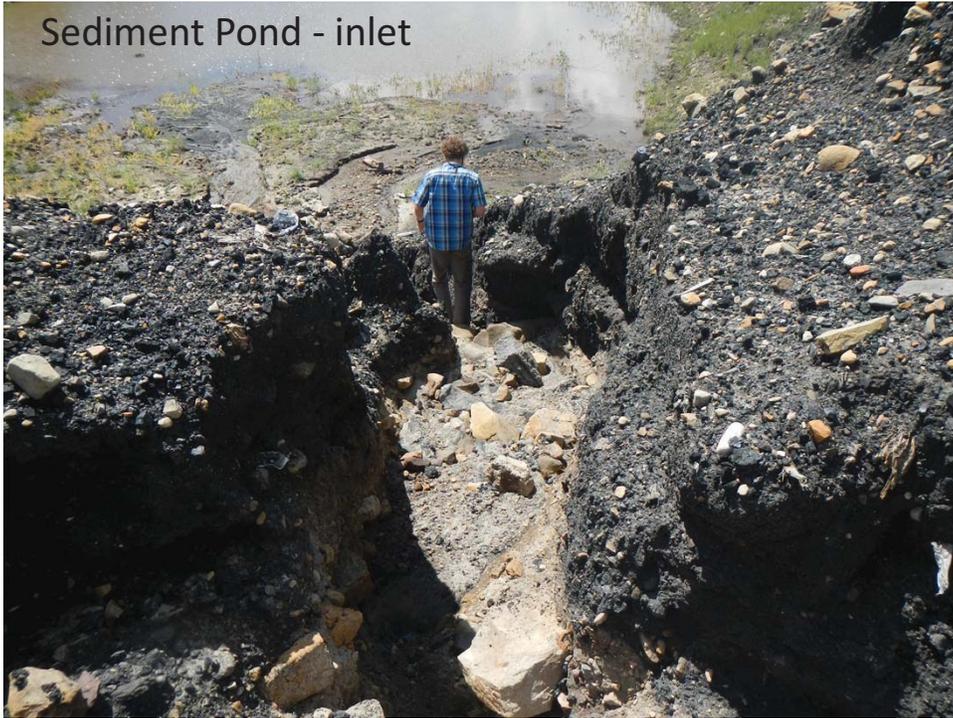
Sediment Pond – inlet,
coal mine waste
pushed into pond

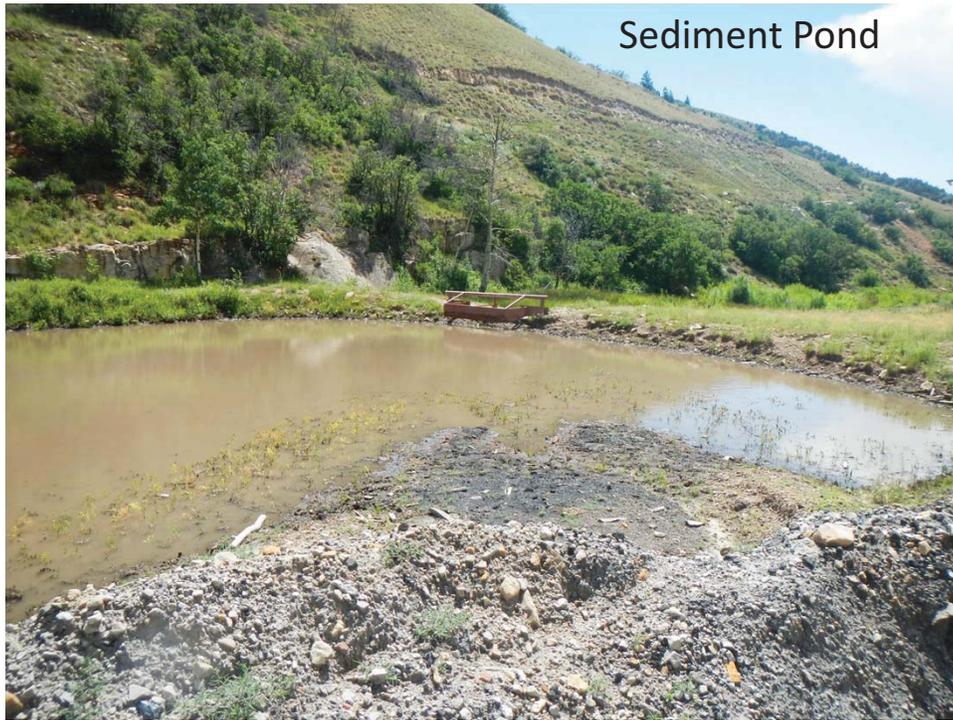
Sediment Pond

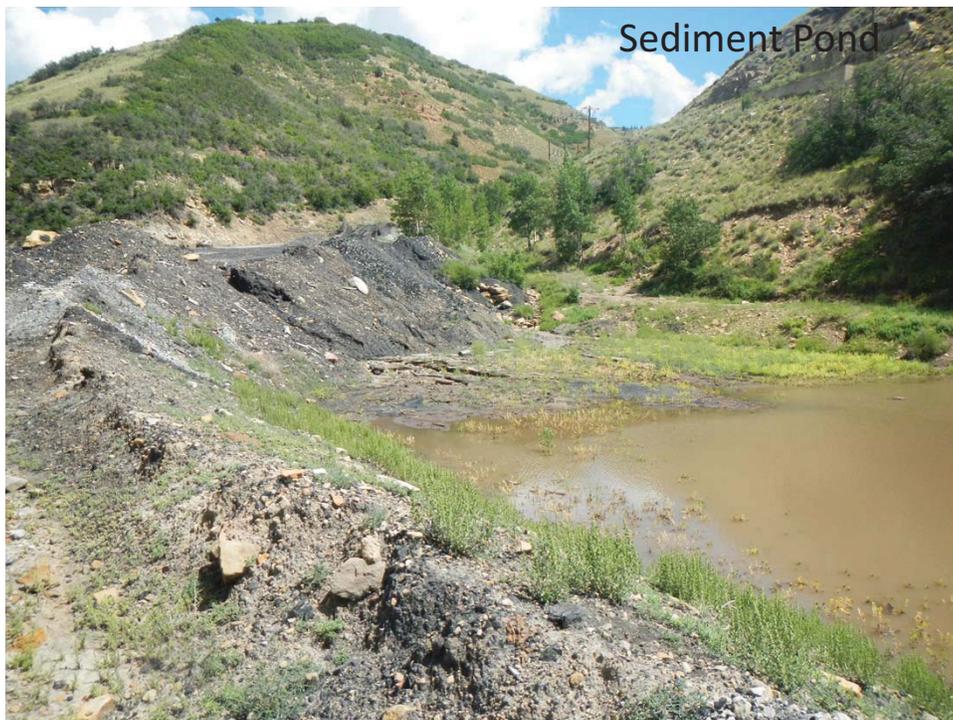
Sediment Pond
