Failure to Abate CO #21155

Inspection Report

InspectionID Report Number: 5260

Site: **HORIZON MINE**

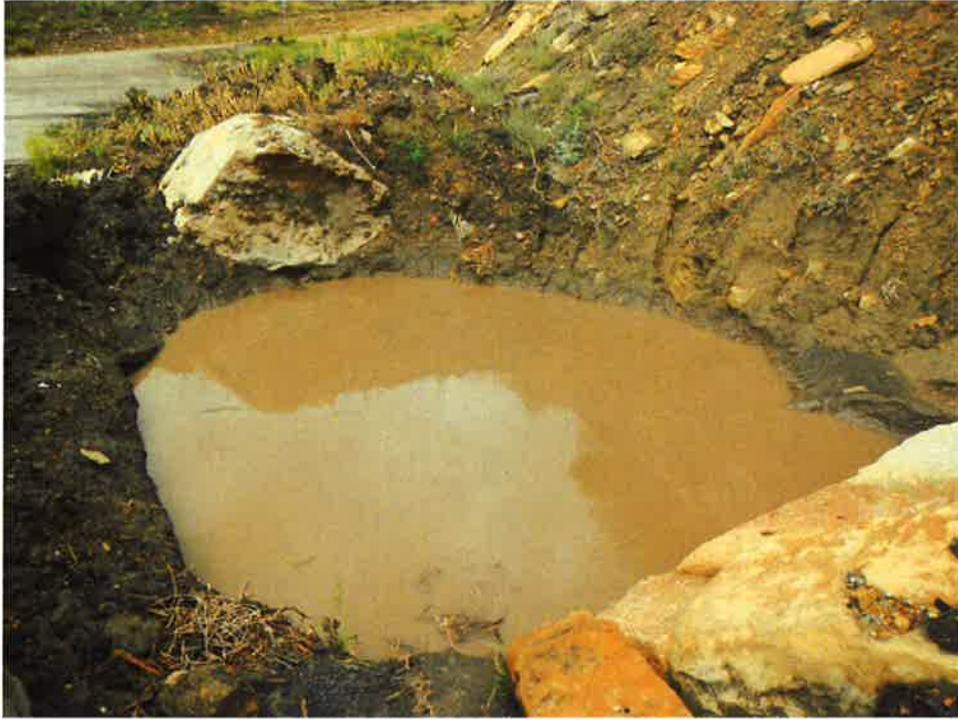
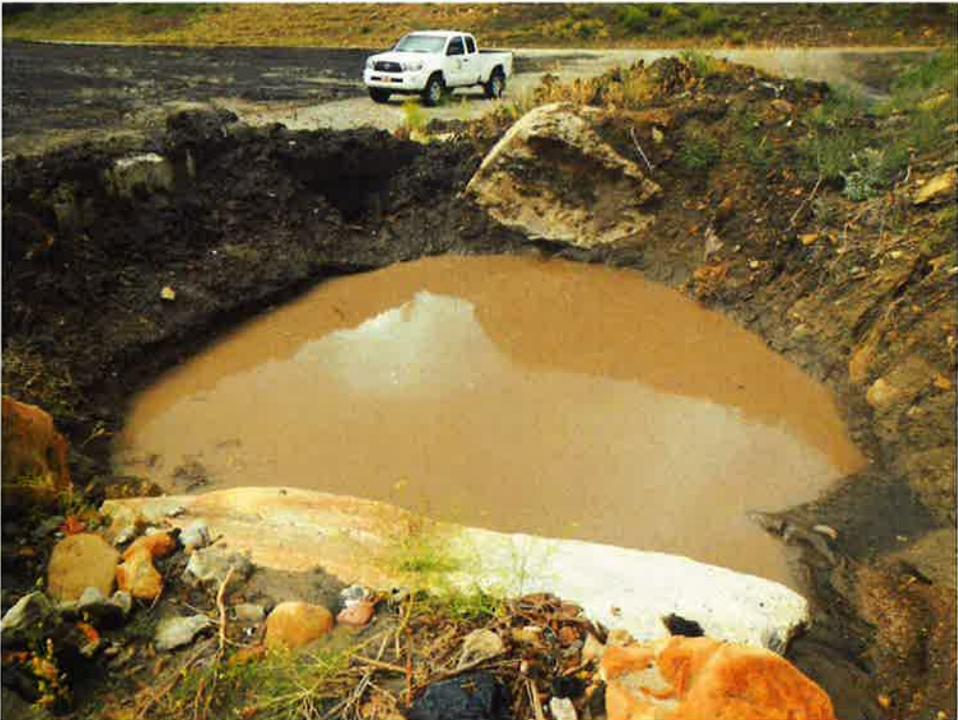
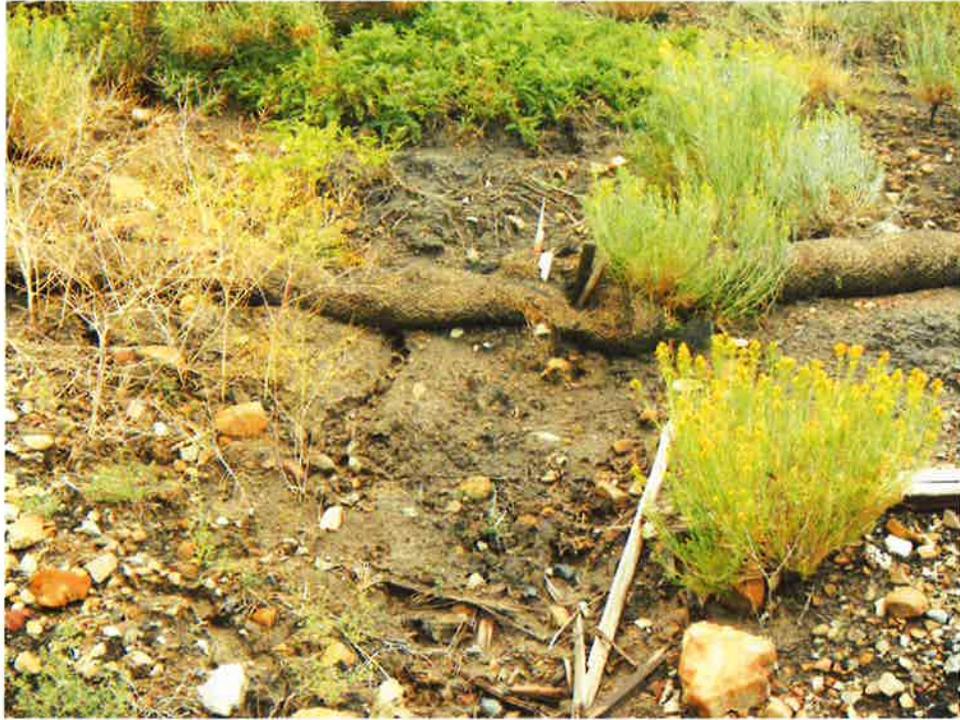
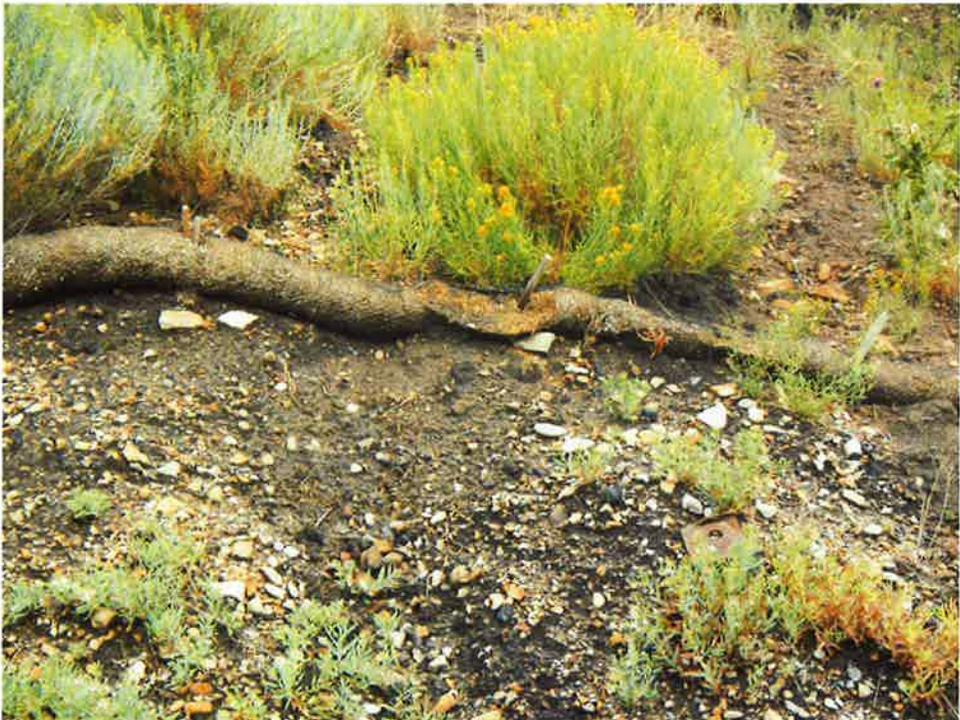
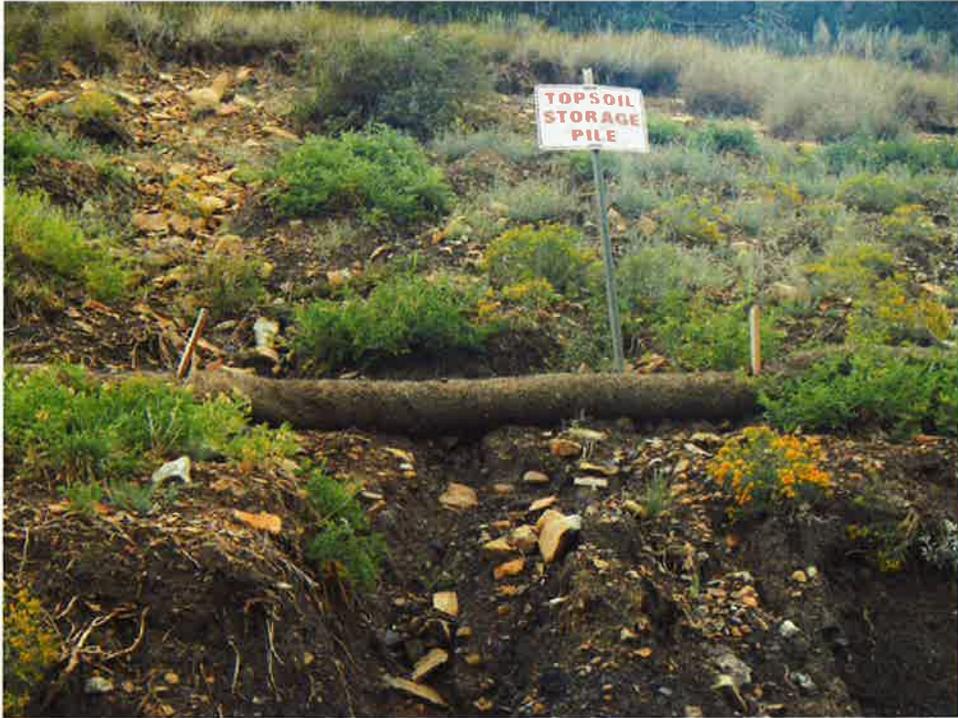
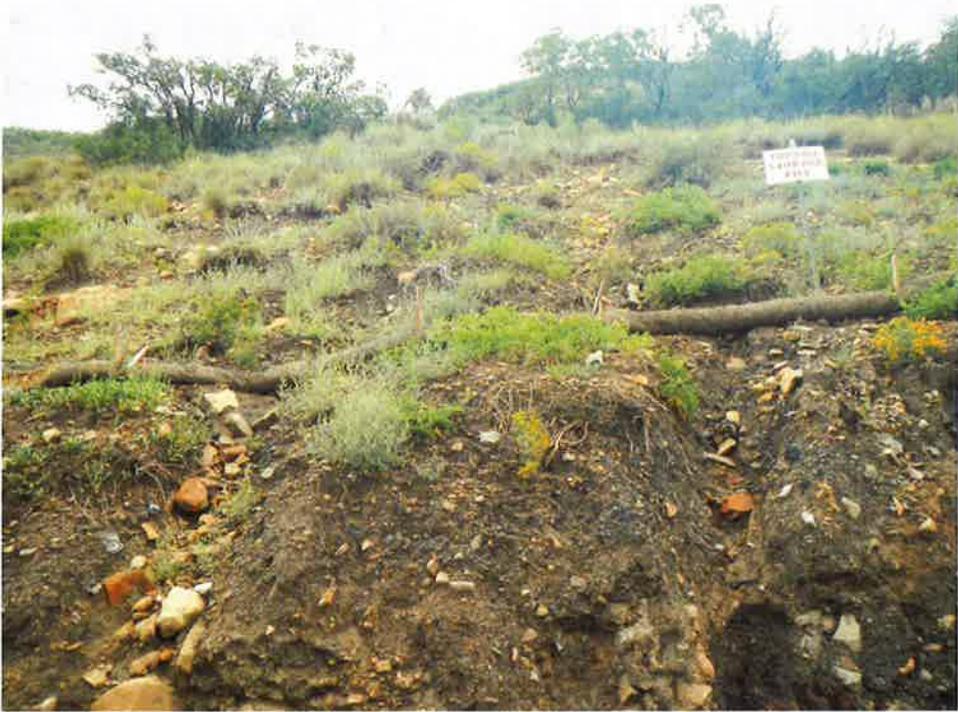
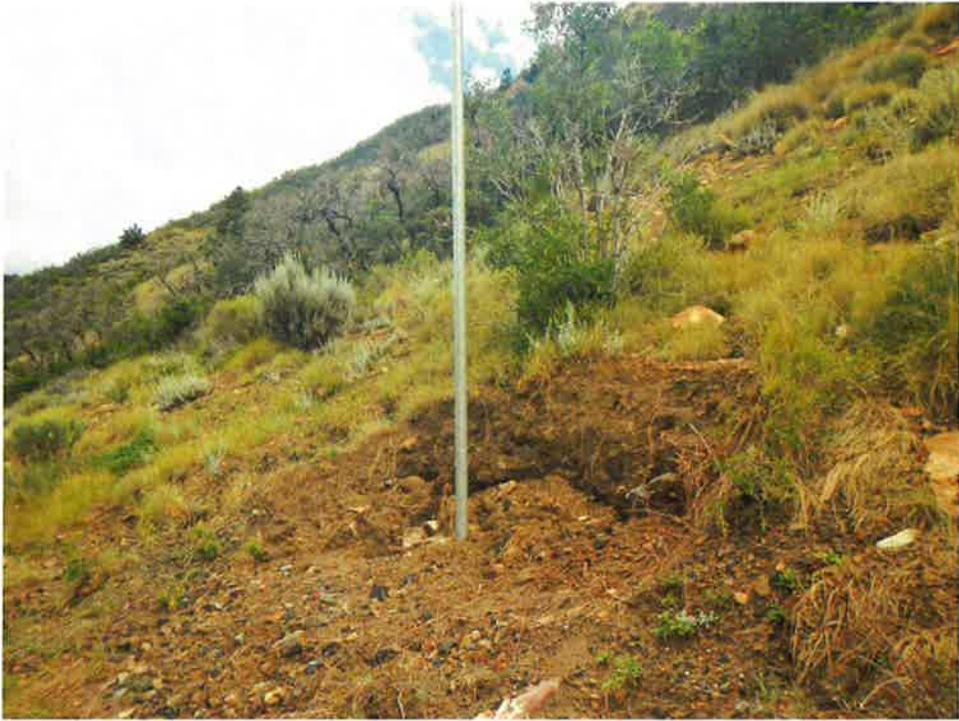
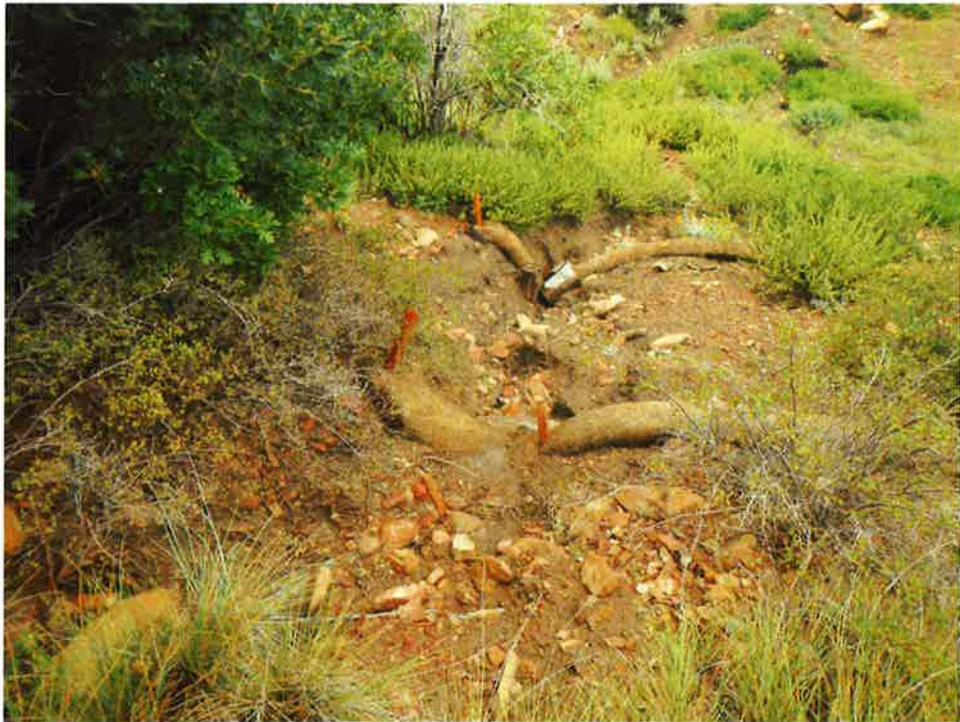
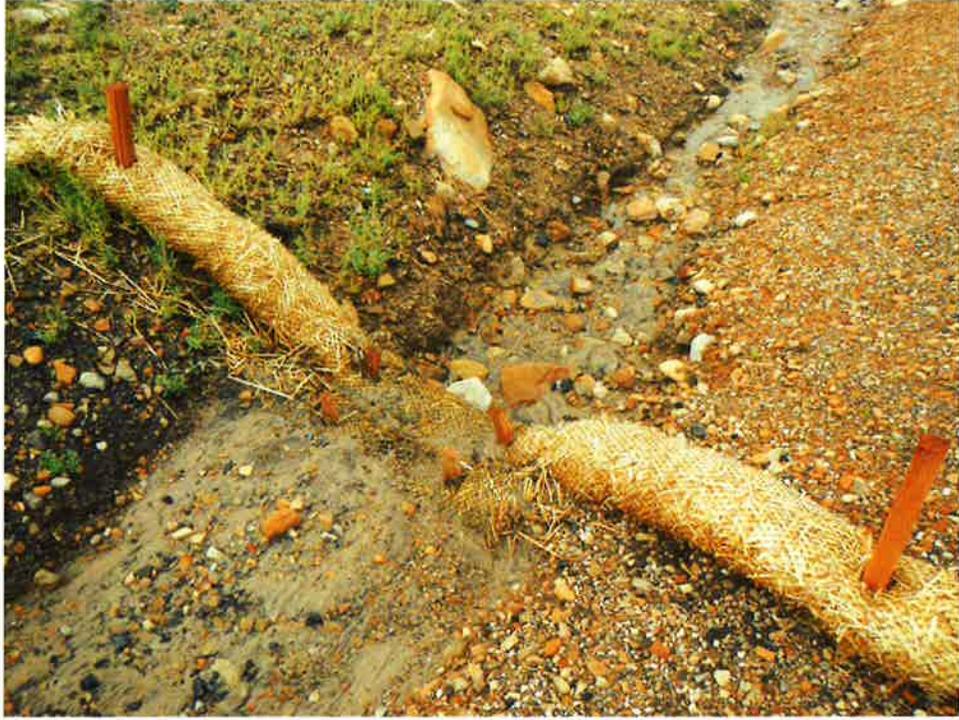
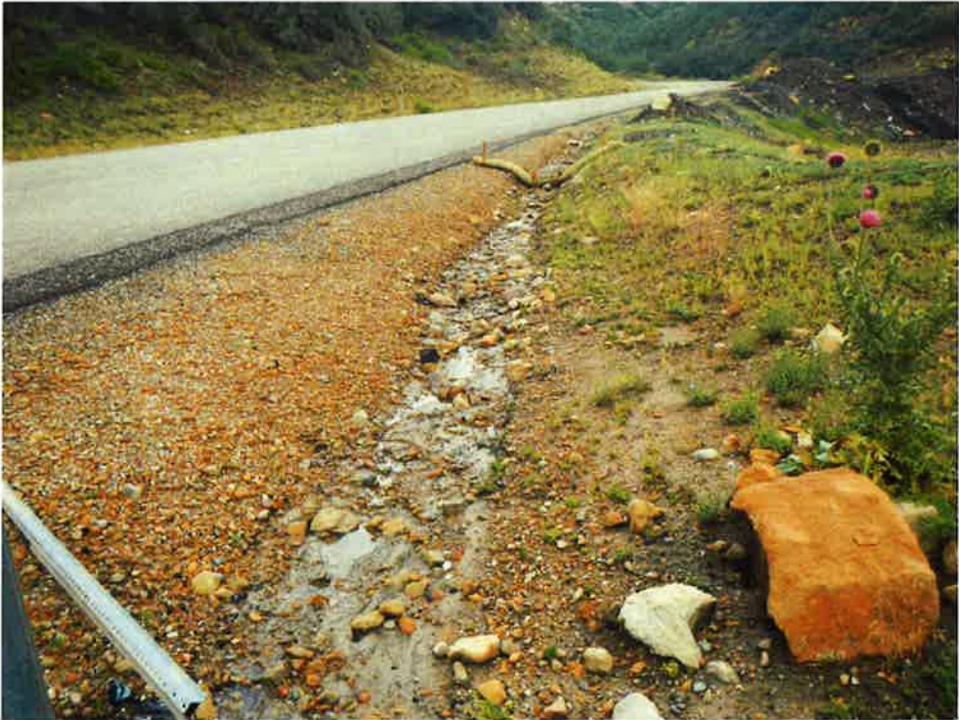
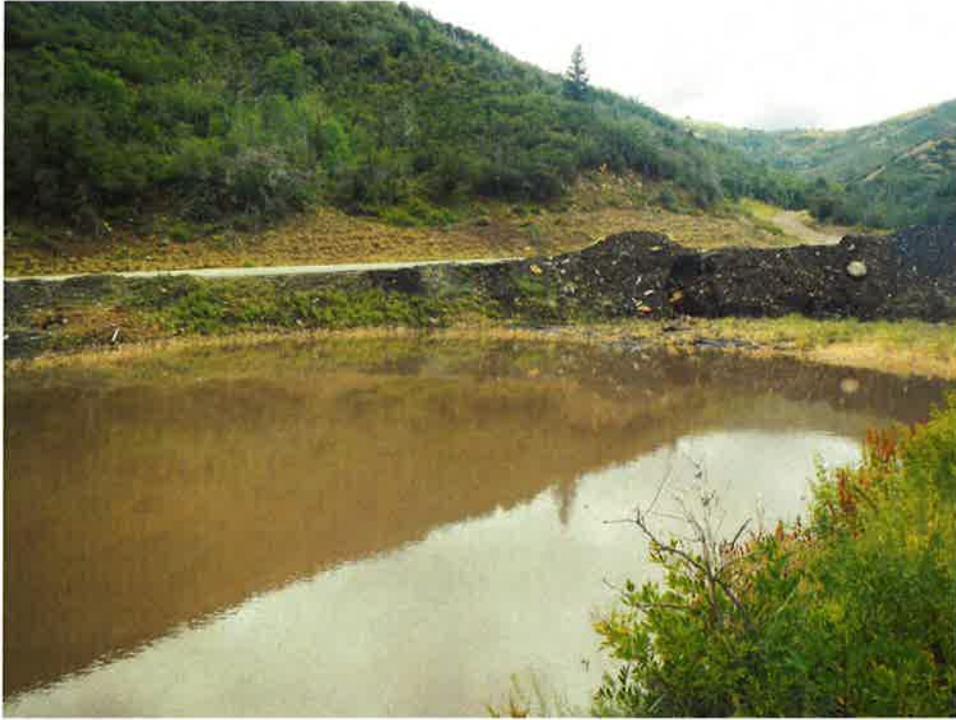
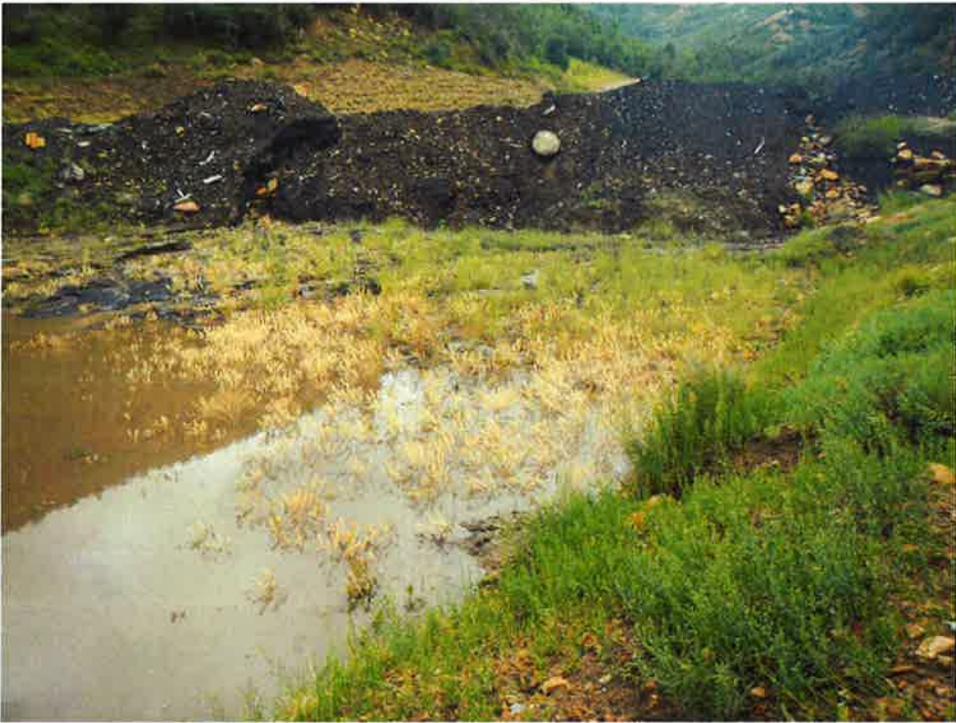
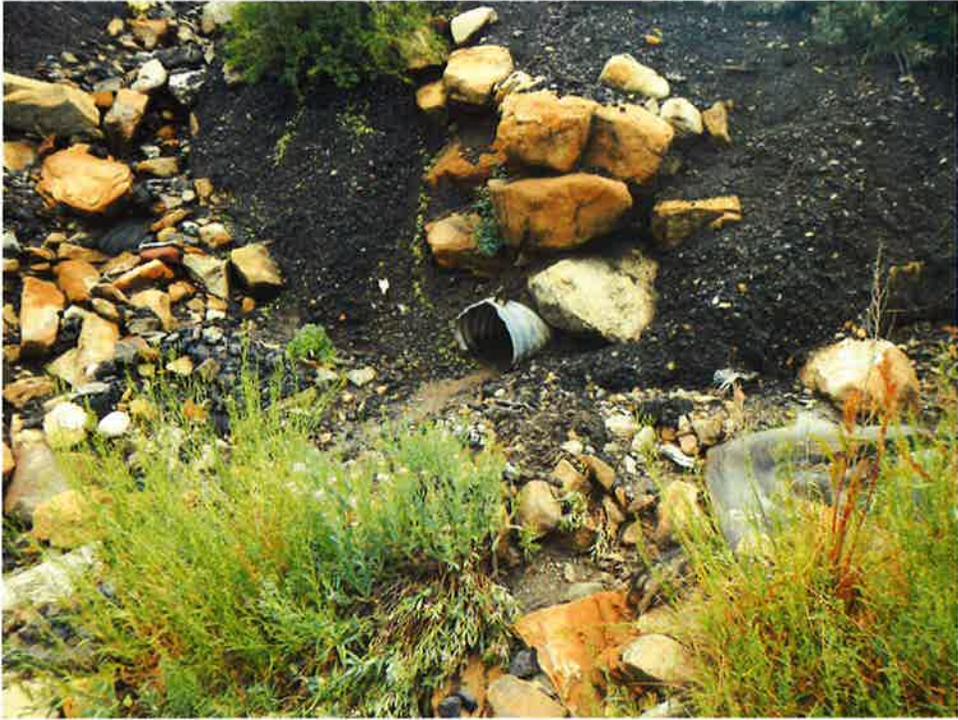
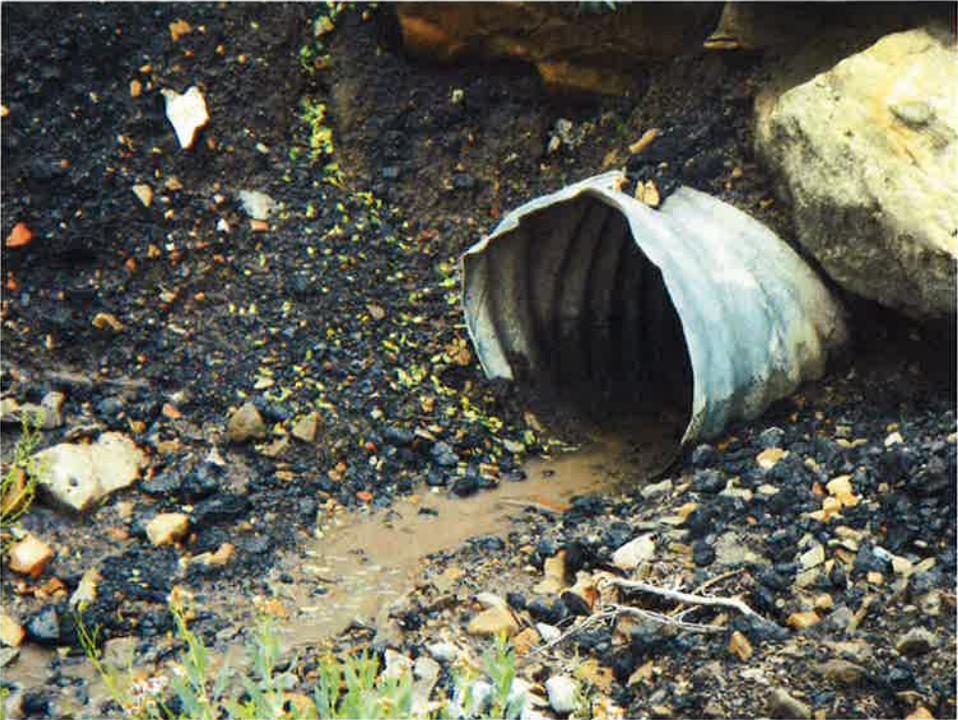
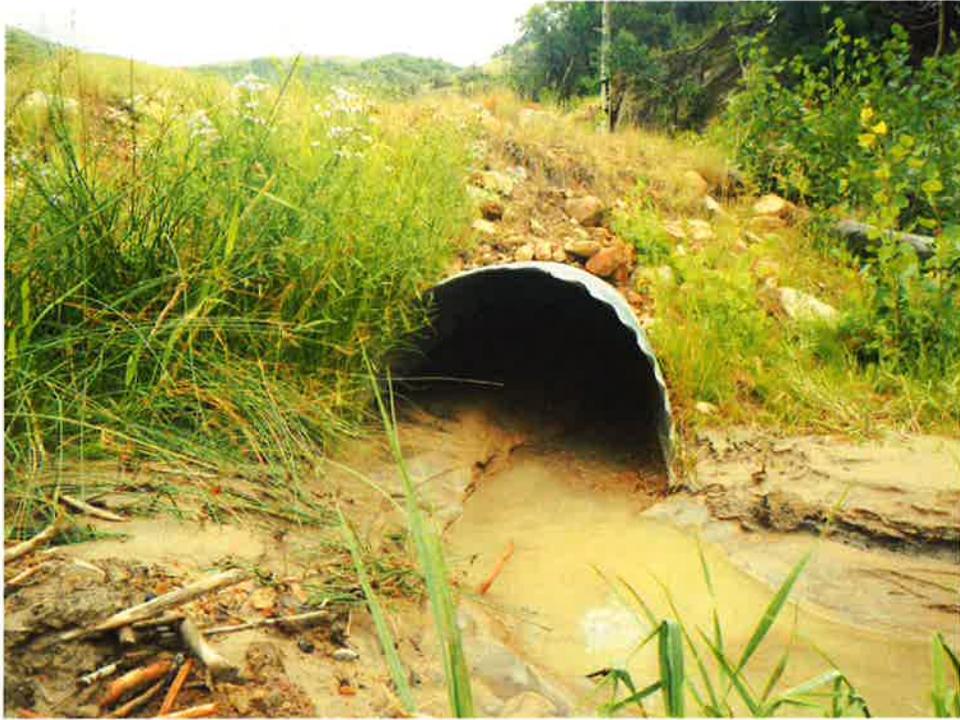
NOV 21151 was issued for failing to maintain the inlet to culvert DC-2 and the outlet of culvert UC-1. At the time of the NOV issuance, the inlet to DC-2 had been completely buried by mud, and the outlet of UC-1 was half full of sediment. The outlet of UC-1 still appears to be half full of sediment. It looked like some mud had been removed from the outlet, but not enough to remove any significant sediment.

During the inspection there was evidence that some mud and sediment had been pulled from the inlet of DC-2 but there was a large pond of water at the inlet, and almost no water was passing through the outlet of DC-2. The culvert appears to be completely blocked. See inspection pictures for more details.

NOV 21151 was not abated as required, as a result, FTACO 21155 was issued.
