DOGM, Daily Construction Progress Report

Horizon Mine Reclamation

C/007/020

Date: July 20, 2018 M T **W** Th F

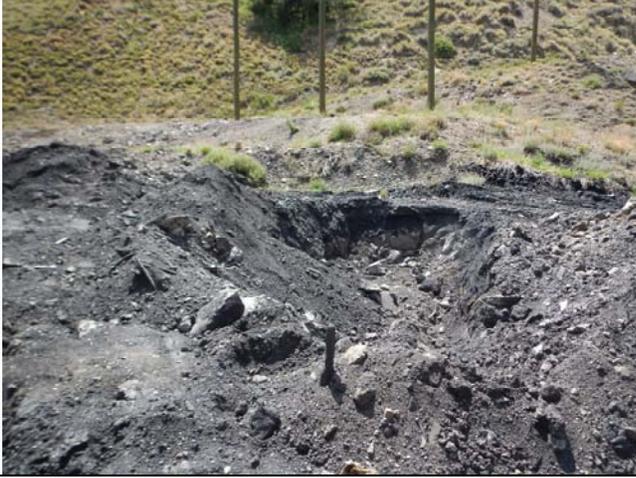
PHOTO 1

Concrete foundations at base of power polls demolished

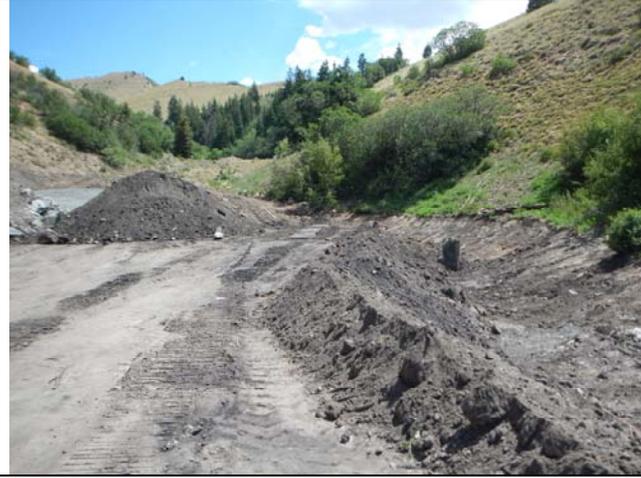
PHOTO 2

They began cutting the initial location of the channel starting at the portals. As the channel curves around where the fan portal used to be it runs for another 50 to 75 feet along the southeast bank adjacent to the undisturbed hillslope. This allows for a larger repository cell along the northwest slope where the portals sat.

Beginning cut of channel on right side of photo

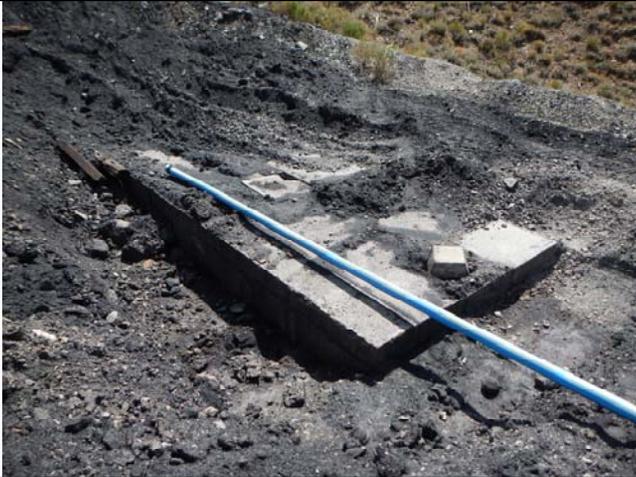
PHOTO 3

Waste and Waster Logistics pumped the septic tank. It took two loads for a total of about 6500 gallons.

Gray water septic tank pumped no sludge in tank.

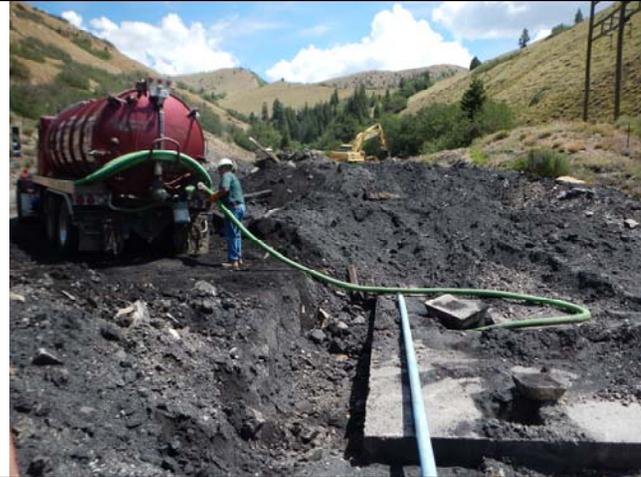
PHOTO 4

Gray water septic tank pumped no sludge in tank.

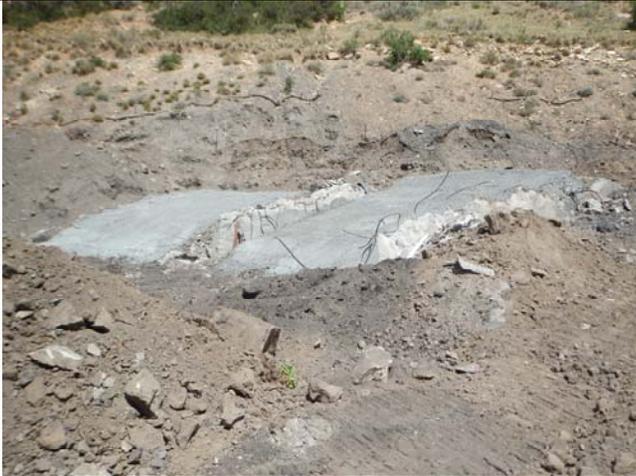
Steve continued with excavator work to fill the fan portal in compacted lifts. He will place some dirt on top of the concrete seals poured yesterday to help keep moisture in the concrete so it cures better. They will not begin placing heavy material or driving on the concrete seals for a week to let the concrete fully cure.

PHOTO 5
Curing concrete portal seals.

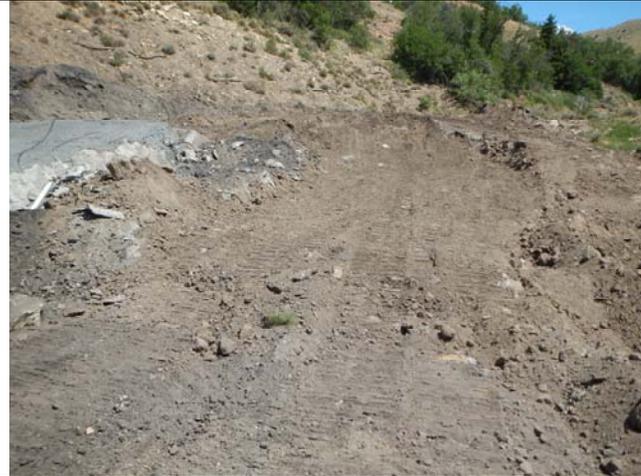
PHOTO 6
Backfilled fan portal.

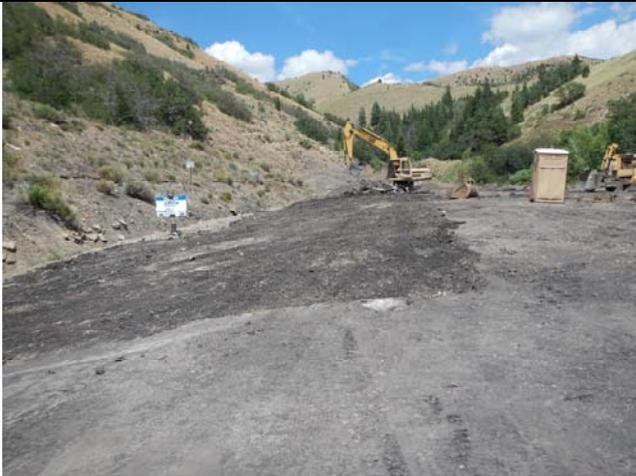
The excavator and loader are tearing up the asphalt on the upper pad and placing in the upper pad excess backfill placement area.

WORK items approved: The asphalt has been peeled back and it appears coal fines make up a significant amount of the road base material. I told Steve it's okay to place these coal fines in the upper pad excess backfill placement area. I let him know all the coal fines placed in this area must be covered with 4 feet of clean backfilled material.

PHOTO 7
Stripping concrete from upper pad.
