DOGM, Daily Construction Progress Report

Horizon Mine Reclamation

C/007/020

Date: July 26th, 2018 M T W **Th** F S

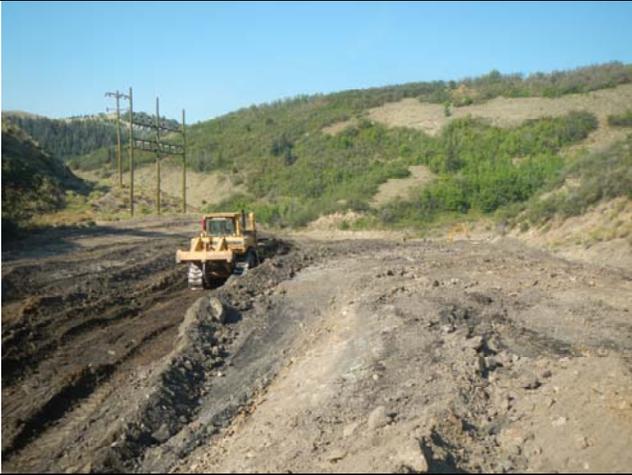
PHOTO 1
Moving Material Down from Upper Pad

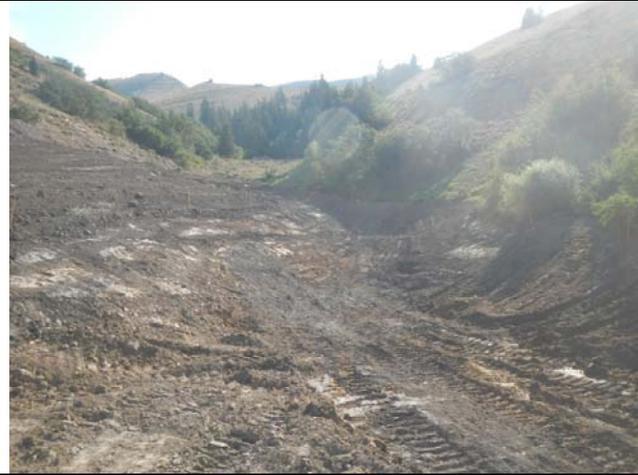
PHOTO 2
Excavated Upper Pad Area

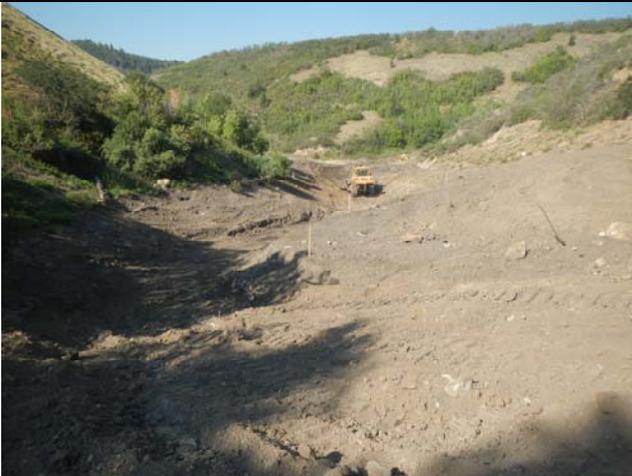
PHOTO 3
Moving Material Down from Upper Pad

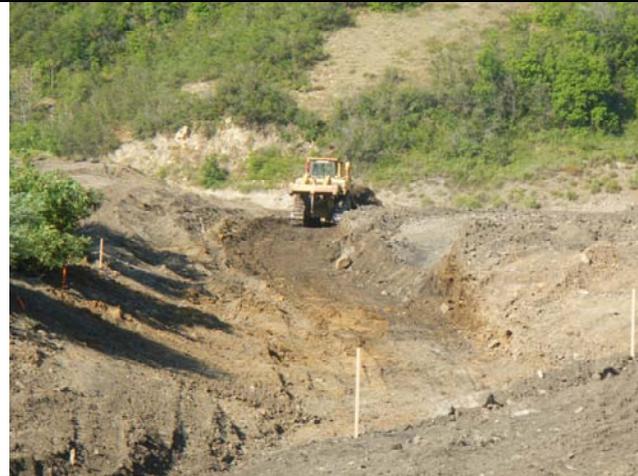
PHOTO 4
Moving Material Down from Upper Pad

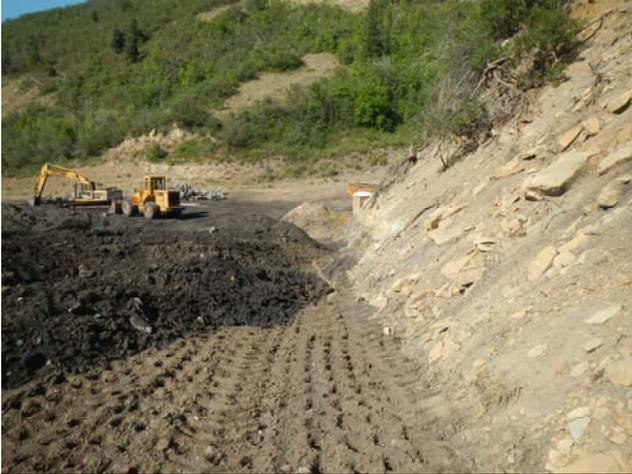
PHOTO 5

Disturbed Drainage Ditch Backfilled/Compacted

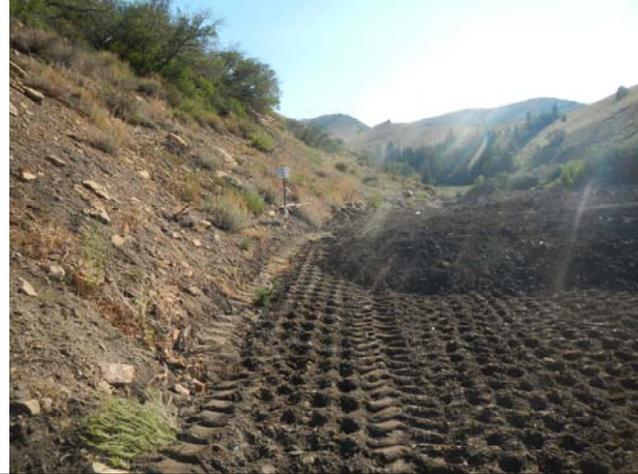
PHOTO 6

Disturbed Drainage Ditch Backfilled/Compacted

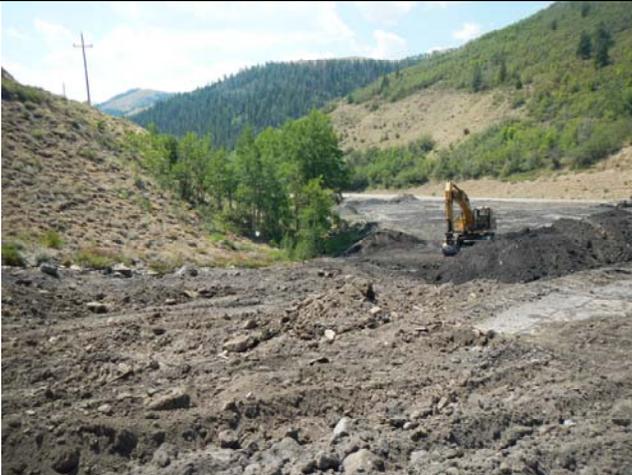
PHOTO 7

Lower Pad Area

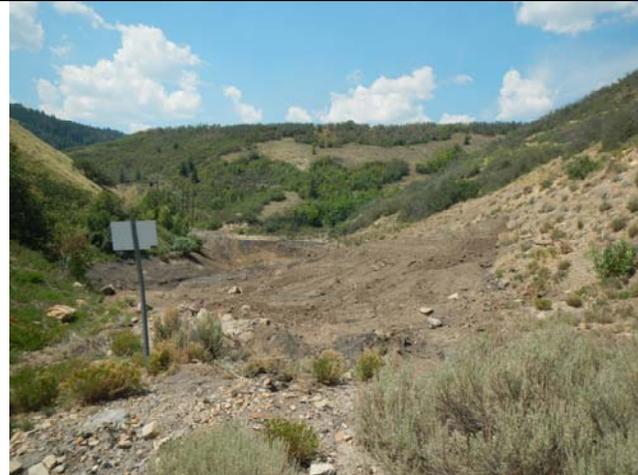
PHOTO 8

View From Upper Topsoil Pile

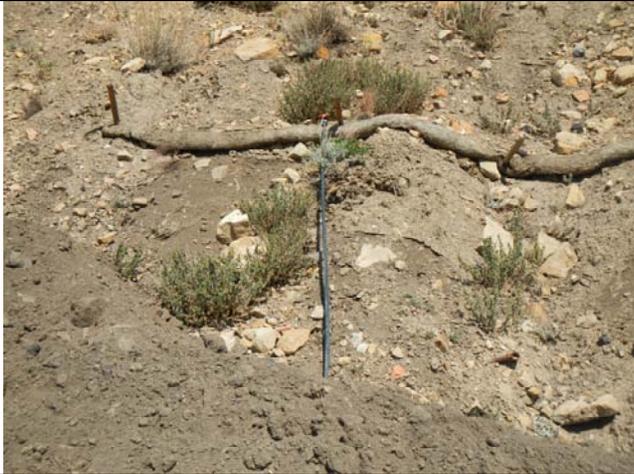
PHOTO 9
Installed Air Sampler Pipe (Belt Portal)

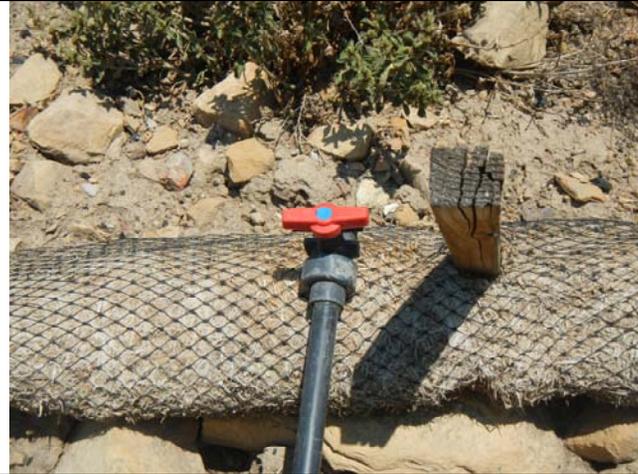
PHOTO 10
Installed Air Sampler Pipe (Belt Portal)

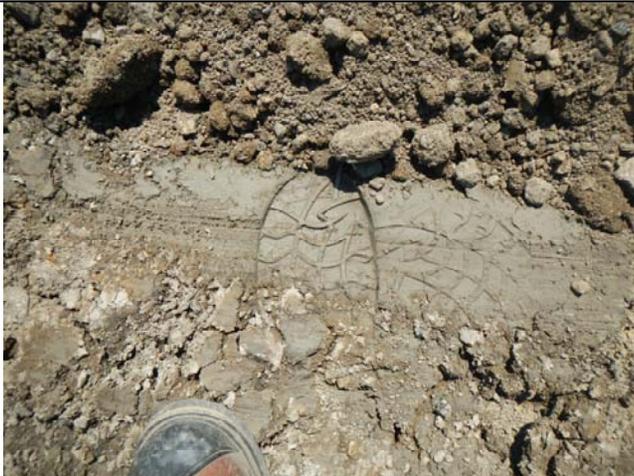
Per the scope of work, a final compaction report is to be provided to DOGM once the final grading has been performed. The report needs to describe the methodology utilized to achieve the 85% Proctor density and final compaction results. This was discussed with the contractor and they understand this requirement. The native soil material below the accumulated coal refuse material on the pads has been observed to be damp/moist. The moisture content of the soil lends itself to achieving better compaction results.

PHOTO 11
Moist Native Soil Material (below asphalt/coal waste)

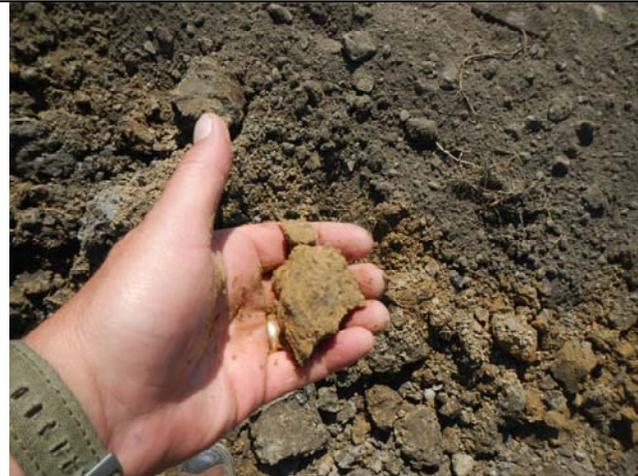
PHOTO 12
Moist Native Soil Material (below asphalt/coal waste)
