## DOGM, Daily Construction Progress Report

Horizon Mine Reclamation

C/007/020

Date: July 30, 2018 **M** T W Th F

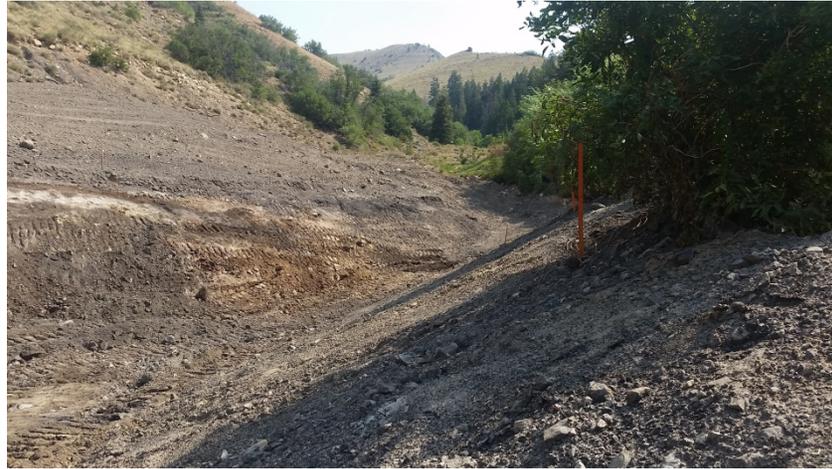
**PHOTO 1 (10:00am)**

**View of buried portals + reclaimed Portal Canyon channel.**

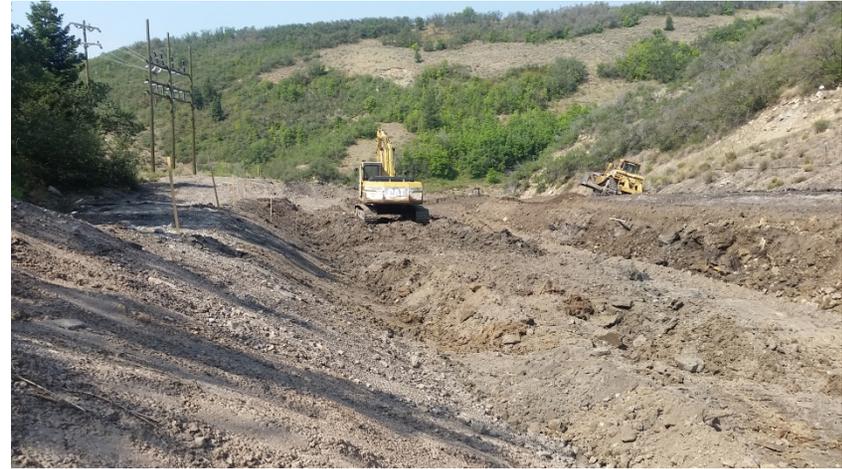
**PHOTO 2 (10:00am)**

**Dal at work uncovering buried culvert while Steve pushes fill material from the upper pad down canyon.**

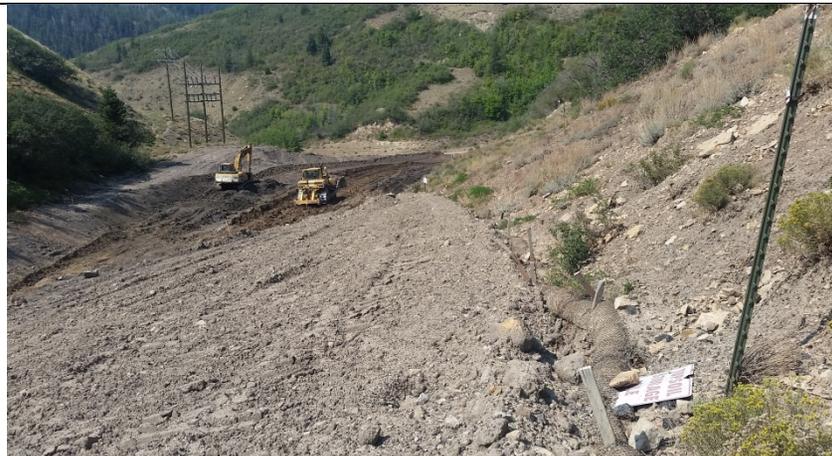
**PHOTO 3 (10:00am)**

**Standing atop the buried portals looking down canyon.**

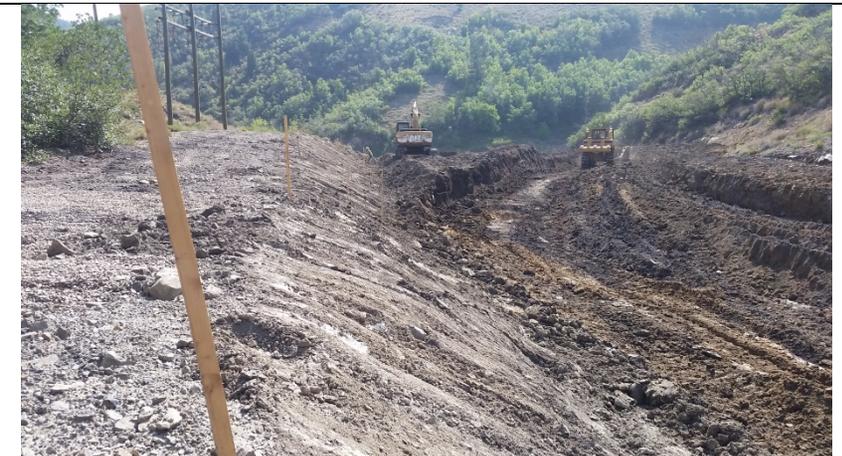
**PHOTO 4 (3:00pm)**

**Notice Dal shooting grade on the slopes beside the excavator.**

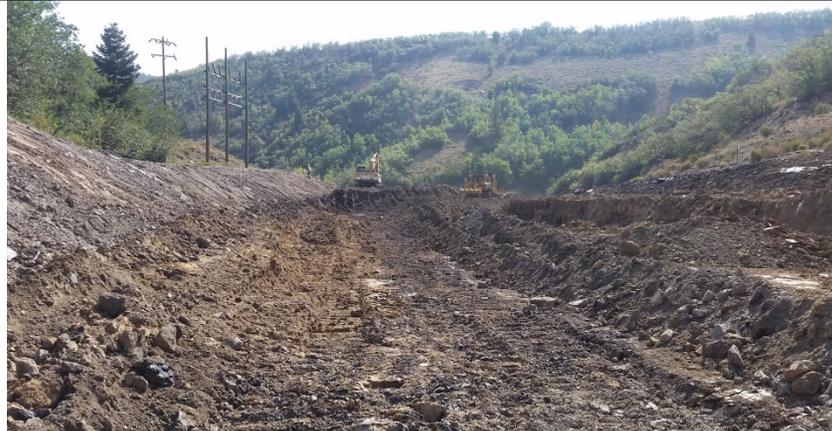
**PHOTO 5 (3:00pm)**

**Standing in the channel looking down canyon. Steve pushing fill with the D8, Dal shooting grade on the slopes.**

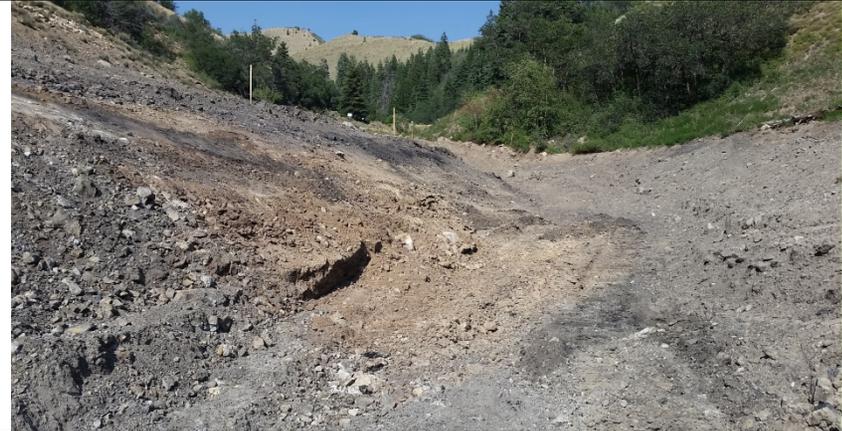
**PHOTO 6 (3:00pm)**

**Standing in the channel looking up canyon. Notice severed section of undisturbed culvert poking out of the soil at the top of the channel.**

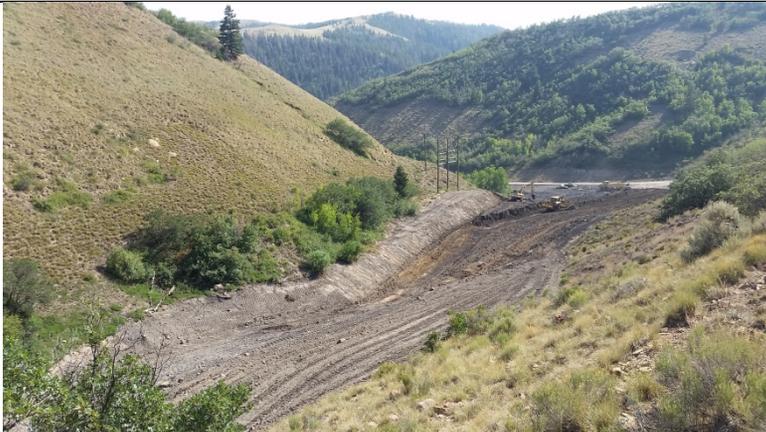
**PHOTO 7 (4:30pm)**

**View from the vent pipe on the upper road.**
