DOGM, Daily Construction Progress Report

Horizon Mine Reclamation

C/007/020

ATTACHMENT A – July 31, 2018 Horizon Reclamation Progress

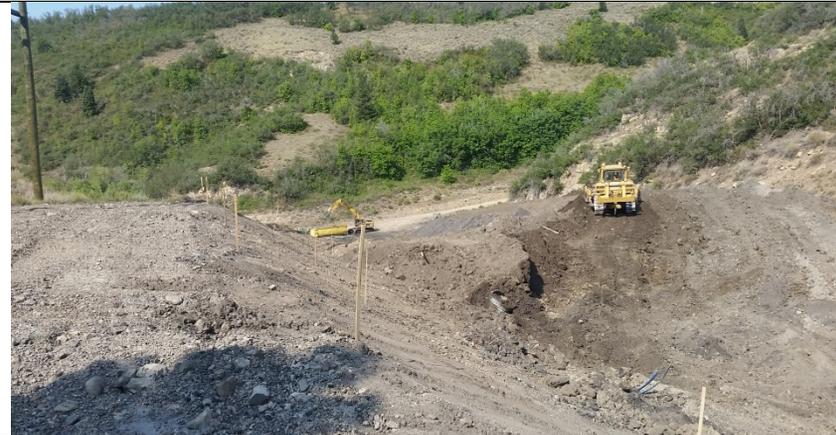
PHOTO 1 (10:30am)

Steve pushes while Dal chases scrap metal on the lower pad. Notice the undisturbed culvert poking out of the berm above.

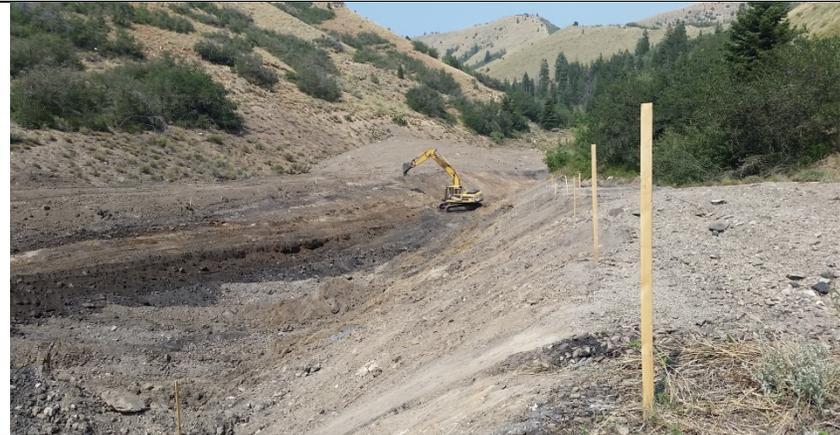
PHOTO 2 (3:30pm)

Dal at work establishing final grade on the reclaimed slopes beneath the buried portals.

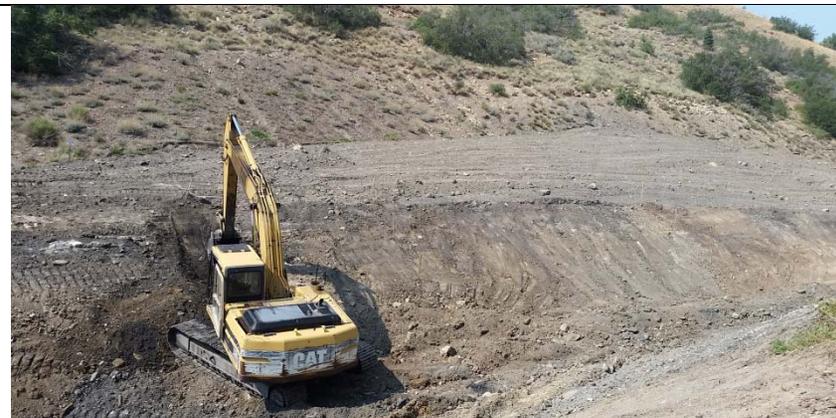
PHOTO 3 (3:30pm)

Dal feathering in final slopes with trackhoe excavator.

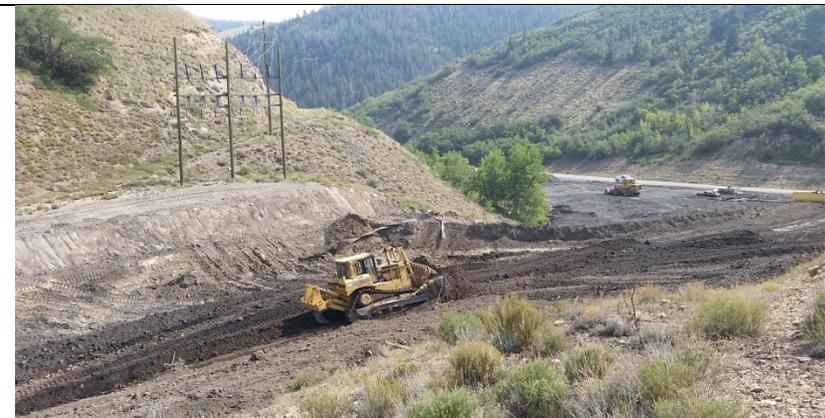
PHOTO 4 (3:30pm)

Steve pushing fill. Notice length of uncovered culvert above the Dozer.

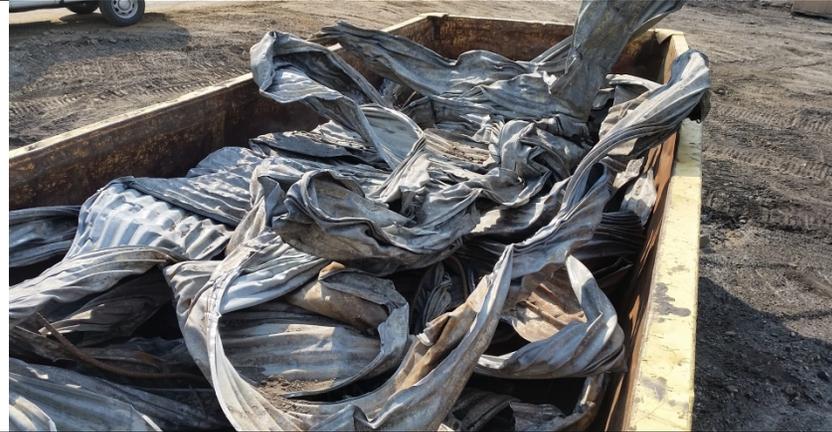
PHOTO 5 (3:30pm)

Scrap steel bin containing various lengths of undisturbed culvert uncovered by the D8 dozer.

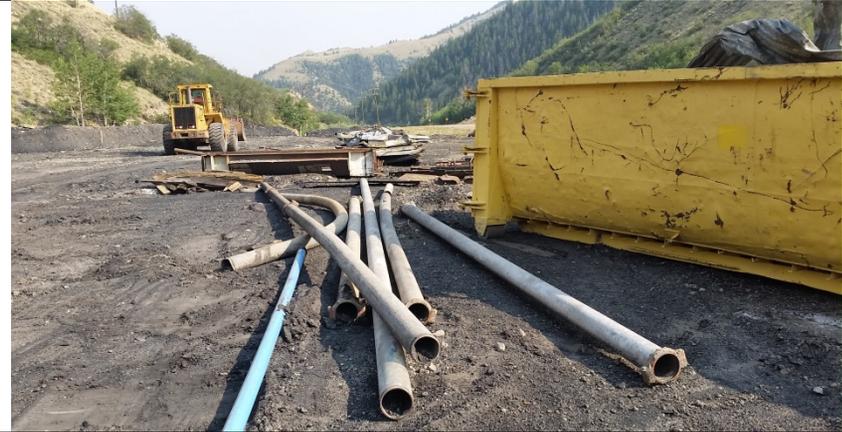
PHOTO 6 (3:30pm)

These lengths of steel pipe were uncovered in the area of the disturbed culvert. They will be salvaged.

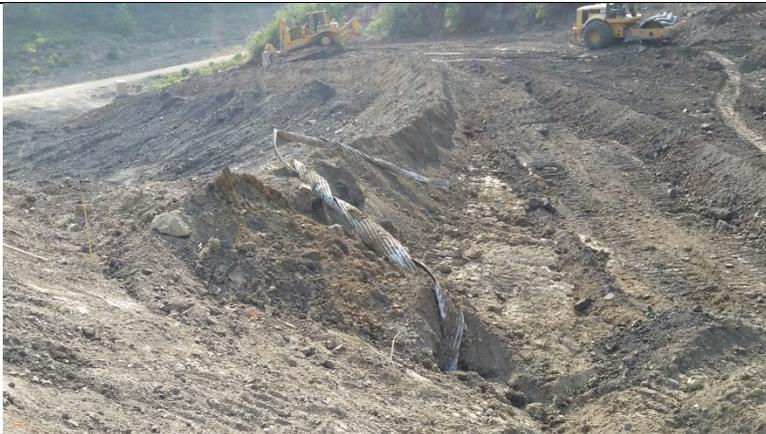
PHOTO 7 (5:00pm)

Steve pushes with the dozer while Dal compacts with Sheepsfoot roller.

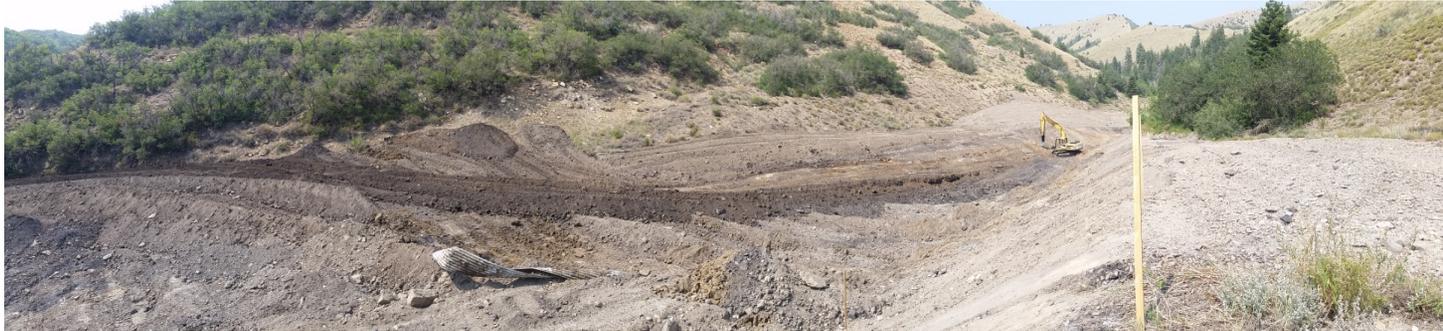
PANORAMA 1

Looking upcanyon at Dal in the Excavator.

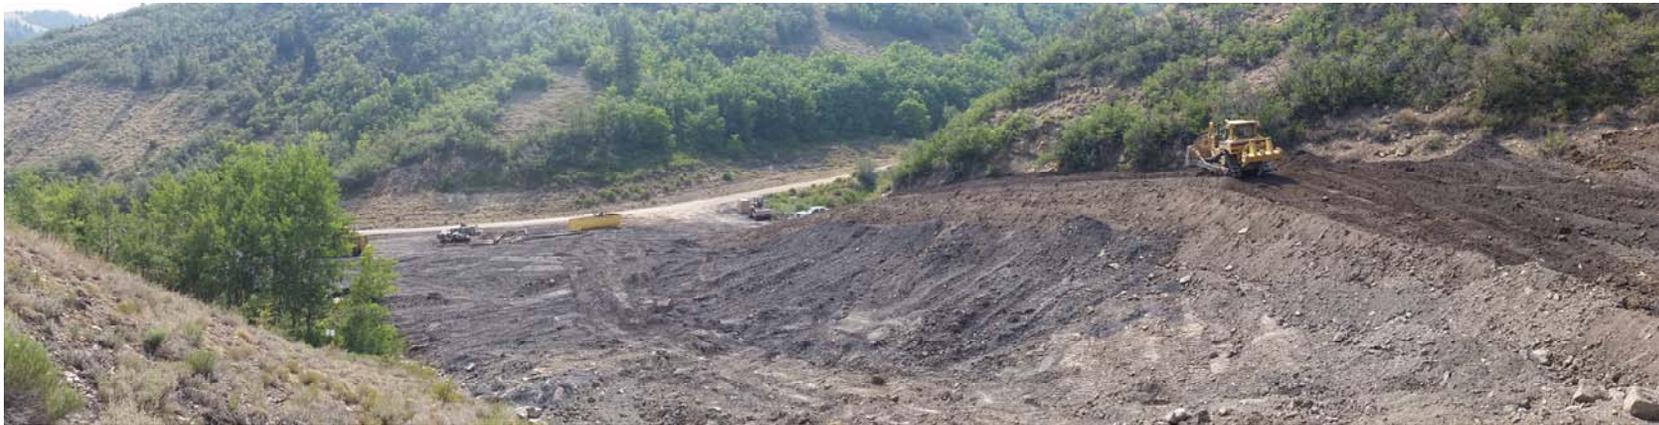
PANORAMA 2

Looking downcanyon at Steve in the D8 Dozer.
