Attachment A photos August 20, 2018

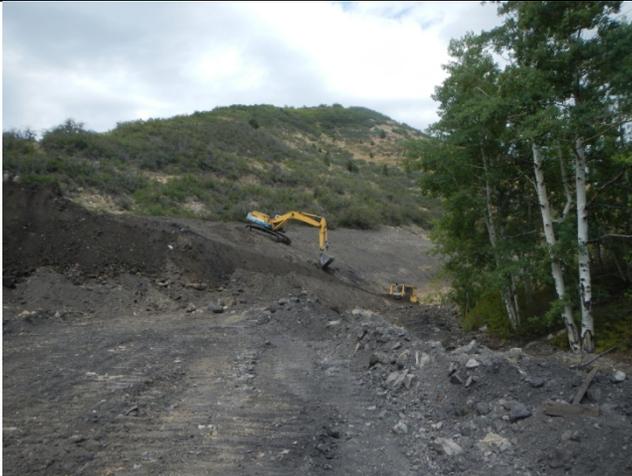
PHOTO 1 Dozer pushing soil to West. Excavator perfecting 2h:1v slopes

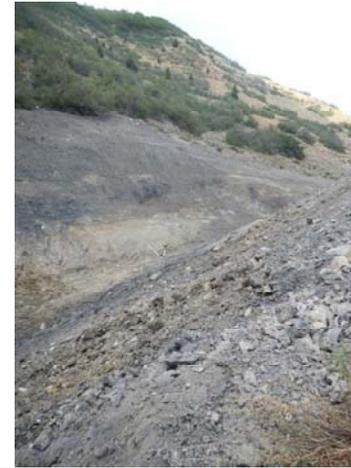
PHOTO 2 Portal Cyn 2h:1 v slopes to be roughened

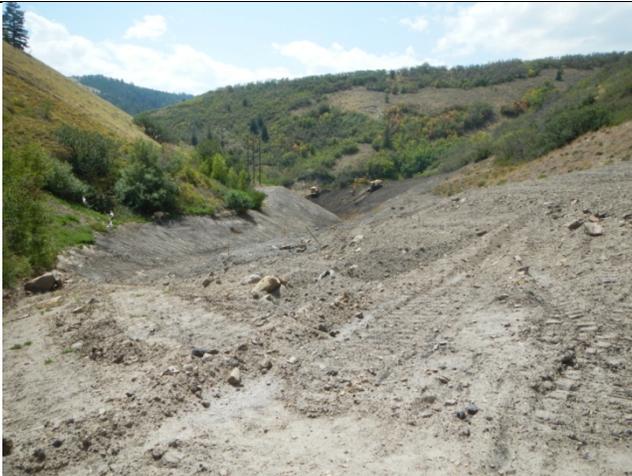
PHOTO 3 View S of Portal Cyn at location of buried portals

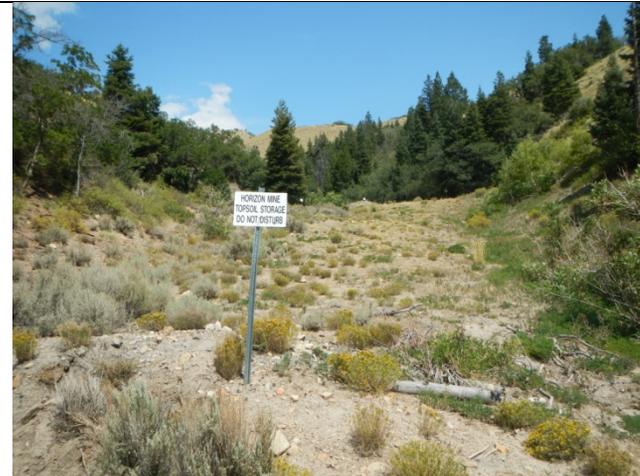
PHOTO 4 View up Portal Cyn taken at aspen at base of topsoil pile on E side

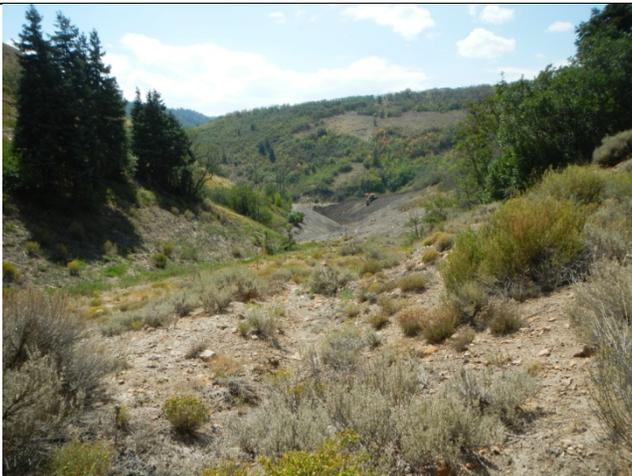
PHOTO 5 Taken at pine tree on West side of topsoil pile.

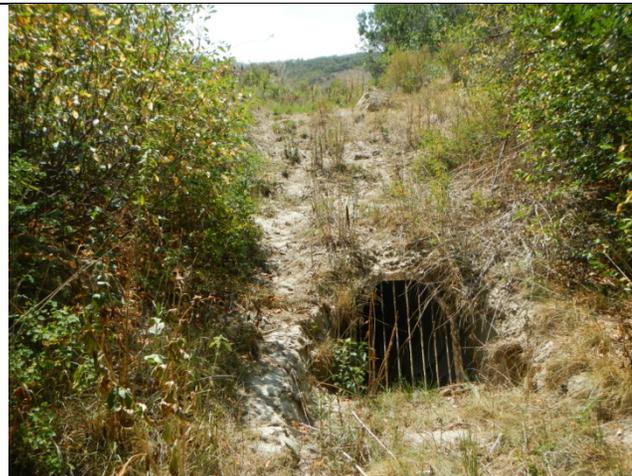
PHOTO 6 UD inlet and topsoil stockpile above

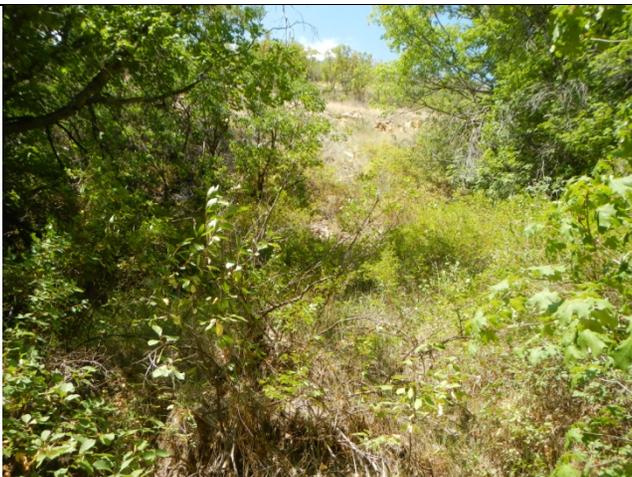
PHOTO 7 Portal Cyn looking at W slope above UD inlet

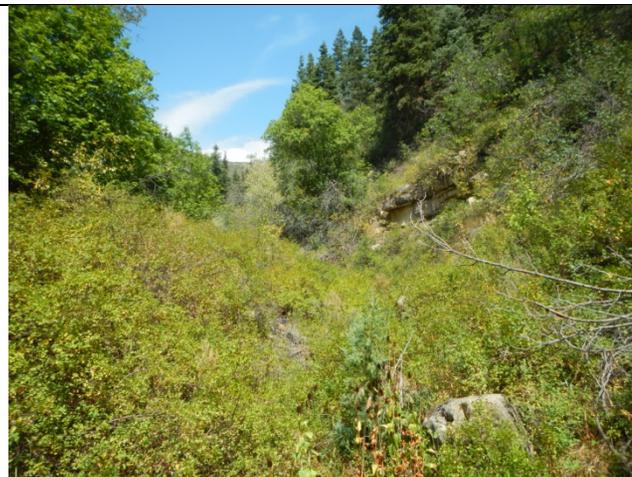
PHOTO 8 Portal Cyn looking upstream and E slope above UD inlet

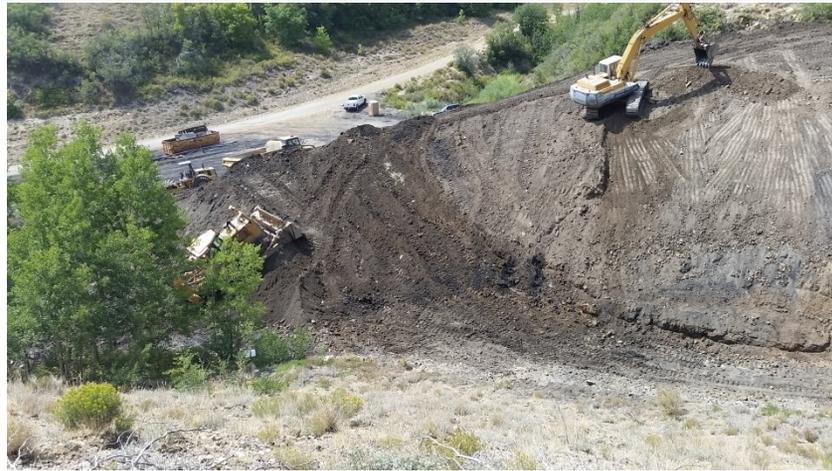
PHOTO 9 Another shot of Steve pushing from the bottom and Dal finishing on top.

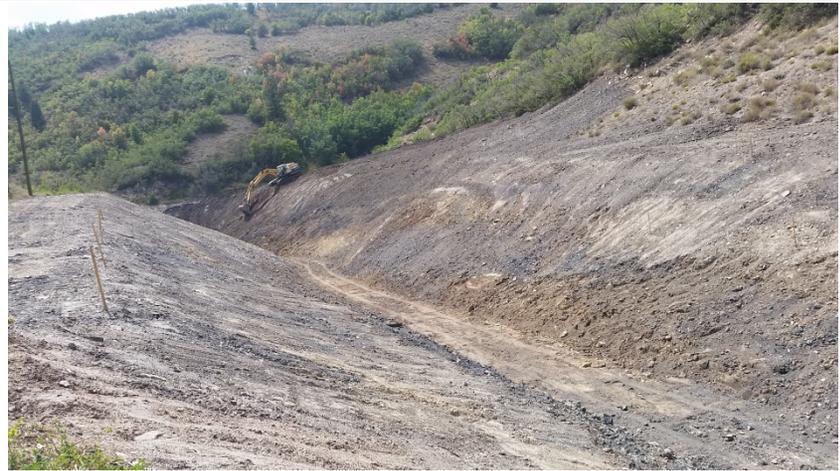
PHOTO 10 Taken from the top of the finished slopes to the east of the channel. These slopes are ready for roughening/topsoil placement.

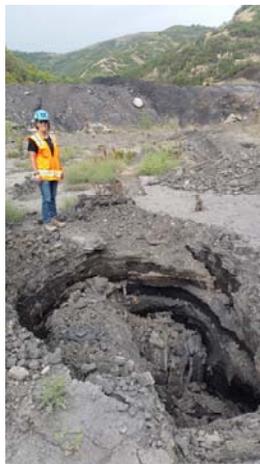
PHOTO 11 The test pit in the bottom of the sed pond with 5' Priscilla for scale. It appears to be coal fines from top to bottom.

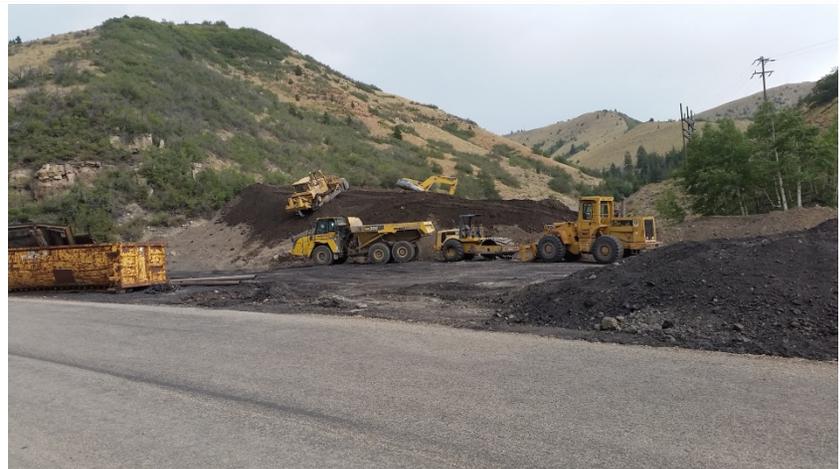
PHOTO 12 All of the machinery currently on site. Looking north from the paved county road.

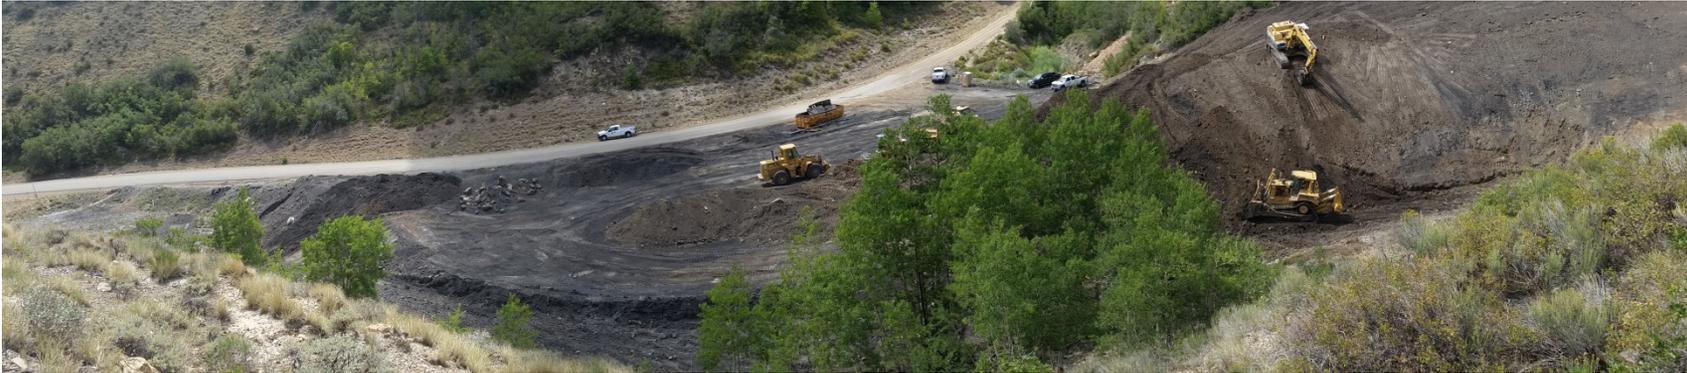
PANORAMA 1 Taken from a location on the hillside just south of the power poles. This gives a view of Steve and Dal finishing the channel emerging from portal Canyon on the right. The lower pad area is in the center, and the sediment pond is on the far left.

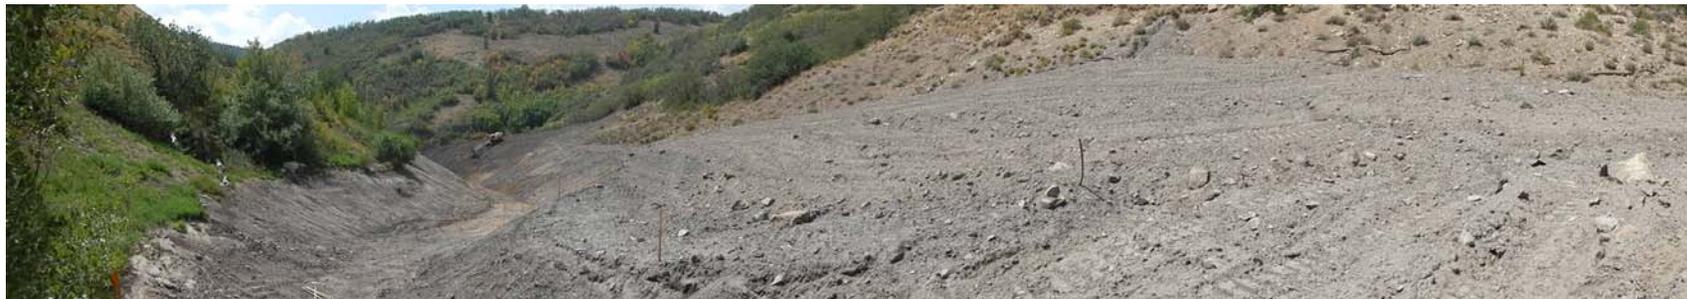
Panorama 2 Taken from the quaking aspen on the East slope at the base of the topsoil pile, showing Portal Canyon.
