DEPARTMENT OF NATURAL RESOURCES
DIVISION OF OIL, GAS AND MINING

TO: Susan Linner, Permit Supervisor
FROM: Lynn Kunzler, Reclamation Biologist *L. K.*
RE: As-Built Plans and Site Conditions, North American Equities, Inc., Blazon #1 Mine, ACT/007/021, Folder #2, Carbon Co., Utah.

BLAZON #1 MINE REVEGETATION	
Approximate Areas of Potential Revegetation Problems

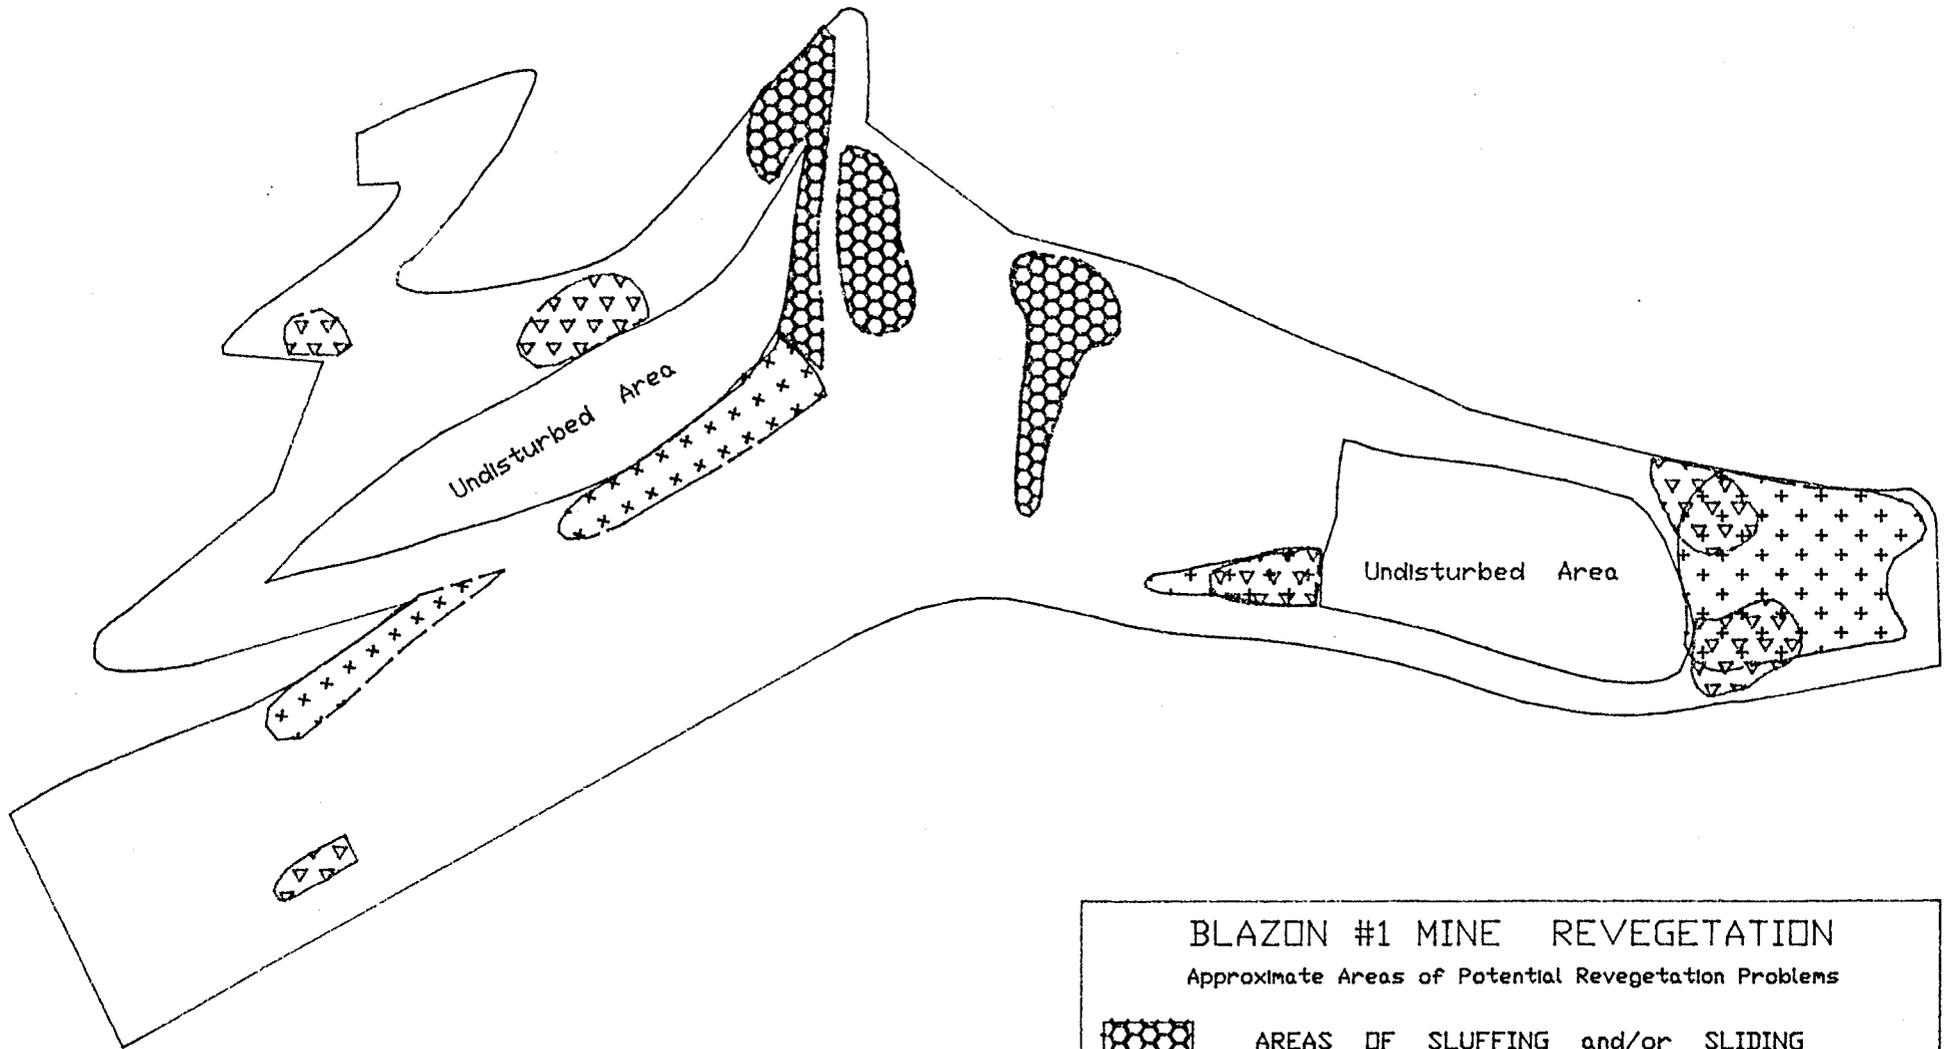
Please refer to the attached drawing entitled Blazon #1 Mine Revegetation for the following comments. Please note, the drawing is not necessarily to scale and the areas depicted represent only the approximate location and extent of revegetation problems. The actual size, shape and location may vary significantly:

1. During the site visits, several areas were noted that have either sluffed/or experienced slides (surface failure). This type of instability generally removes seeded materials and

thus would require retreatment of revegetation practices. Since the area in the Little Snider Drainage experienced sluffing (the area was hydromulched), NAE will need to provide better surface stability such as using curlex blankets as mulch. The slide area on the reclaimed portal slope will need to be revegetated.

2. Several areas were observed in the field that were not hydromulched as required by the plan, including the topsoil storage area and culvert A, the cut slope east of the pad, the disturbed area between the sediment pond and the reclaimed transformer road, and disturbed areas between Mud Creek and the access road. The Division is uncertain at this time whether these same areas were seeded or not. NAE will be required to (sic) reseed and mulch these areas if adequate vegetation does not establish this year (Adequate vegetation in this instance refers to the general level of vegetation on these sites as compared to other revegetated areas and not to meeting the revegetation success criteria). Also, these areas need to be indicated on Plate 1.

3. Several areas were observed where straw had been scattered. As noted in previous correspondence, this straw was contaminated with viable noxious weed seed. Depending on the establishment of the noxious weeds and the type and level of weed control needed, these areas may also require revegetation after weed control.

Before the Division can approve the as-built plans, NAE must address the above comments, including time frames for implementation of the necessary contingency plans and the submittal of an accurate as-built map. Before the serviceberry contingency plan can be approved, the 1990 planting window must be identified and proof that the serviceberry plants are ordered must be provided to DOGM.
