DEPARTMENT OF NATURAL RESOURCES  
DIVISION OF OIL, GAS AND MINING

December 1, 1989

Re: TDN X89-02-116-2, TV3, Blazon #1 Mine, ACT/007/021, Carbon County, Utah

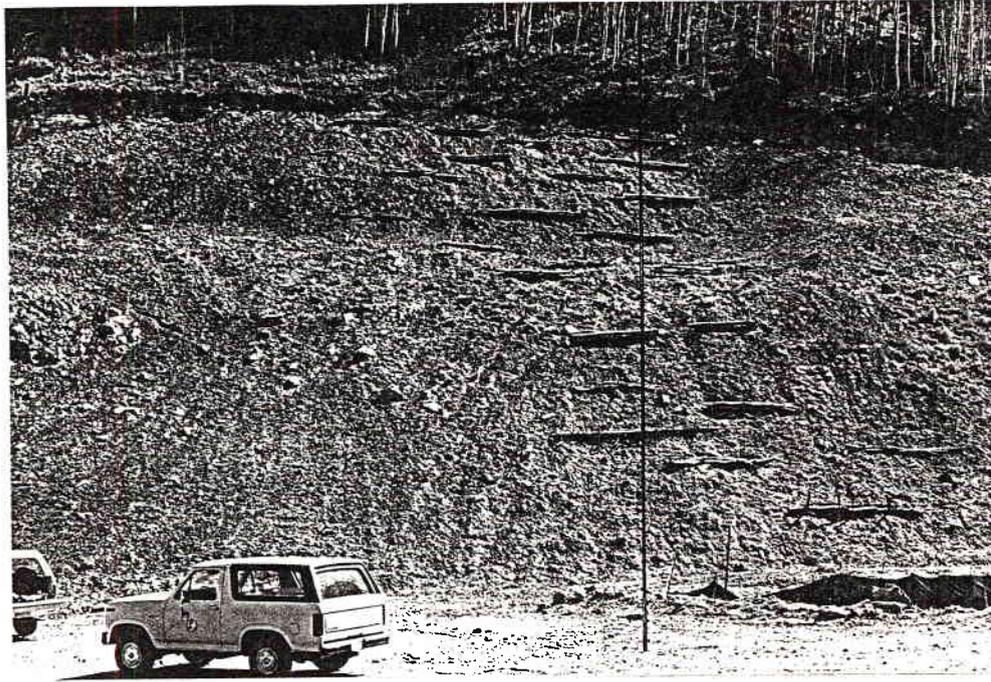
Number 1 of 3 reads: "Failure to eliminate or reduce all highwalls to closely resemble the general surface configuration of the surrounding terrain. Includes highwalls remaining on backfilled portal slope; former access road cut; and highwall east of the concrete pad which also contains an exposed coal seam."

Clearly, approximate original contour has been achieved, and compliance with UMC 817.101 (b)(5)(ii) "...highwalls shall be reduced or eliminated as determined by the Division" (emphasis added) has been achieved. I have enclosed a photograph of the highwalls in question also showing the undisturbed slope that demonstrates that the topographic relief of the remaining highwalls does not remotely approach the topographic relief of the mine environs ("general surface configuration of surrounding terrain" as cited in the TDN). I believe this is also demonstrated by the topographic profile of which I have also enclosed a copy.

(Approx) topographic profile

Photo illustrating a portion of the highwall in question, depicting the line of topographic profile drawn through the reclaimed area

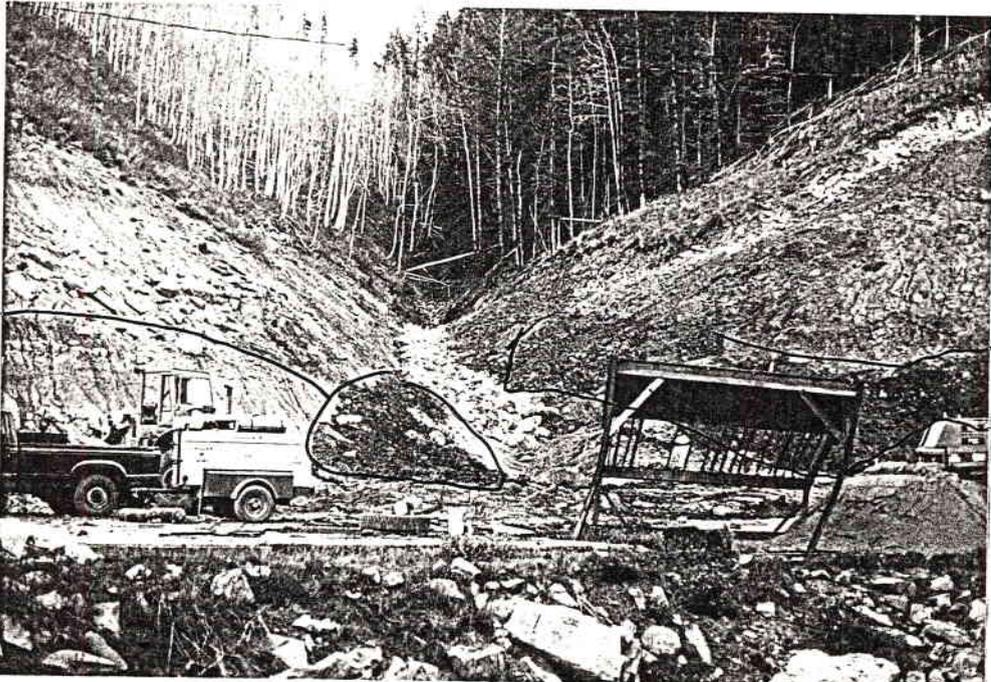
Number 2 of 3 reads: "Failure to dispose of underground development waste as approved in the Mining and Reclamation Plan (MRP) for permit INA/007/021. Waste materials were used as backfill on the slope northeast and adjacent to the Little Snyder Canyon culvert inlet area."

3. The material in question is well above the highwater zone of the Little Snyder drainage, as is demonstrated by the photo enclosed that shows location of the questionable materials, the drainage, and the rip rap designed to protect the areas adjacent to Little Snyder drainage. Backfilled materials of this nature were placed on the opposite side of Little Snyder drainage in accordance with the approved MRP.

4. All of the drainage from the area cited in the TDN reports to a sedimentation pond.
5. As a practical rather than a regulatory consideration, the estimated volume of the material in consideration is less than 20 cubic yards. Removal of this material would have jeopardized reclamation already completed, while the burial, reseeding and plan modification allowed by the Division fostered pragmatic, cost effective reclamation by the operator and is in concert with the approved MRP.

Plan modified to allow placement of these materials in advance of TDN

MRP allowed placement of these materials

Photo showing location of underground development waste being placed with respect to ripraped channel and Little Snyder culvert head (prior to covering). Note: these materials were approved for placement on the right side of the photo. The approx. 20 cubic yards that were the subject of the TDN are shown on the left side of the photo.

I recommend that number 2 of 3 be vacated on the basis of proper amendment of the plan in advance of the TDN, and submit that the Division is applying correct professional judgment in evaluating the technical merits of MRPs.
