### Division of Oil, Gas and Mining

# Inspection Report

Permit Number:	C0070021
Inspection Type:	COMPLETE OVERSITE
Inspection Date:	Wednesday, June 12, 2013
Start Date/Time:	6/12/2013 8:00:00 AM
End Date/Time:	6/12/2013 12:00:00 PM
Last Inspection:	Monday, August 06, 2012

Site: **BLAZON #1 MINE**

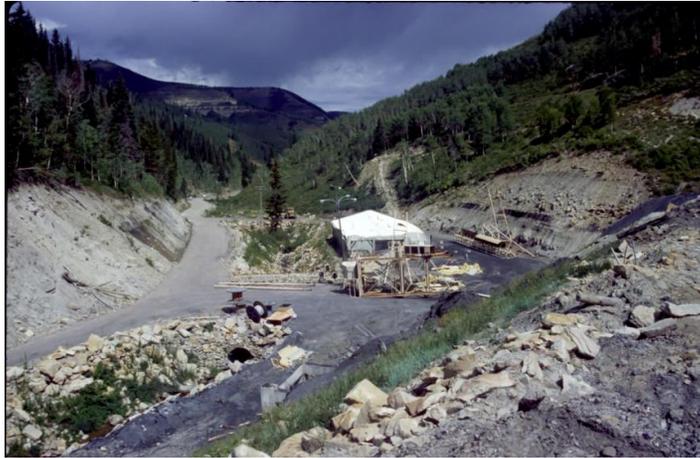
2000 BEFORE looking downstream before stream restoration (note pine tree to left of structure)

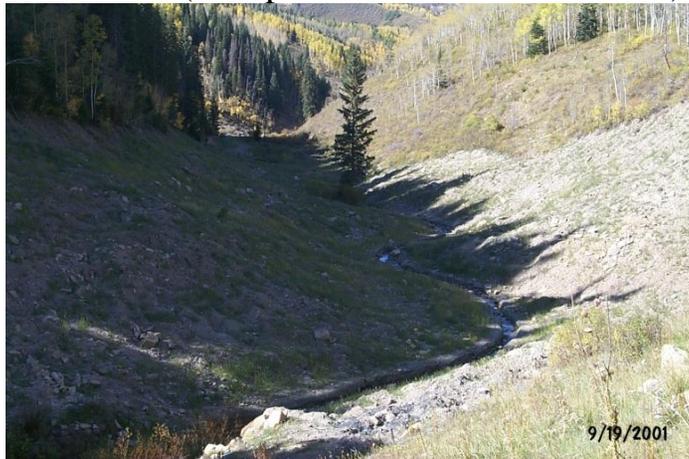
2001 AFTER looking downstream at reconstructed stream channel (note same pine tree is preserved).

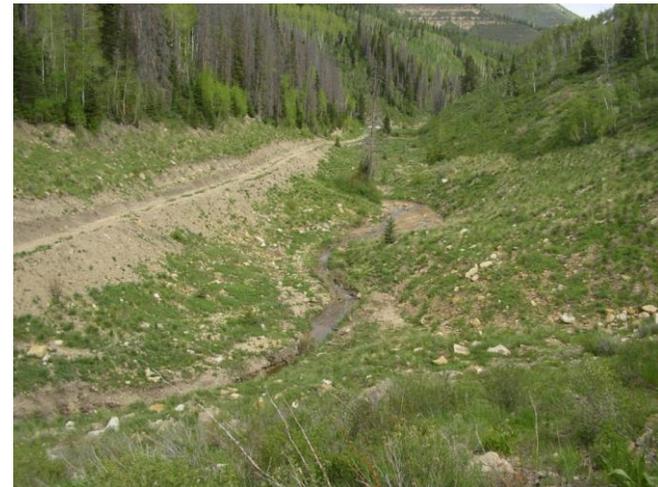
A road was constructed prior to August 6, 2012. It is assumed that the landowner made this road.

2013 looking downstream at reconstructed channel (Note: road blazed by new owner)

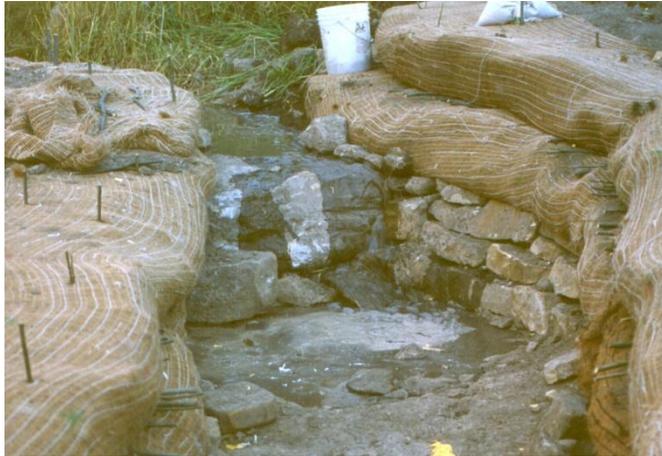
2000 constructed drop structure

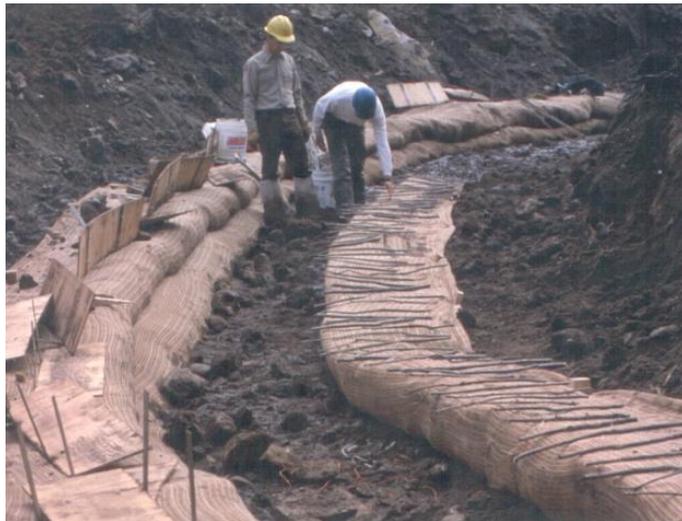
2000 willow cuttings laid between layers of burlap reinforced stream bank

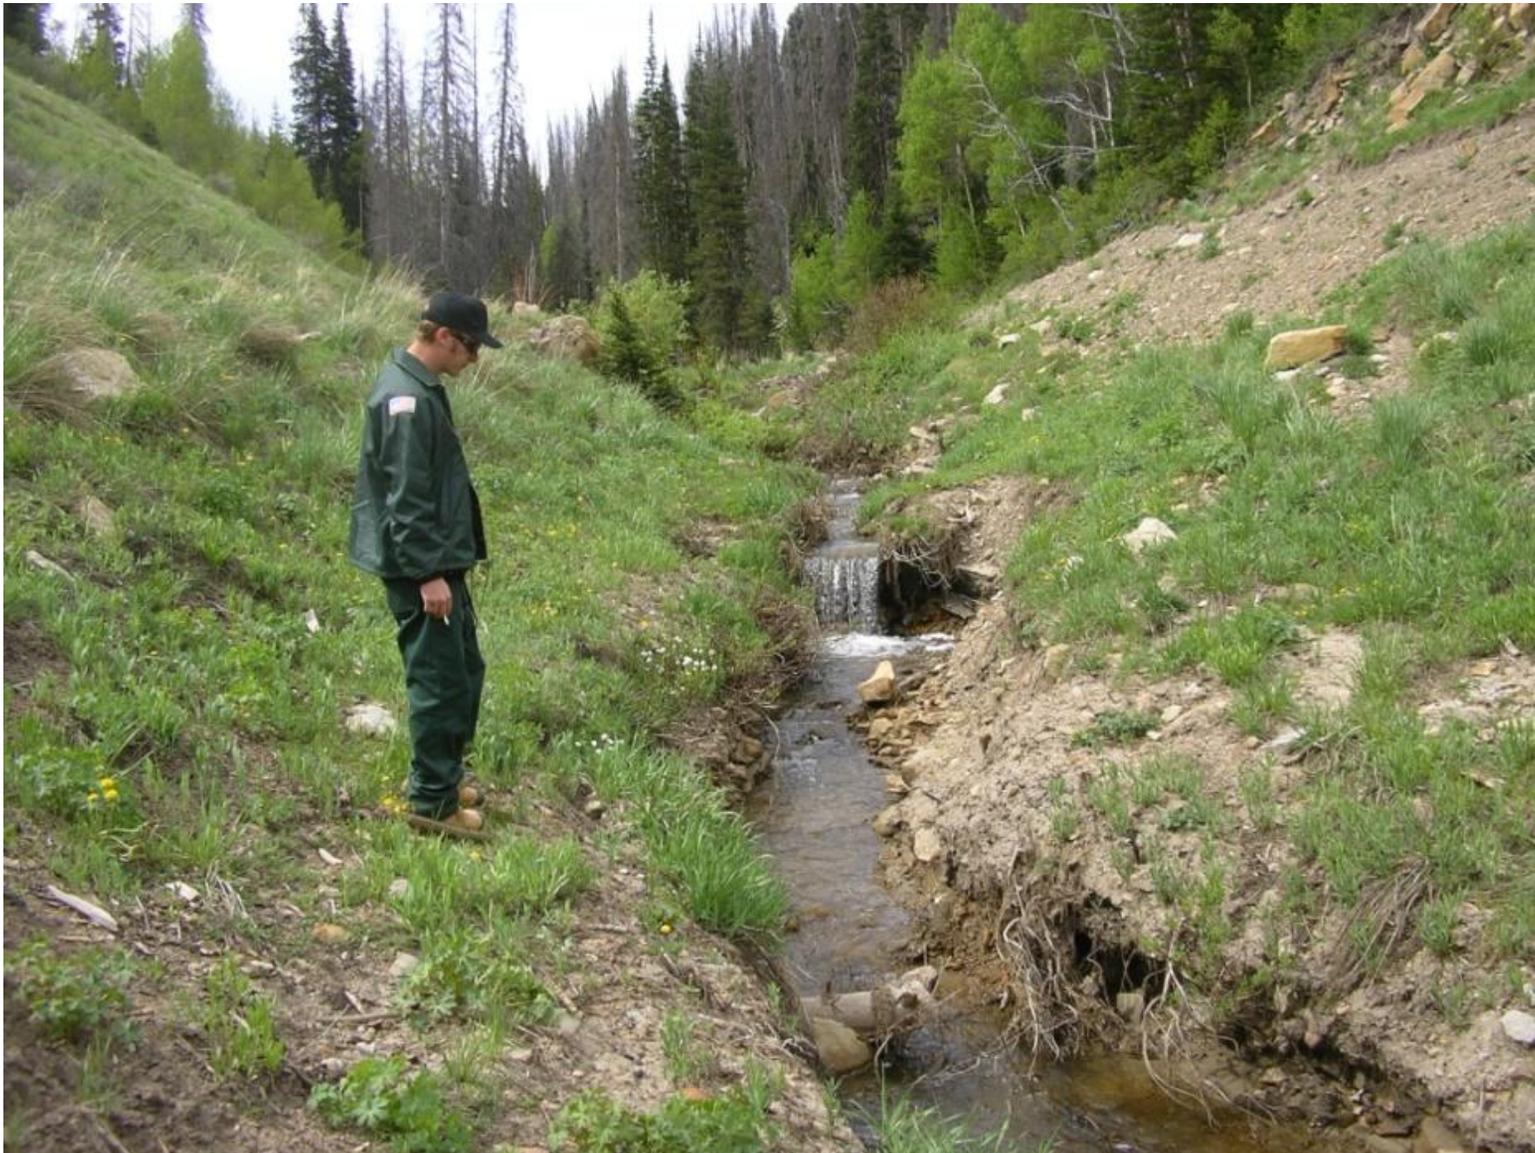
The site has been pocked. There were no signs of erosion to the land except to one minor section of the stream bank. This was caused by high water flow.

The road was made and the dirt was side casted. There are a couple places along the road where the material has eroded along the slopes of the road. This material does not enter the creek do to the vegetation.

2013. Stream banks have stabilized. Drop structures in the stream channel are functioning. Recent high flows have cut stream bank. Road outslope is visible on the right above the stream.

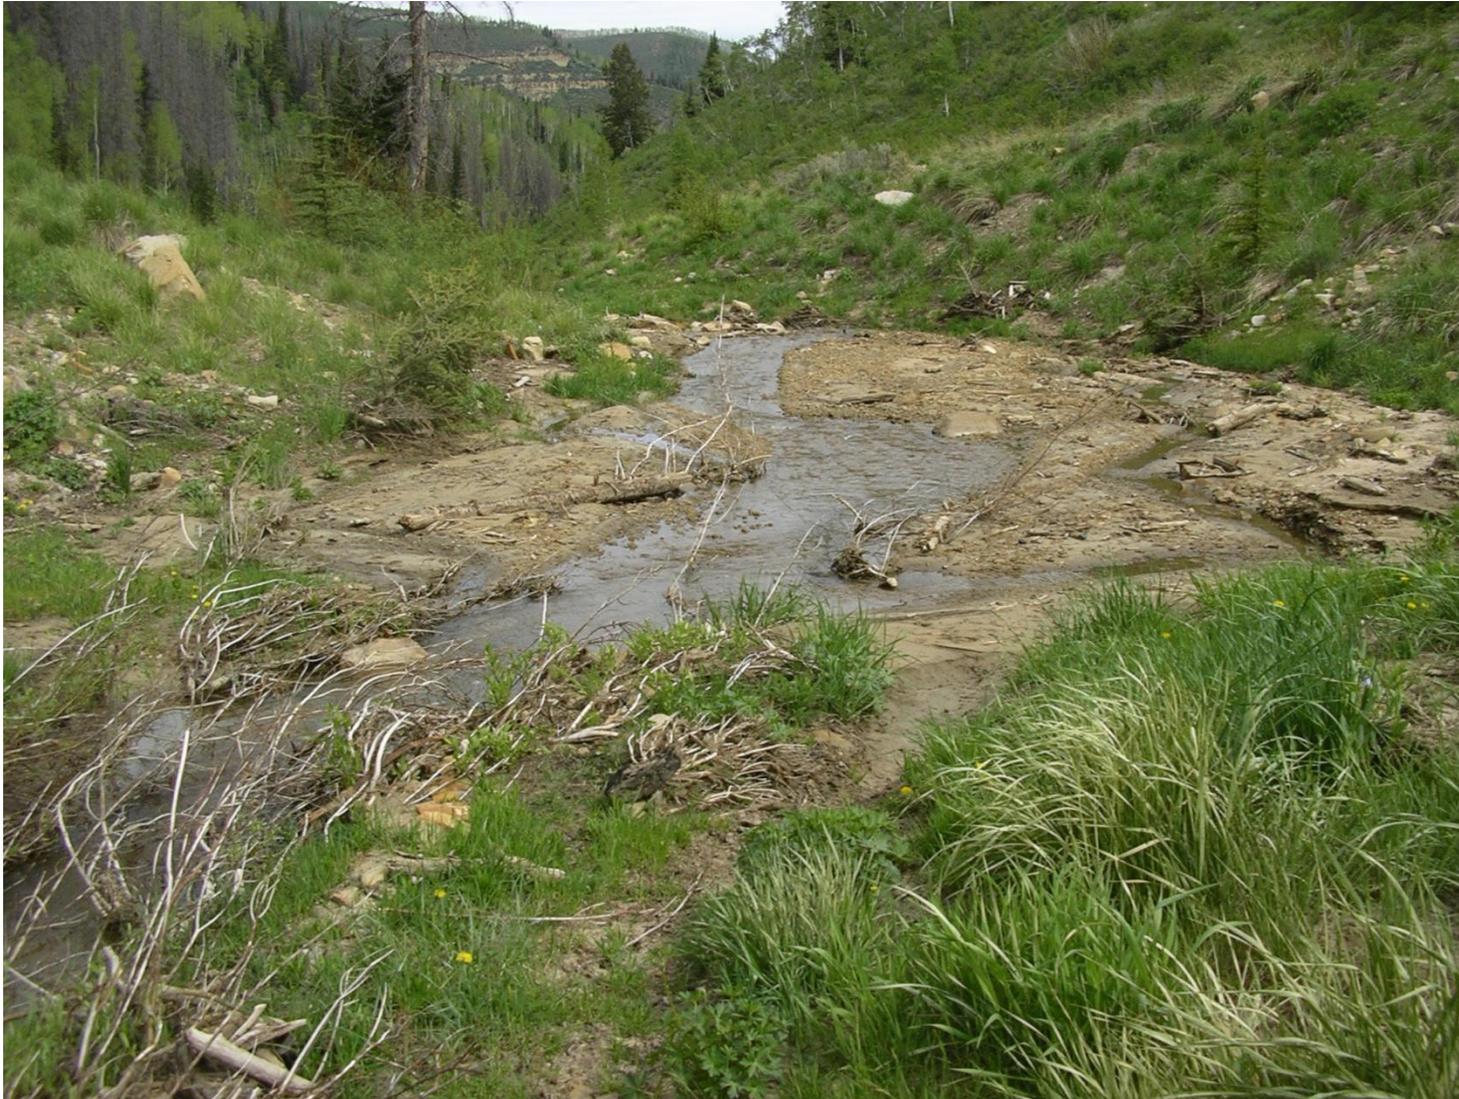
There were changes to the stream since the last inspection on August 6, 2012. The stream had heavy flow and over cap the banks. This caused sediment deposition and wood on the banks of the stream. The stream did very well to handle the excess water flow. The excess water came from last year's forest fire above the reclaim site. This same condition happened at the Star Point reclamation site causing the main diversion to erode. The Blazon stream did not erode but deposited sediment and wood.

The site has sufficient vegetation. The vegetation around creek was beaten down due to creek overtopping.

2013. Stream overflowed its banks and deposited sediment along channel, creating a braided stream channel.

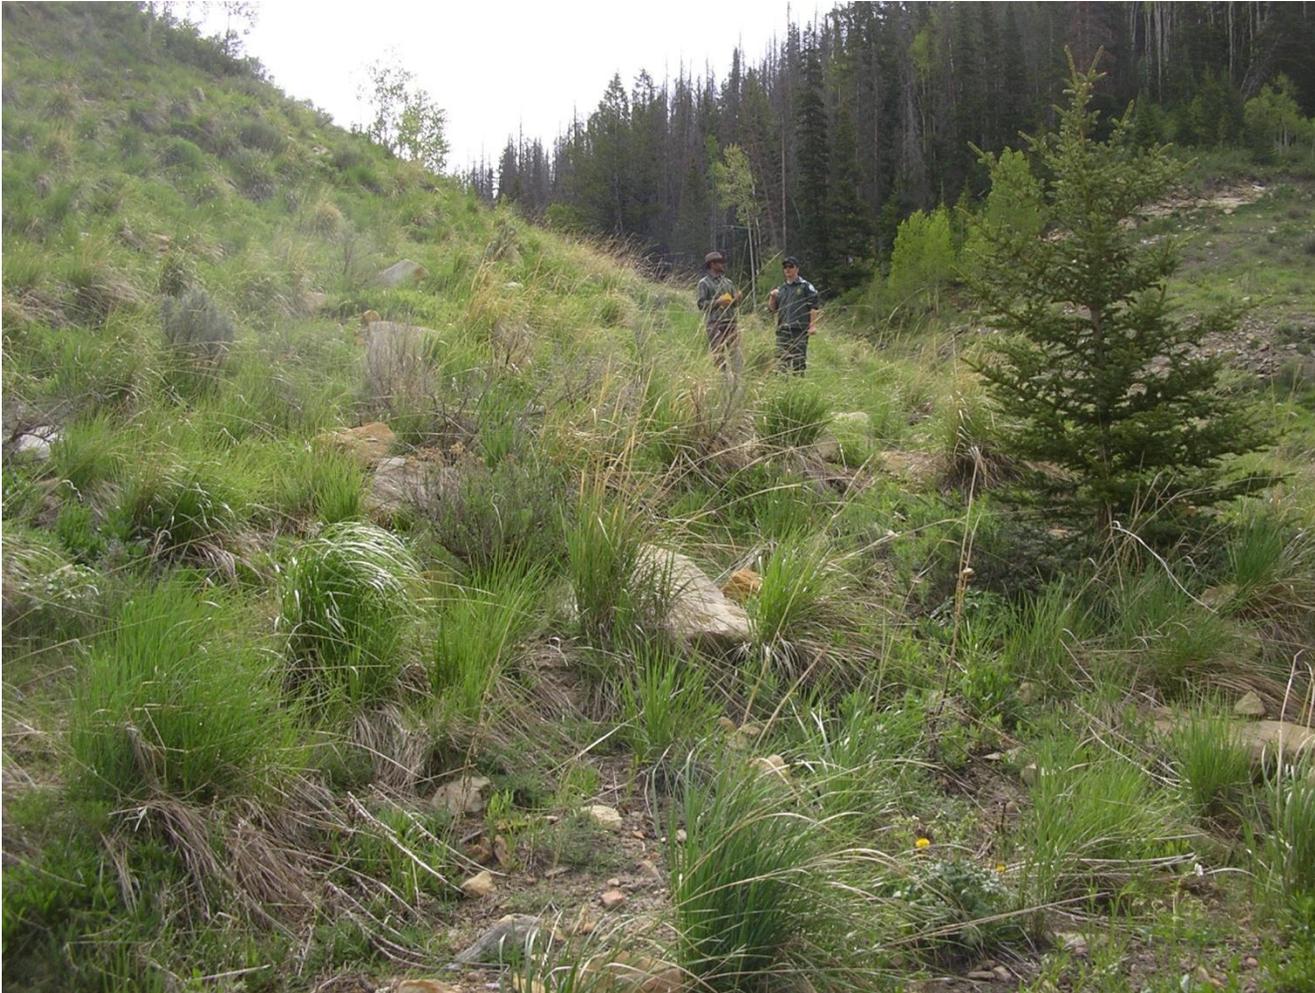
2013. Reclaimed slopes of Little Snider (side canyon).

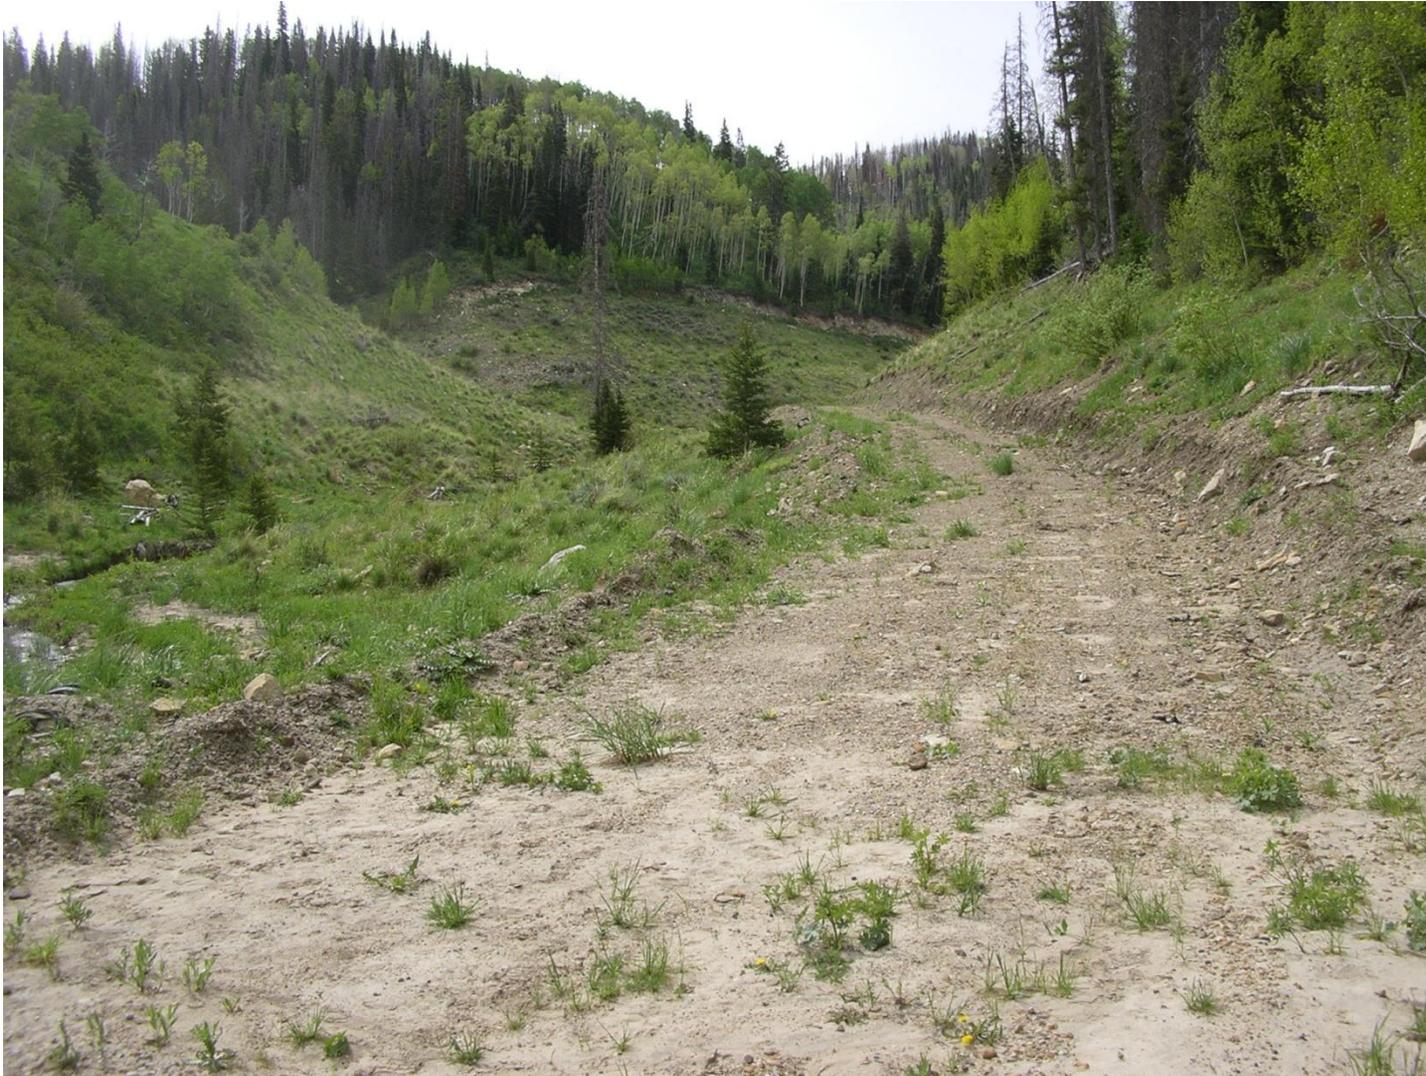
2013. Locked gate blocks access to new road cut into the site in 2012.  
Reclaimed slope visible on left side of photo.
