DEPARTMENT OF NATURAL RESOURCES
DIVISION OF OIL, GAS AND MINING

March 11, 2002

RE: Technical Field Visit, Topsoil Stripping, Savage Industries Inc., Savage Coal Terminal, C/007/022

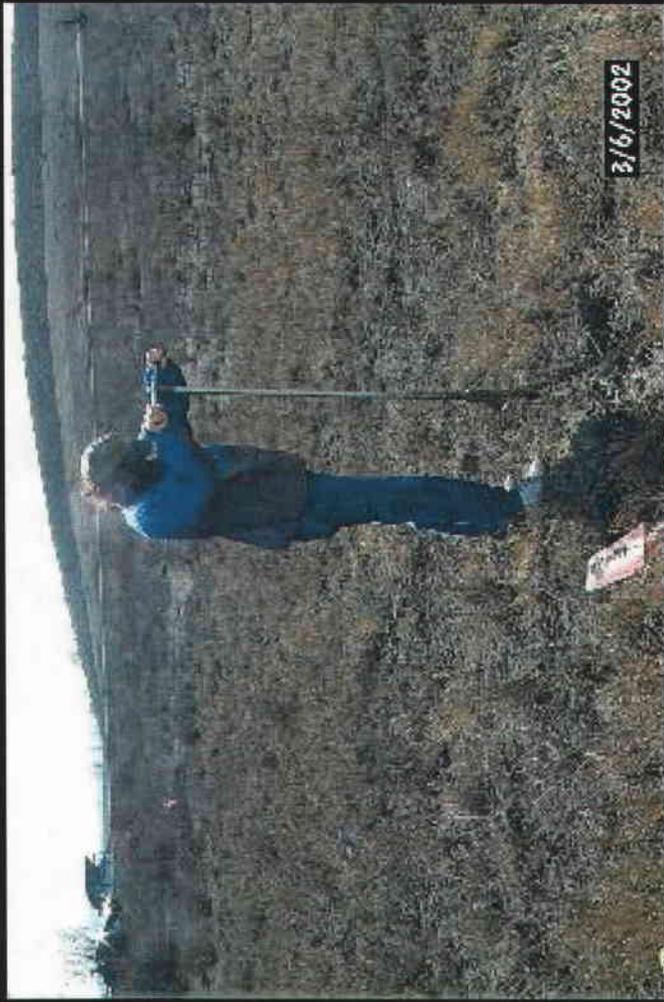
p0003409.jpg

indicate that topsoil would not be salvaged from the area. Visual observation of the flagged area revealed almost 100% cover by non-weedy species, predominantly saltgrass (*Distichlis*). For this reason, a soil sample was composited from eight subsamples within the flagged area (Sample #1, attached image P0003409.jpg). Subsamples were drawn from 0 – 6 inches, the projected depth of soil salvage.

Soil Sample Map Unit	pH	EC (mmhos/cm)
Flagged Area (Saltair Silty Clay and/or Killpack Silt Loam)	7.7	4.8
Southeast half of area to be disturbed (Chipeta Silty Clay)	7.4	2.9
Northwest half of area to be disturbed (Chipeta Silty Clay)	7.8	2.6

The flagged area soils had good structure and aggregation and supported a thriving vegetative community. The pH and EC of the flagged area soils was suitable for native plant species growth. Therefore, soils within the flagged area should also be included for topsoil salvage.

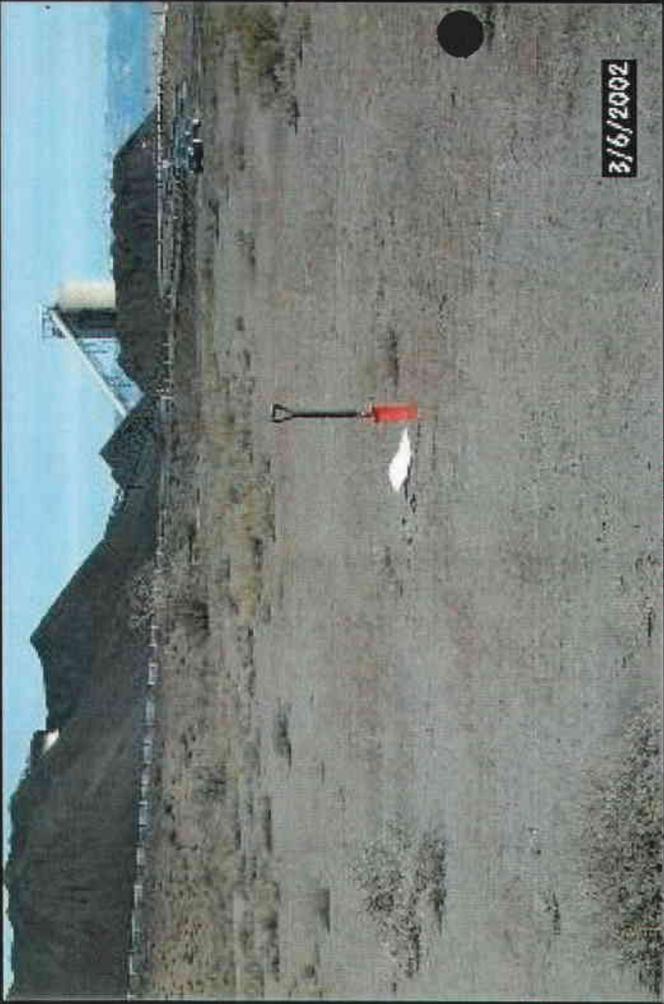
p0003422.jpg

Two more soil samples were drawn from the Chipeta soil, representing: a) the southeast area supporting only sparse vegetation (Sample #2, attached image P0003422.jpg) and b) northwest area supporting a vegetative community of shrubs and grasses (Sample #3, attached image P0003423).

Sample #2 (southeast Chipeta soils) was a composite of 8 subsamples drawn from a 0 – 6 inch depth. Sample #3 (northwest Chipeta) sample was a composite of 4 subsamples from 0 – 6-inch depth. The disparity in the number of subsamples was due to the soil development in Sample #3 soil that allowed the soil to remain aggregated on the spade and provided a greater sample size per hole to the sample bag. Sample #2 soil was very loose and had very little soil profile development, consequently, only about half of the soil lifted from sub-sample holes remained on the spade and then the hole was filled with loose, fine particles from the surface, so that a new hole had to be dug to get adequate representation of the six-inch depth soil.

The southeast half of the area to be disturbed had no aggregation or profile development. It appeared as though these soils may have been disturbed in the past by vehicle traffic, although that is not indicated by Plate 3-1. Soil aggregation and profile development in this soil type is the key to soil infiltration. Water penetration of the soils can be improved by management practices such as incorporation of organic matter into the soil (i.e. test plot #2) and by creating microbasins to trap moisture and hold it long enough for it to infiltrate (i.e. evidenced by the subsoil pile terraces). Limiting the south exposure of the piles would also increase moisture content in the soil.

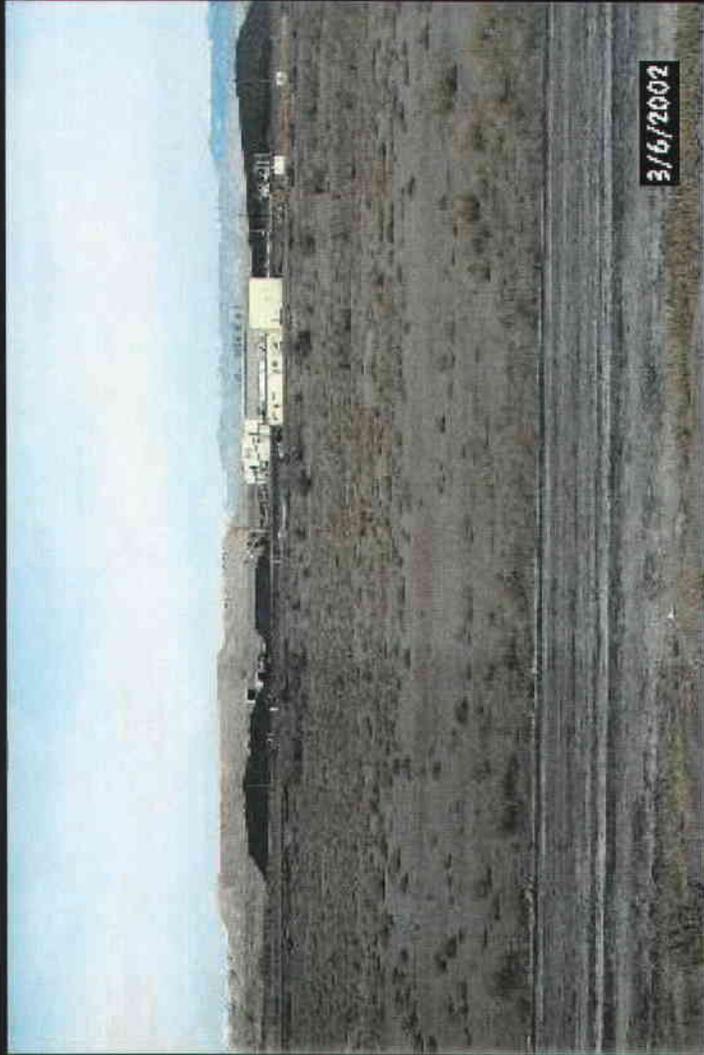
p0003412.jpg

The soil to be disturbed for additional coal storage is shown on Plate 3-2 of AM02A and in the attached image P0003412.jpg. Soils had been previously mapped and are shown on Plate 8-1 as Chipeta Silty Clay, Killpack Silt Loam, and Saltair Silty Clay Loam. Soil in the vicinity of the Killpack Silt Loam and Saltair Silty Clay map units had been flagged by the Permittee to

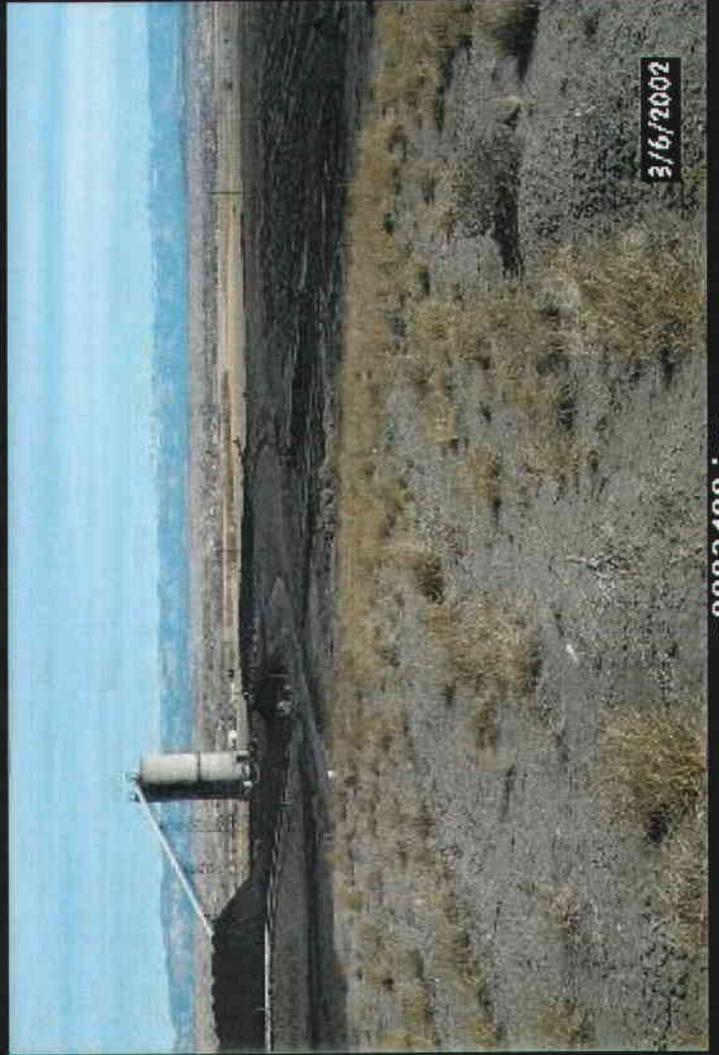
p0003420.jpg

The area of refuse storage has diminished as shown in attached image P0003420, but is not progressing as scheduled in Figure A3-4-1. The refuse pile was being re-mined at a rate of 2,000 tons/day through August of 2001. In September, that rate fell to 450 tons/day and by October 2001, re-mining had stopped entirely.

Although no re-mining of the refuse pile is occurring at present, it appears that there is a large area that could either serve as coal storage or be contemporaneously reclaimed with live-hauled topsoil from the proposed coal storage location.
