Wild West Equipment & Hauling, LLC
Wildcat Load Out
5495 West 3550 North, Helper, Utah 84526
P.O. Box 1, Price, Utah 84501
Phone: (435) 472-3988 – Fax: (435) 472-3456

Re: C/007/033 Wildcat Loadout 2013 Annual Report

WILDCAT LOADOUT REFUSE PILE INSPECTION REPORT

Quarterly Inspection Form - Refuse Disposal Areas

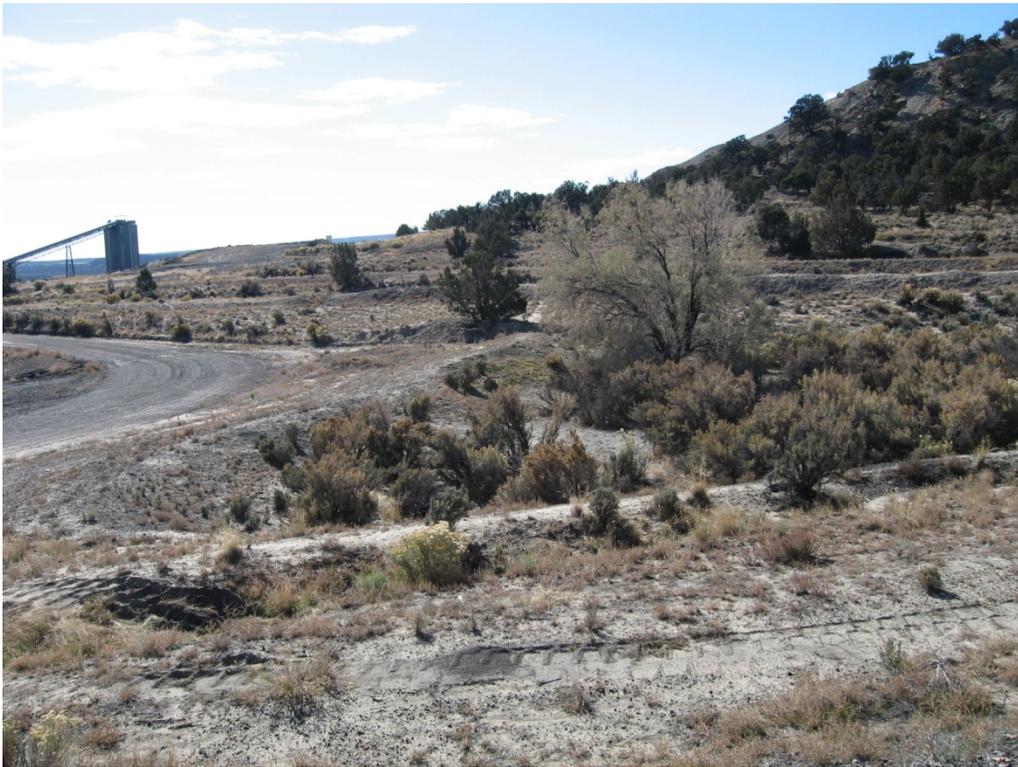
Permanent Impoundment (Lower Cell)

4. Field Information: Provide current water elevation, whether pond is discharging, type and number of samples taken, monitoring/instrumentation information, inlet/outlet conditions or other related activities associated with the pond including but not limited to sediment cleanout, pond decanting, embankment erosion/repairs, monitoring information, vegetation on out slopes of embankment erosion/repairs, monitoring information, vegetation on out slopes of embankments, etc.
During the annual inspection, November 6, 2013, the vegetative cover looked good with no signs of erosion. Both spillways look good with no signs of stability problems.

5. Field Evaluation: Describe any changes in the geometry of the impounding structure, average and maximum depths and elevations of impounded water, estimated sediment or slurry volume and remaining storage capacity, estimated volume of water impounded and any other aspect of the impounding structure affecting its stability or function which has occurred during the reporting period.
The sediment pond is dry, see the attached photograph. Sediment is approximately 24" below cleanout level.
