**WILDCAT COAL FINES ISSUE
DIVISION ORDER-04 (WIND BLOWN FINES)
FIRST QUARTER 2014**

March 28, 2014

WILD WEST EQUIPMENT & HAULING, LLC

**J. T. Paluso, P.E.
EIS ENVIRONMENTAL & ENGINEERING CONSULTING
31 NORTH MAIN**

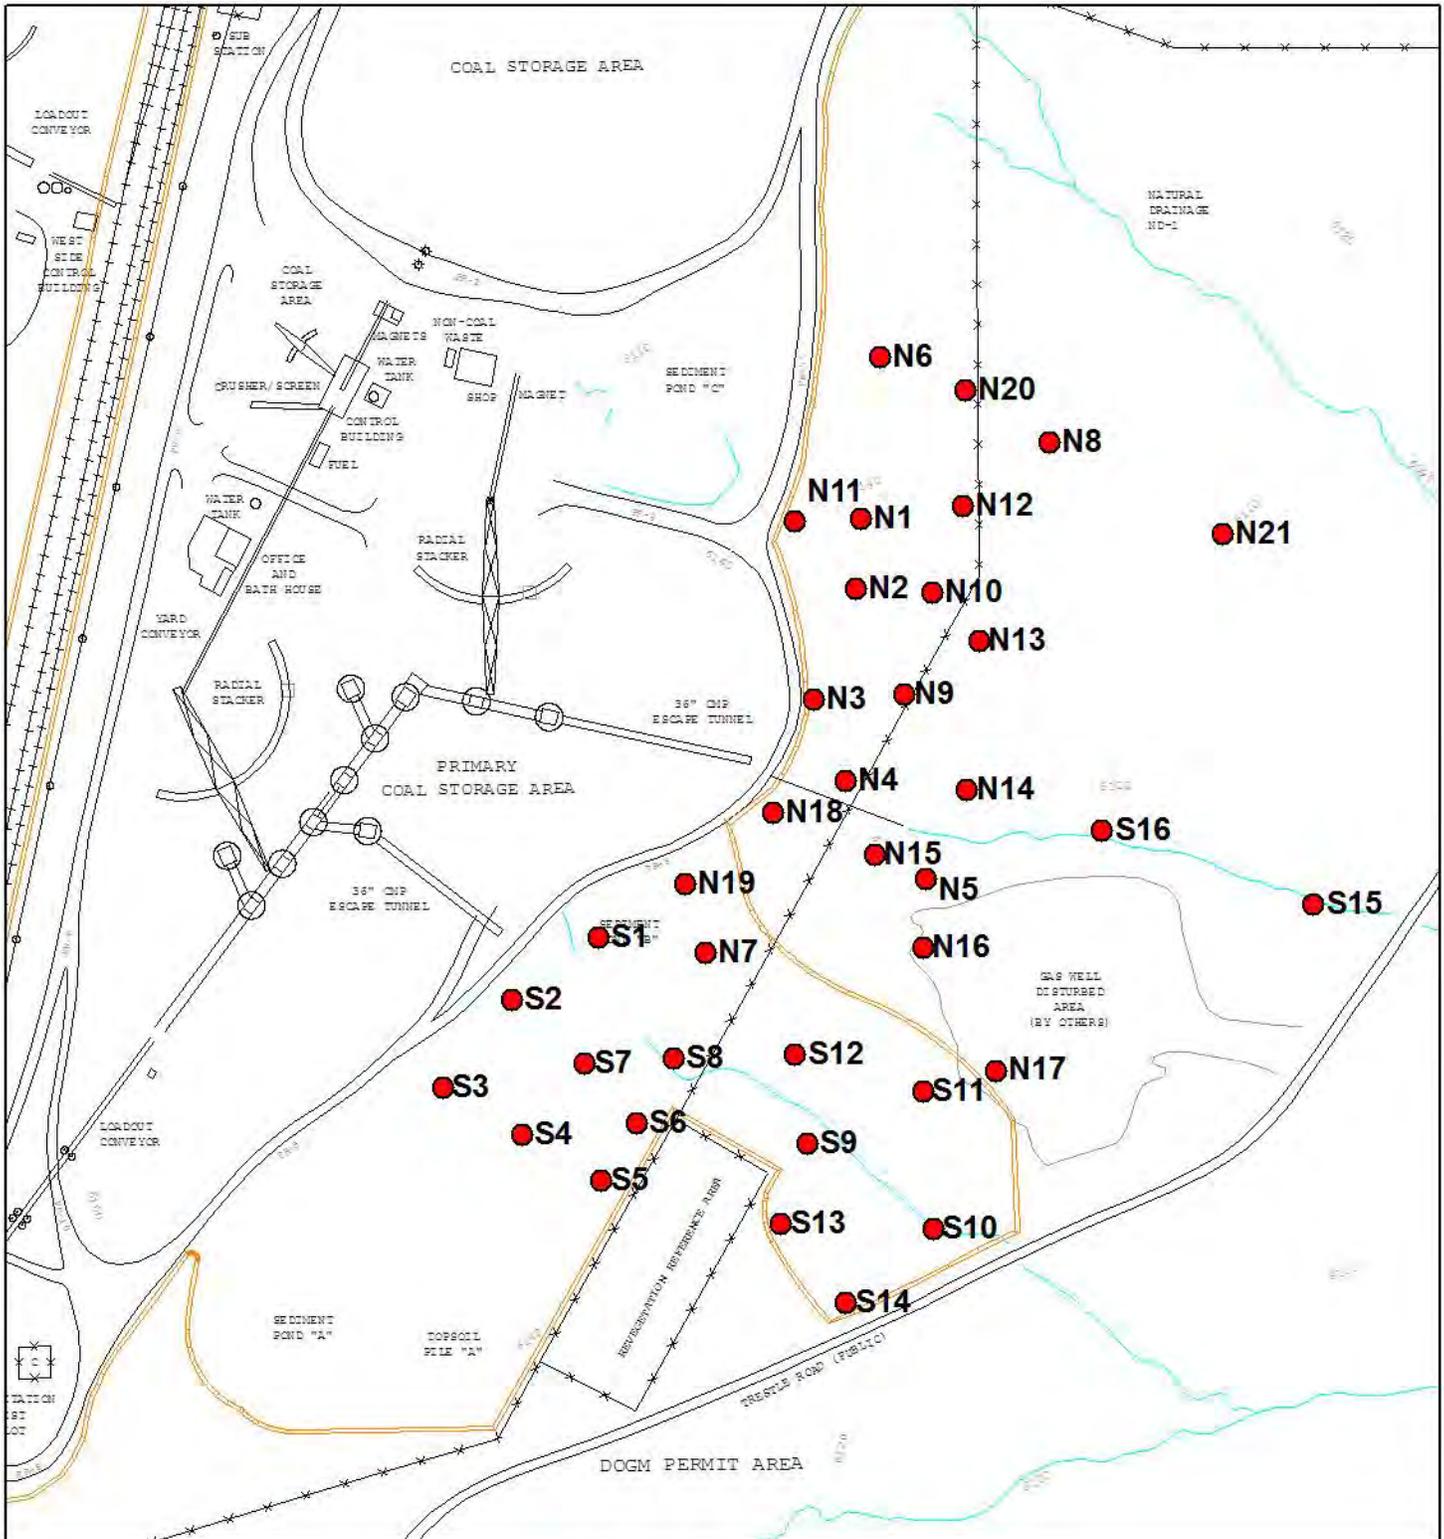
FIGURE 1

There are now 22 sampling points on the north area and 16 sampling points on the south area. Figure 1 shows the sampling points and Figure 2 shows the areas that are of concern. Each point was located with a GPS. Refer to Appendix 1 for the GPS coordinate location of each point.

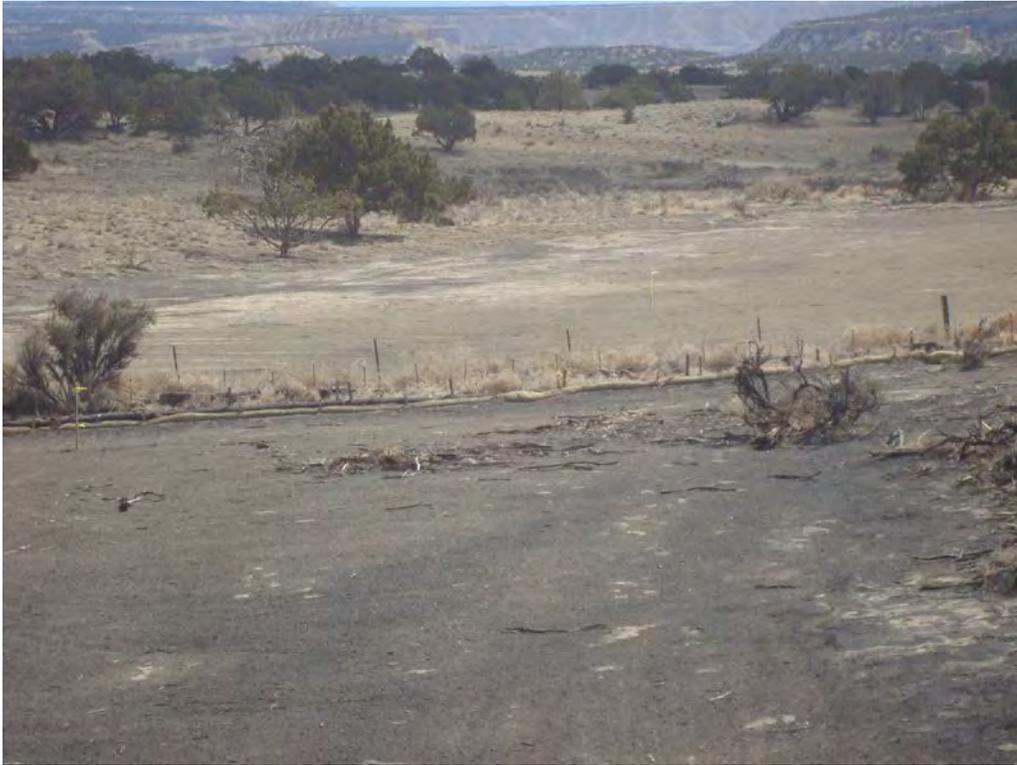
LOOKING EAST NEAR TRUCK ENTRANCE

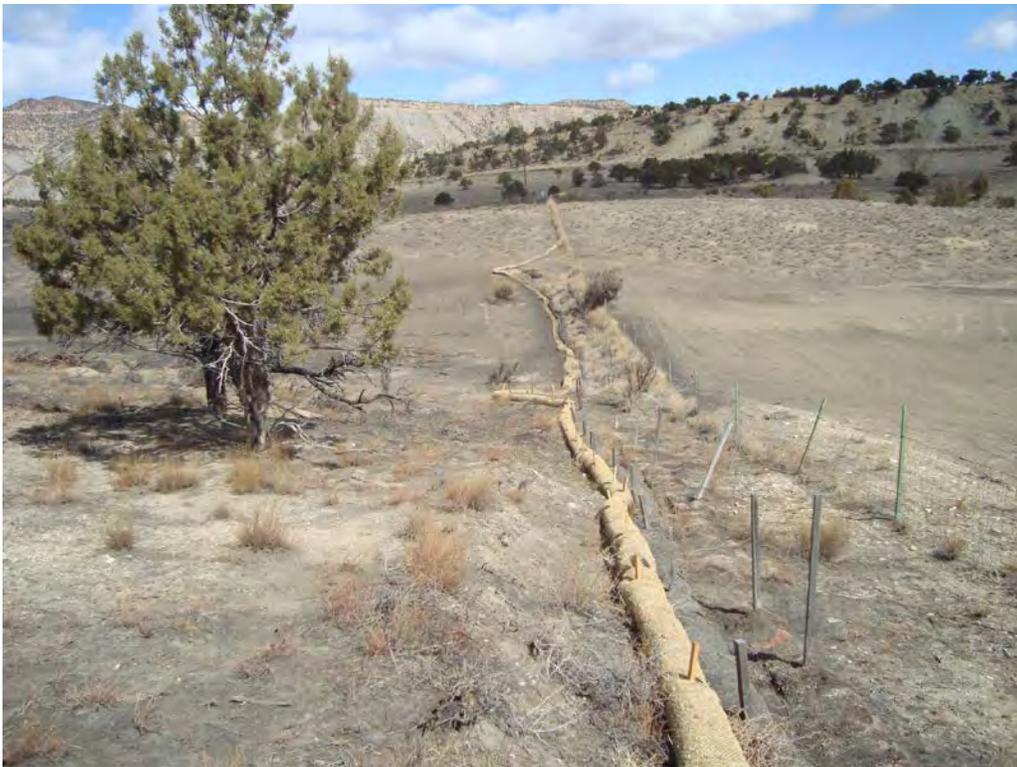
STRAW ROLLS LOOKING NORTH TOWARDS TRUCK ENTRANCE

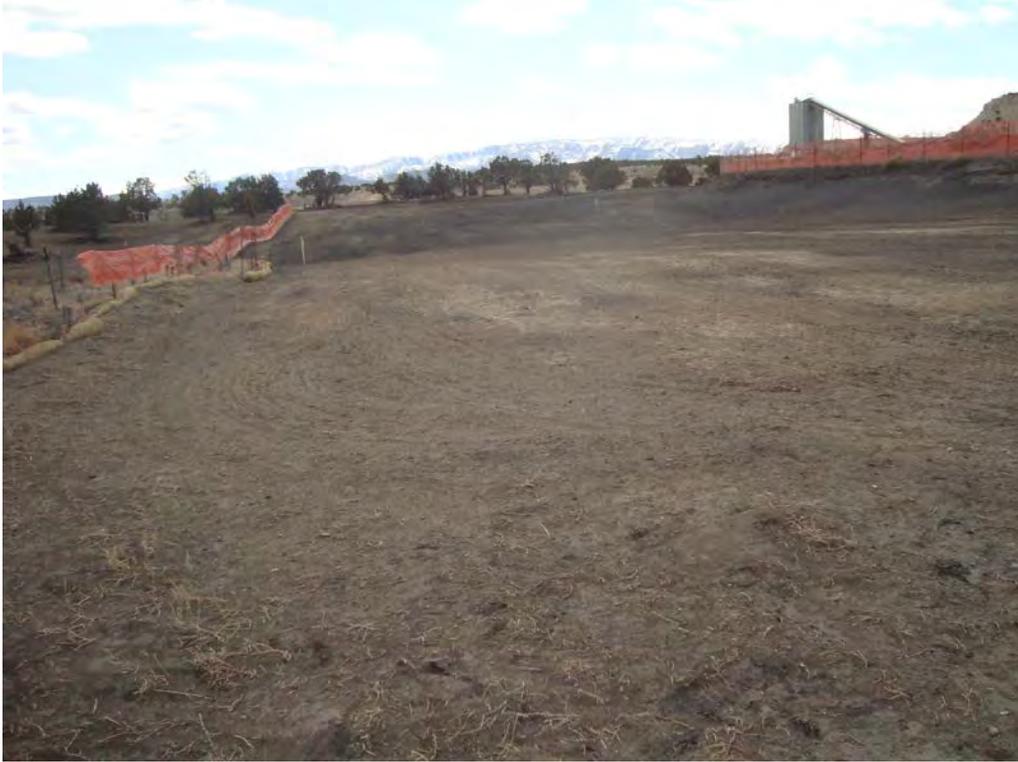
AREA CLEANED EAST OF COAL PILE LOOKING SOUTH
NEW STRAW ROLLS AND WIND FENCE
