Wild West Equipment & Hauling, LLC
Wildcat Load Out
5495 West 3550 North, Helper, Utah 84526
Phone: (435) 472-3988 – Fax: (435) 472-3456

Re: C/007/030 Wildcat Load Out 2014 Annual Report

Annual Report

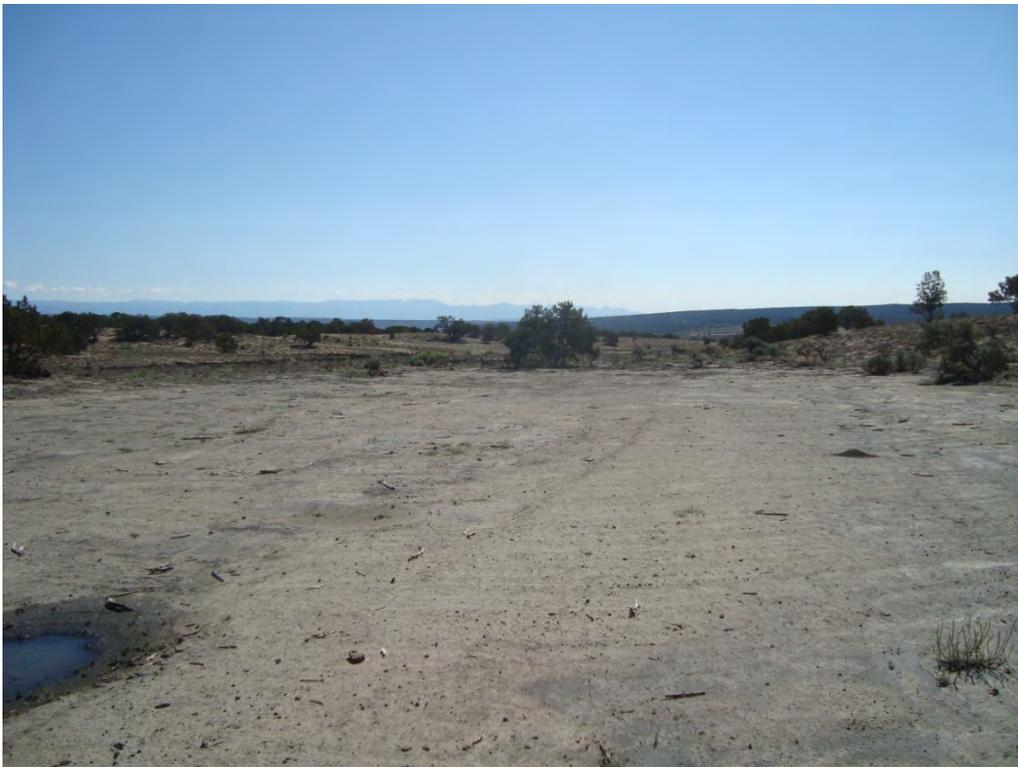
NORTHERN AREA LOOKING FROM N20 TOWARDS N21

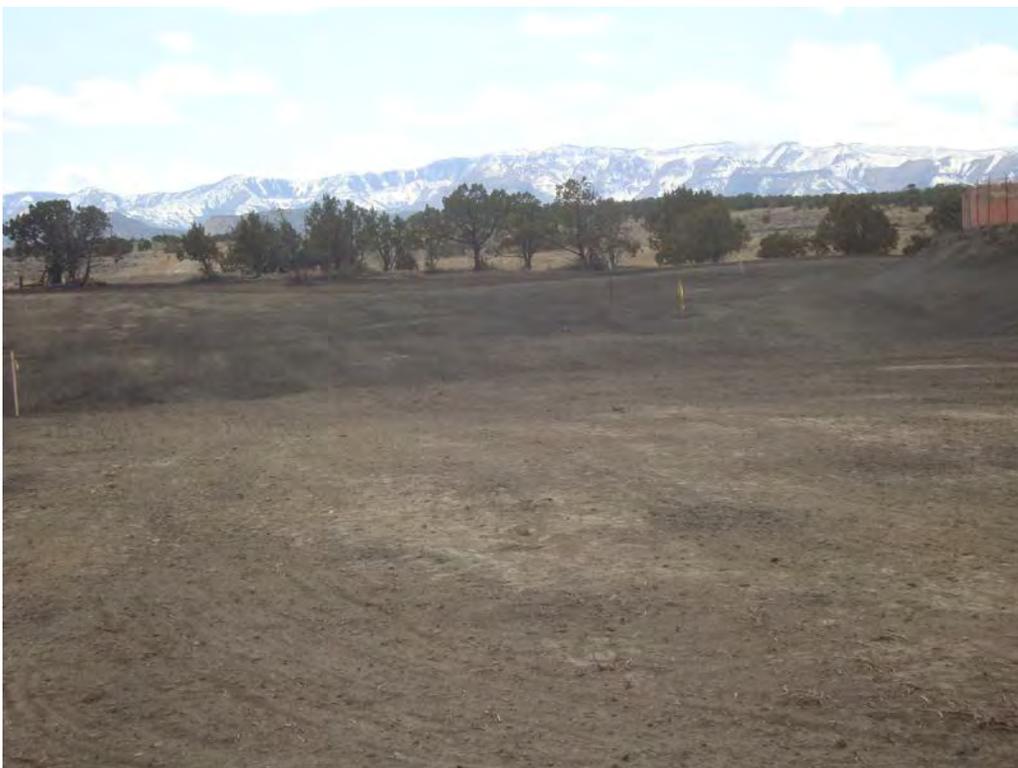
Areas that had coal fines accumulation of over 4” were cleaned during the month of March. New sediment control straw rolls were installed in these areas. In an attempt to control the movement of coal fines, new wind fences were installed on the east side of the coal pile and portions of the east permit boundary fence. The existing wind fence, on the road east of the coal pile, was also extended further to the north.

AREA CLEANED EAST OF COAL PILE LOOKING SOUTH
NEW STRAW ROLLS AND WIND FENCE

CLOSEUP OF SAME AREA

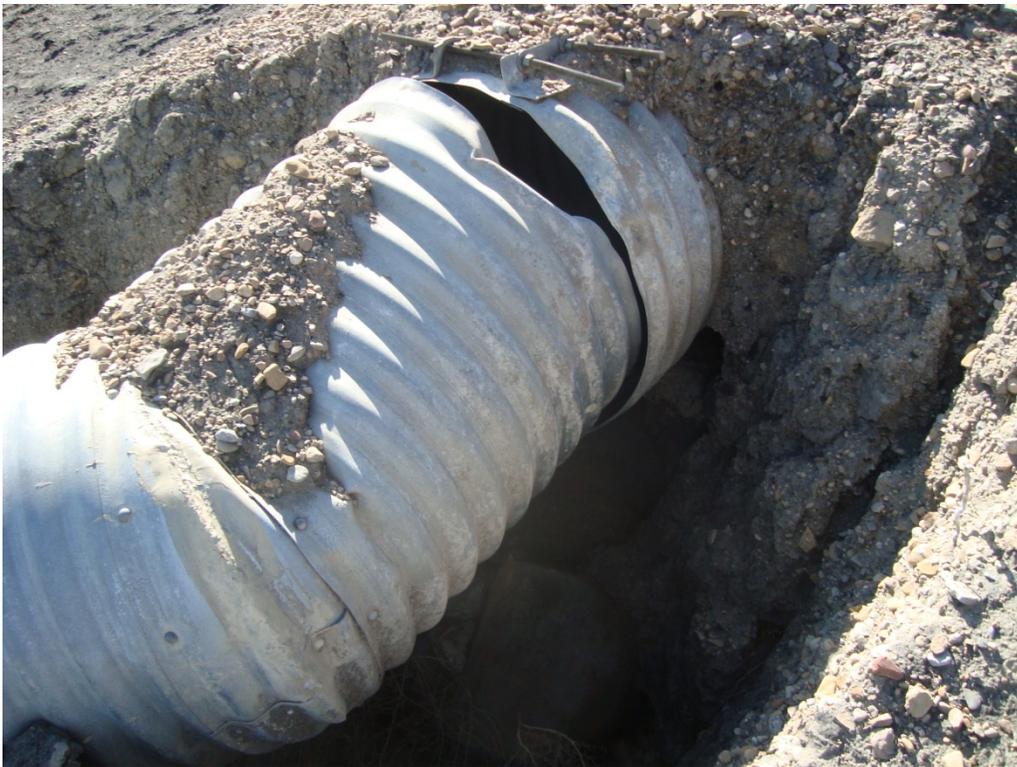
WEST INLET CULVERT BAND IS COMING OFF. PIPE
IS LEAKING & SHOULD BE REPAIRED

West Inlet Pipe Band Coming Loose

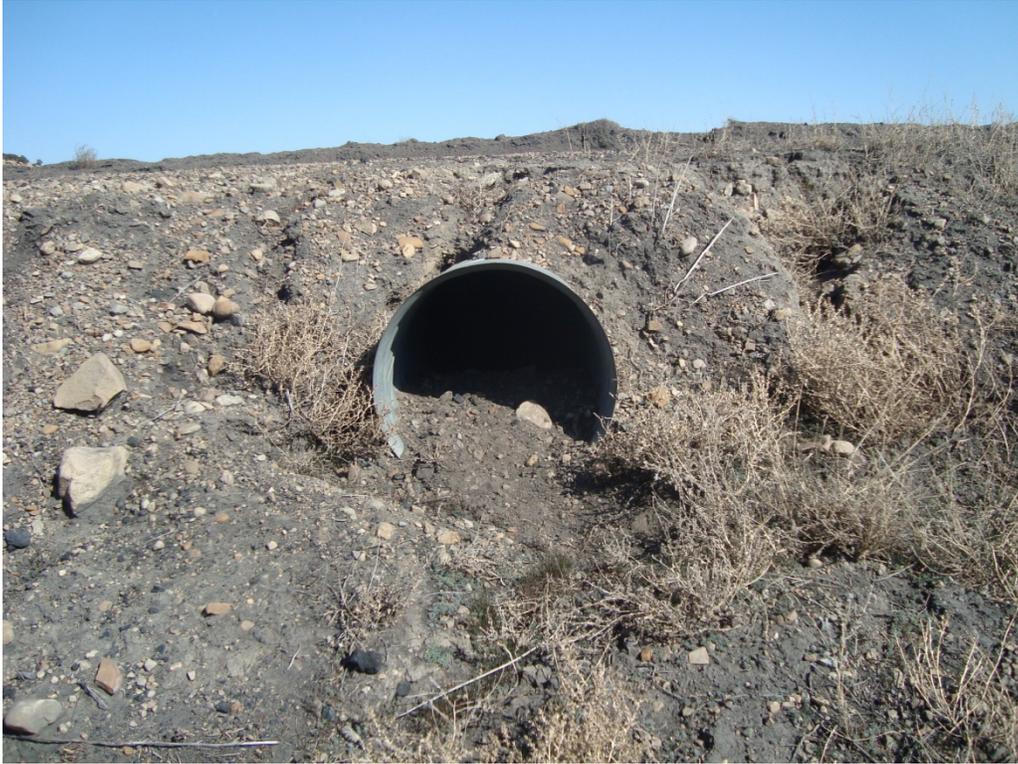
Emergency Spillway Inlet Needs to be Cleaned

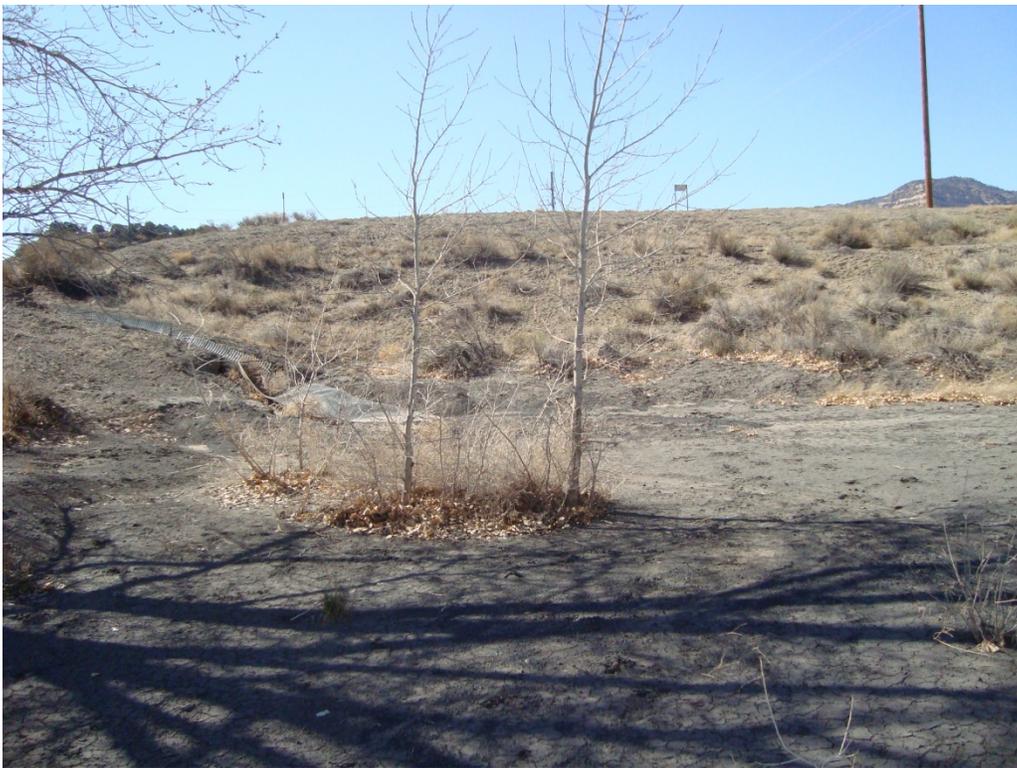
Trees Starting to Grow in Sediment Pond

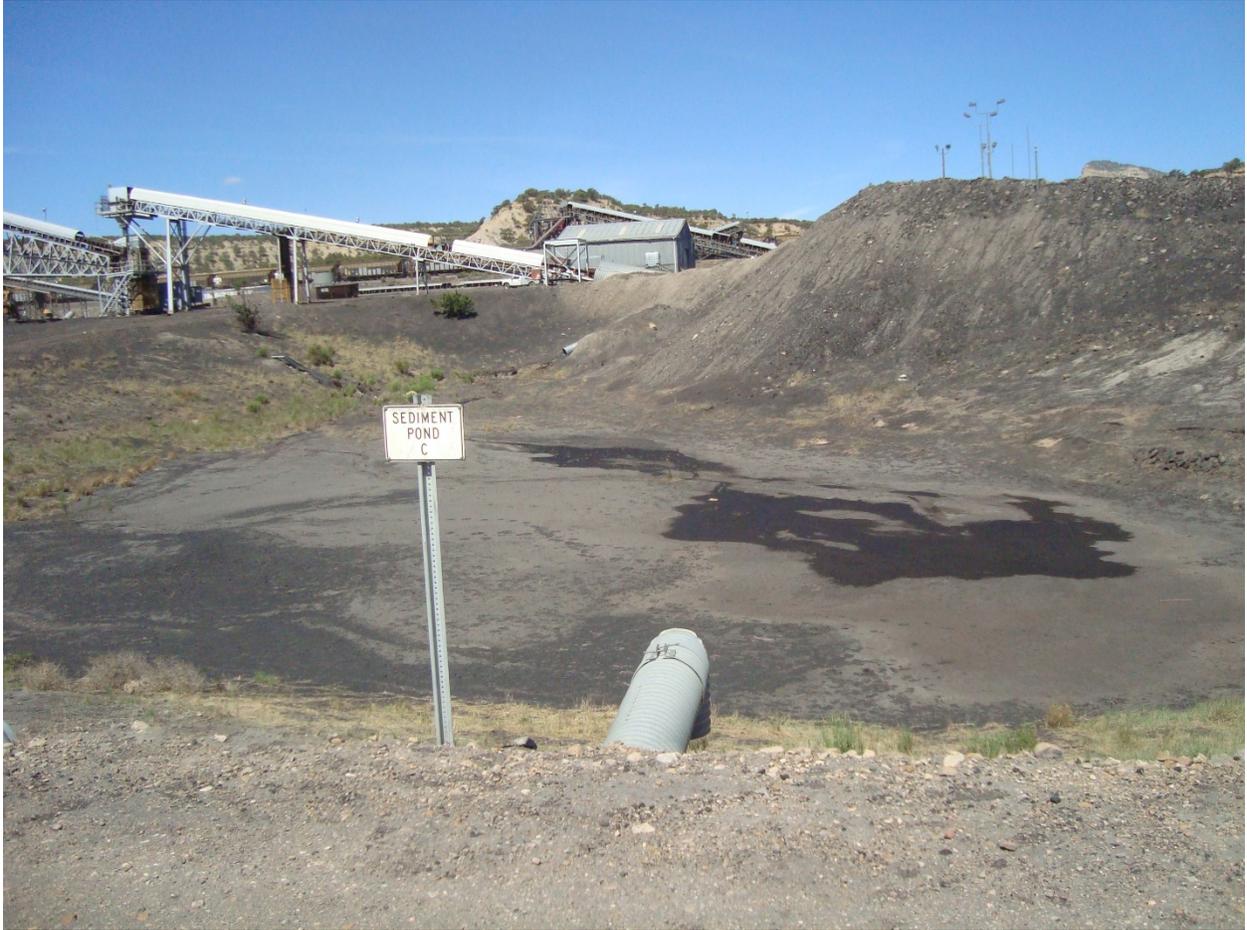
SEDIMENT POND C

GOPHERS & HOLES UNDER INLET SIDE OF PRINCIPAL
SPILLWAY. HOLES SHOULD BE REPAIRED.

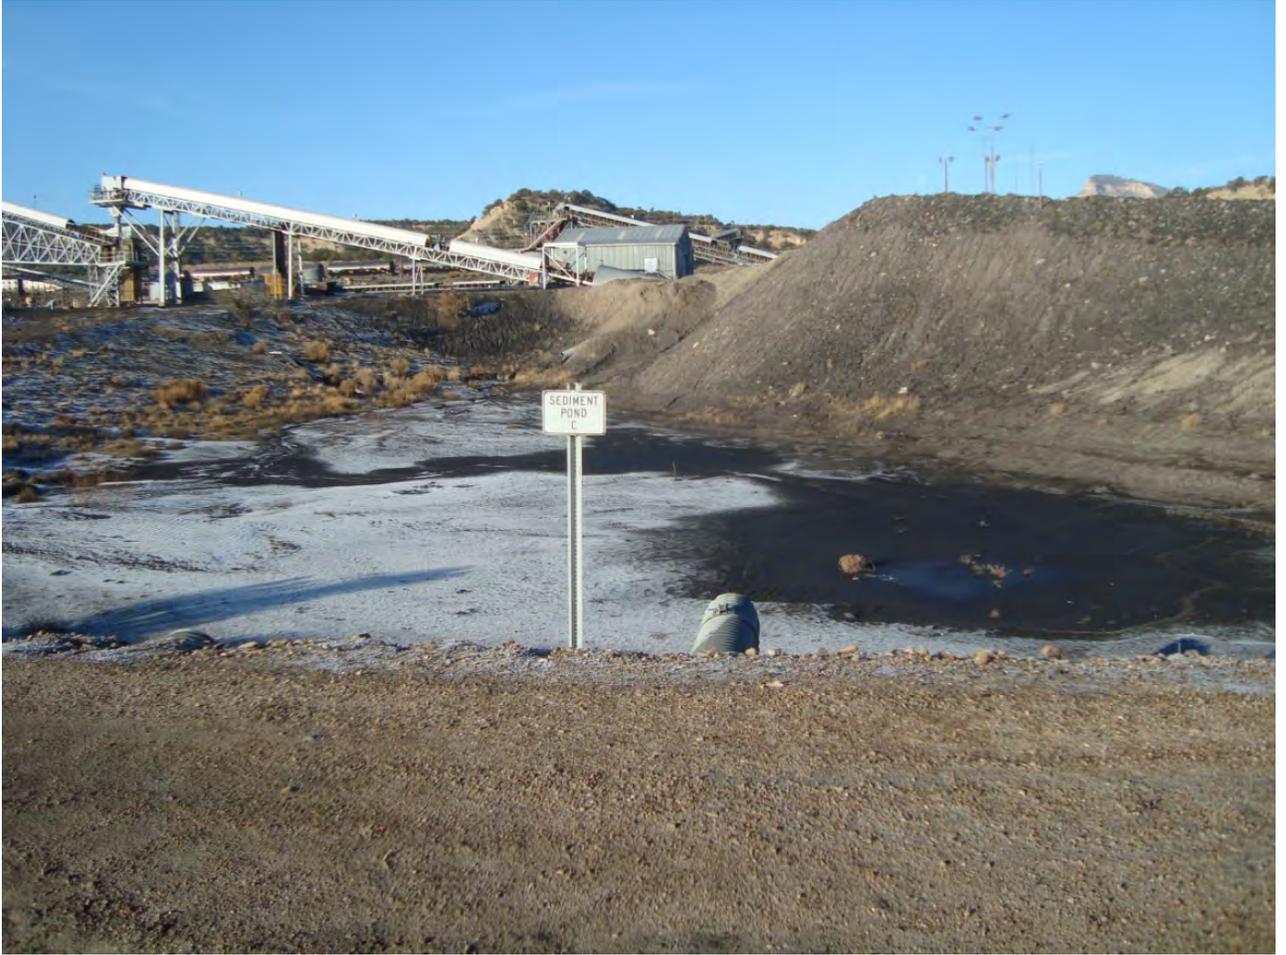
SEDIMENT POND C

The sediment pond was dry. See the attached photograph. Sediment is 11" below cleanout level. Pond sediment is getting close to cleanout level.

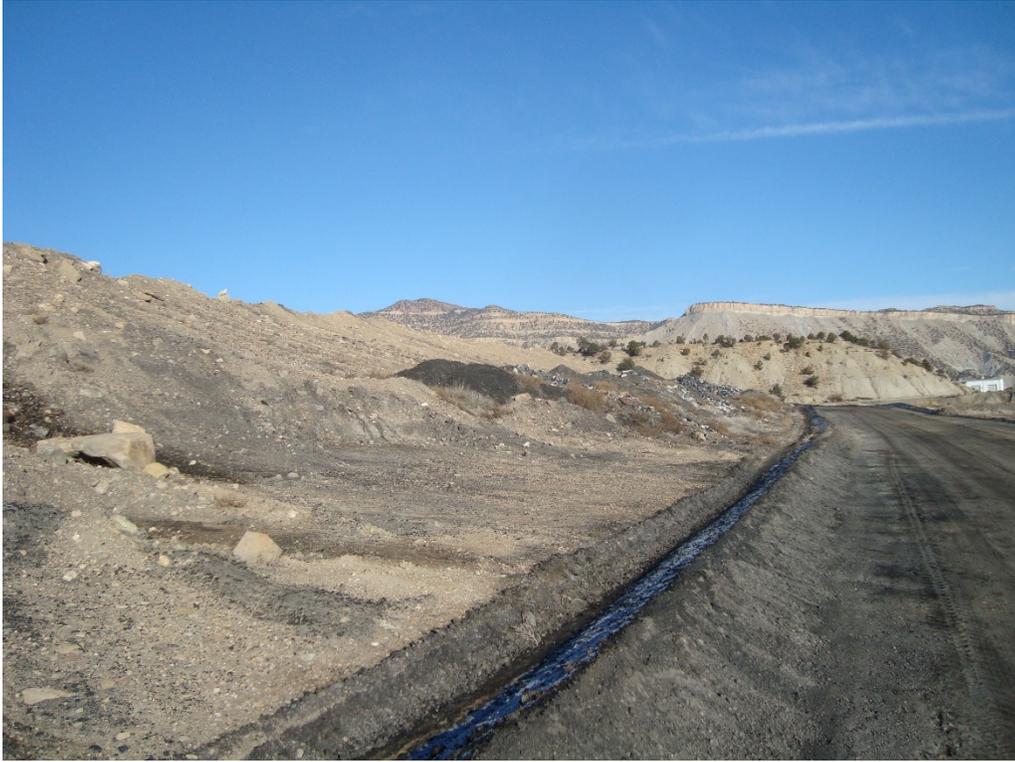
EAST SIDE OF REFUSE PILE
