Fwd: FW: Ponds A, B,C and D Pond Certification

These pond inspections with P.E. certifications for ponds A, B, C, and D at Wildcat were necessary to meet the requirement of R645-301-514.312 after the sediment had been removed (i.e., pond cleanouts). These have also been saved to the "O" drive under C/007/033 so that the next assigned inspector has them available. Tom Paluso did the inspections/certifications. I'm telling you this because I've already completed the second quarter complete inspection with that report for Wildcat.

1. IMPOUNDMENT INSPECTION AND CERTIFIED REPORT		Page 1 of 2	
Permit Number:	ACT/015/025	Report Date: May 26, 2015	
Mine Name:	Wildcat Loadout		
Company Name	Wild West Equipment & Hauling, LLC		
Impoundment Identification:	Impoundment Name	Sediment Pond "A"	
	Impoundment Number:	A	
	UPDES Permit Number:	UTG040007	
	MSHA ID Number:	42-01864	
IMPOUNDMENT INSPECTION			
Inspection Date:	April 13, 2015		
Inspected By:	J.T. Paluso		
Reason for Inspection:	Annual Inspection		
(Annual, Quarterly or other Periodic Inspection, Critical Installation or Completion of Construction)

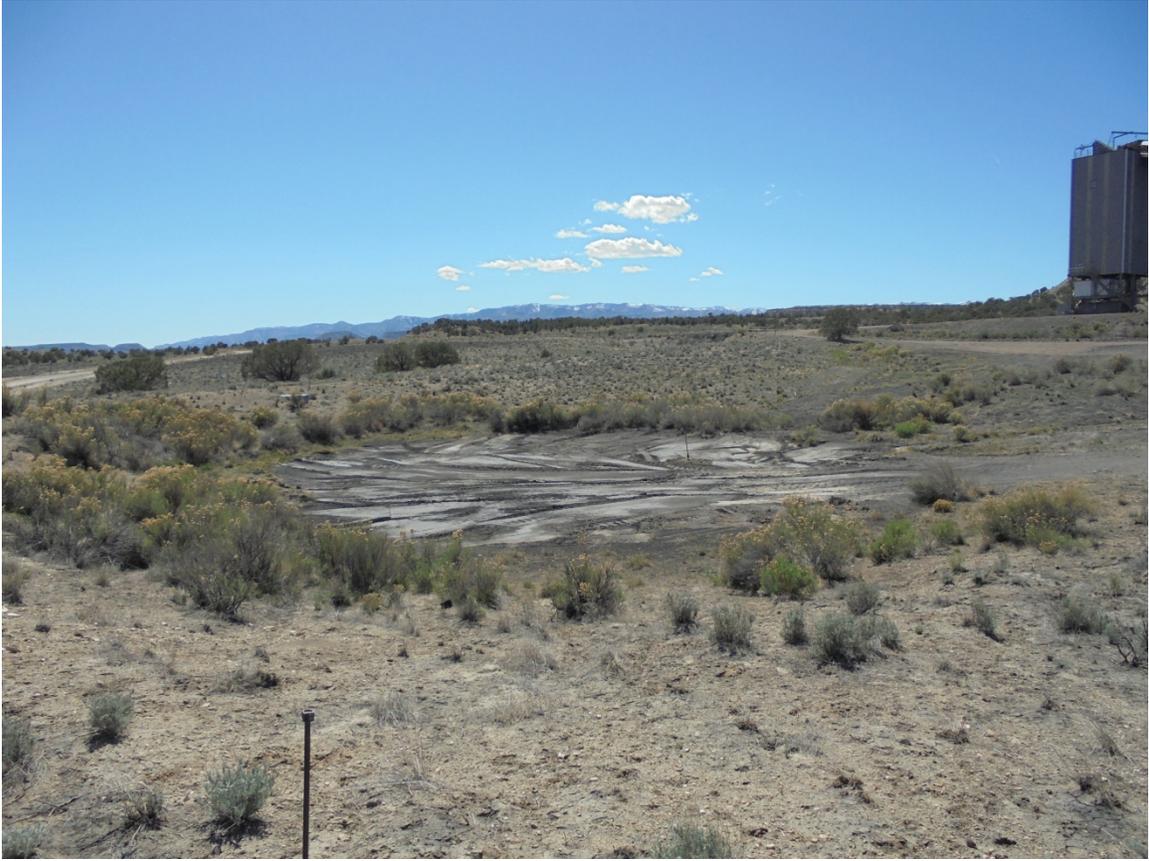
POND A

1. Describe any appearances of any instability, structural weakness, or any other hazardous condition.			
The pond's dam shows no signs of structural instability or other hazardous conditions.			
Required for an impoundment which functions as a SEDIMENTATION POND	2. Sediment storage capacity and storage volumes.		
	Existing Storage Capacity: 2.9 ac-ft		
	Existing Sediment Storage Capacity (To Cleanout): .85 ac-ft

3. Principle and emergency spillway elevations		
	Principle spillway elevation: 6,149.0'		
	Emergency spillway elevation: 6,150.0'		
4. Field Information: Provide current water elevation, whether pond is discharging, type and number of samples taken, monitoring/instrumentation information, inlet/outlet conditions or other related activities associated with the pond including but not limited to sediment cleanout, pond decanting, embankment erosion/repairs, monitoring information, vegetation on out slopes of embankment erosion/repairs, monitoring information, vegetation on out slopes of embankments, etc.			
During the quarterly inspection, April 13, 2015, the vegetative cover looked good with no signs of erosion. Both spillways look good with no signs of stability problems.

5. Field Evaluation: Describe any changes in the geometry of the impounding structure, average and maximum depths and elevations of impounded water, estimated sediment or slurry volume and remaining storage capacity, estimated volume of water impounded and any other aspect of the impounding structure affecting its stability or function which has occurred during the reporting period.			
The sediment pond is dry and the excess sediment has been removed, see the attached photograph. Sediment is approximately 34" below cleanout level.			
Qualified Statement	I hereby certify that I am experienced in the construction of impoundments; I am qualified and authorized under the direction of a Registered Professional Engineer to inspect the condition and appearance of impoundments in accordance with the certified and approved designs for this structure, that the impoundment has been maintained in accordance with approved design and meet or exceed the minimum design requirements under all applicable federal, state and local regulations; and, that inspections and inspection reports are made by myself and include any appearances of instability, structural weakness or other hazardous conditions of the structure affecting stability.

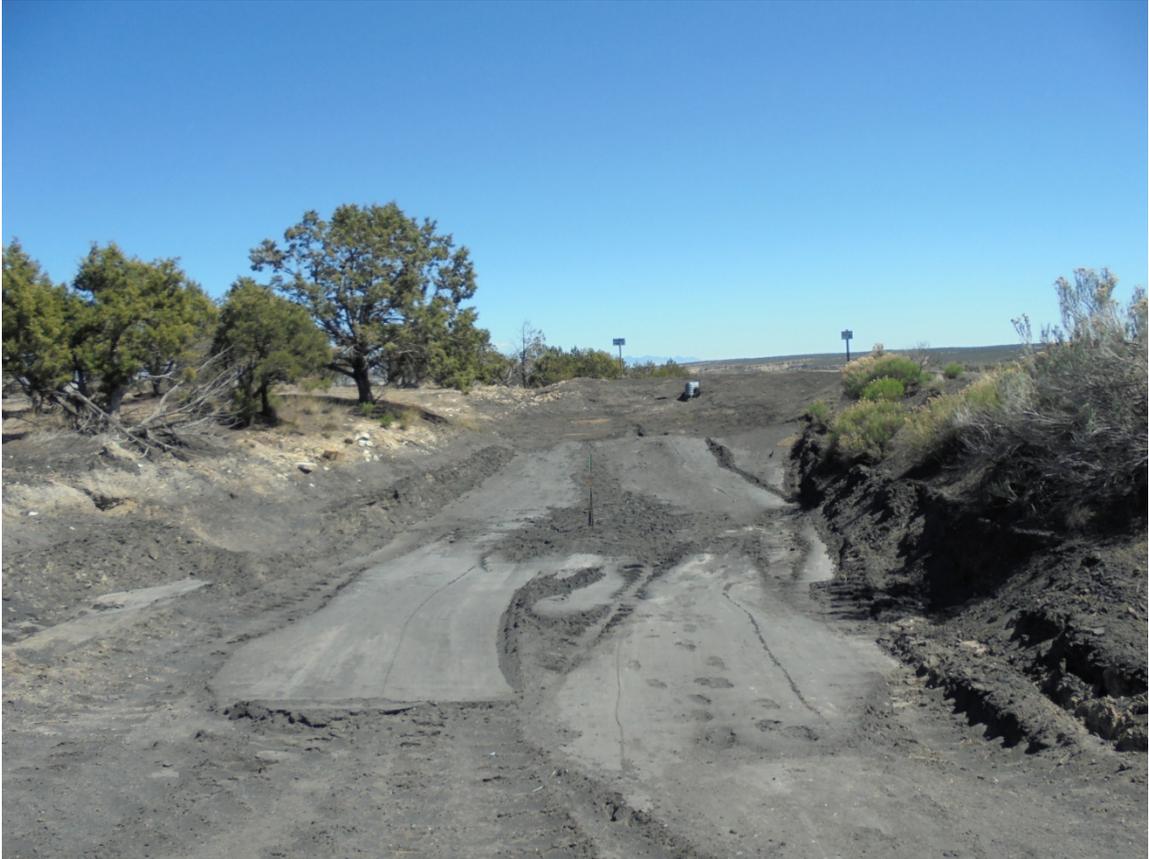
POND B

The pond's dam shows no signs of structural instability or other hazardous conditions.

During the quarterly inspection, April 13, 2015, the vegetative cover looked good with no signs of erosion.

The sediment pond was dry and the excess sediment has been removed, see the attached photograph. Sediment is 38" below cleanout level.

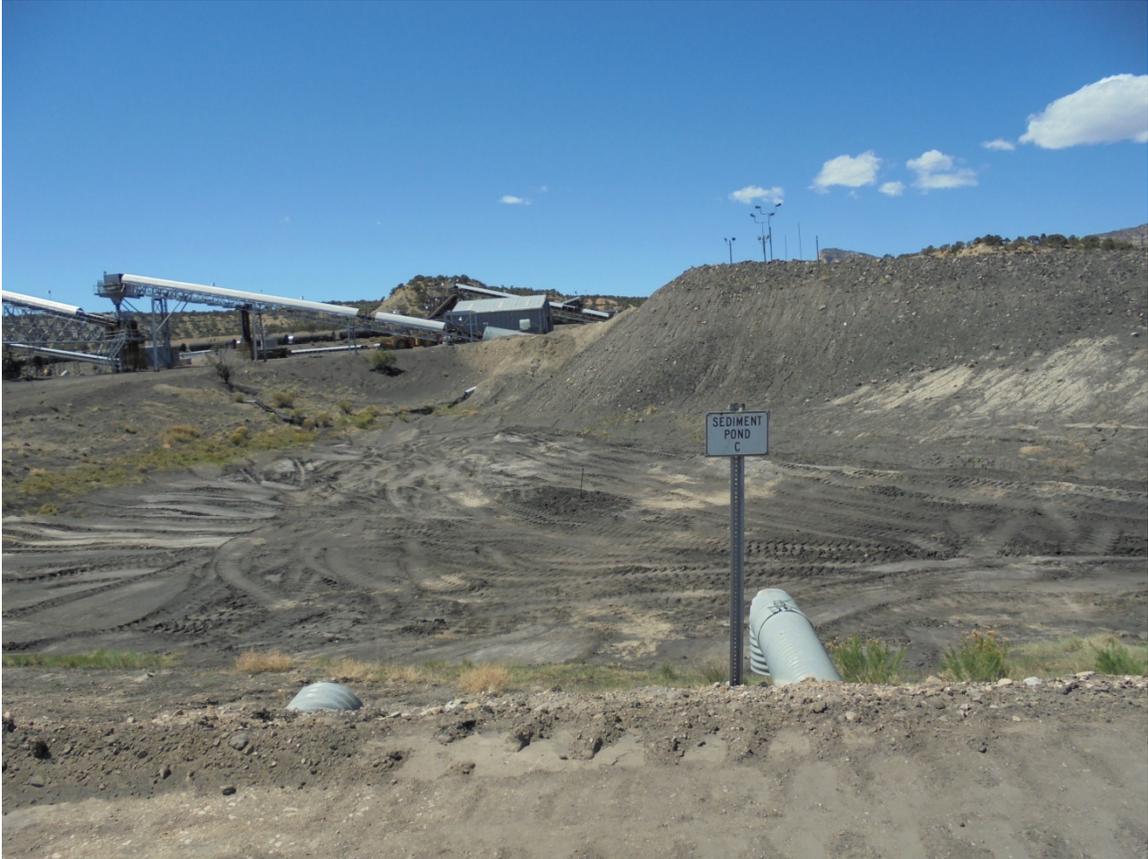
POND C

1. Describe any appearances of any instability, structural weakness, or any other hazardous condition.			
The pond's dam shows no signs of structural instability or other hazardous conditions.			
Required for an impoundment which functions as a SEDIMENTATION POND	2. Sediment storage capacity and storage volumes.		
	Existing Storage Capacity: 4.174 ac-ft		
	Existing Sediment Storage Capacity (To Cleanout): 0.88 ac-ft

3. Principle and emergency spillway elevations		
	Principle spillway elevation: 6,137.0'		
	Emergency spillway elevation: 6,138.0'		
4. Field Information: Provide current water elevation, whether pond is discharging, type and number of samples taken, monitoring/instrumentation information, inlet/outlet conditions or other related activities associated with the pond including but not limited to sediment cleanout, pond decanting, embankment erosion/repairs, monitoring information, vegetation on outslopes of embankment erosion/repairs, monitoring information, vegetation on outslopes of embankments, etc.			
During the quarterly inspection, April 13, 2015, the vegetative cover looked good with no signs of erosion.

5. Field Evaluation: Describe any changes in the geometry of the impounding structure, average and maximum depths and elevations of impounded water, estimated sediment or slurry volume and remaining storage capacity, estimated volume of water impounded and any other aspect of the impounding structure affecting its stability or function which has occurred during the reporting period.			
The sediment pond was dry and the excess sediment has been removed, see the attached photograph. Sediment is 42" below cleanout level.			
Qualified Statement	I hereby certify that I am experienced in the construction of impoundments; I am qualified and authorized under the direction of a Registered Professional Engineer to inspect the condition and appearance of impoundments in accordance with the certified and approved designs for this structure, that the impoundment has been maintained in accordance with approved design and meet or exceed the minimum design requirements under all applicable federal, state and local regulations; and, that inspections and inspection reports are made by myself and include any appearances of instability, structural weakness or other hazardous conditions of the structure affecting stability.

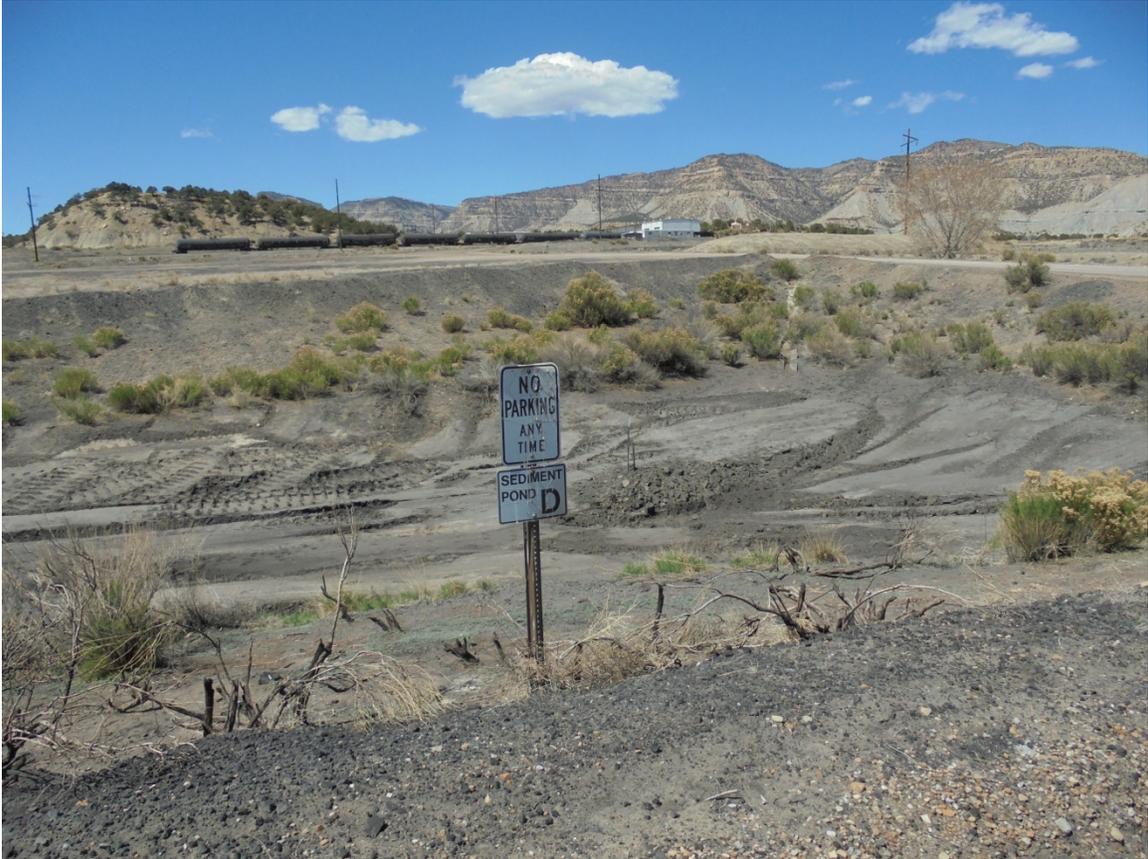
POND D

1. Describe any appearances of any instability, structural weakness, or any other hazardous condition.			
The pond's dam shows no signs of structural instability or other hazardous conditions.			
Required for an impoundment which functions as a SEDIMENTATION POND	2. Sediment storage capacity and storage volumes.		
	Existing Storage Capacity: 1.131 ac-ft		
	Existing Sediment Storage Capacity (To Cleanout): 0.33 ac-ft

3. Principle and emergency spillway elevations		
	Principle spillway elevation: 6,139.0'		
	Emergency spillway elevation: 6,140.0'		
4. Field Information: Provide current water elevation, whether pond is discharging, type and number of samples taken, monitoring/instrumentation information, inlet/outlet conditions or other related activities associated with the pond including but not limited to sediment cleanout, pond decanting, embankment erosion/repairs, monitoring information, vegetation on out slopes of embankment erosion/repairs, monitoring information, vegetation on out slopes of embankments, etc.			
During the quarterly inspection, April 13, 2015, the vegetative cover looked good with no signs of erosion.

5. Field Evaluation: Describe any changes in the geometry of the impounding structure, average and maximum depths and elevations of impounded water, estimated sediment or slurry volume and remaining storage capacity, estimated volume of water impounded and any other aspect of the impounding structure affecting its stability or function which has occurred during the reporting period.			
The sediment pond was dry and the excess sediment has been removed, see the attached photograph. Sediment is approximately 48" below cleanout level.			
Qualified Statement	I hereby certify that I am experienced in the construction of impoundments; I am qualified and authorized under the direction of a Registered Professional Engineer to inspect the condition and appearance of impoundments in accordance with the certified and approved designs for this structure, that the impoundment has been maintained in accordance with approved design and meet or exceed the minimum design requirements under all applicable federal, state and local regulations; and, that inspections and inspection reports are made by myself and include any appearances of instability, structural weakness or other hazardous conditions of the structure affecting stability.
